Field Metalizing of a Steel Beam Bridge

HARDWICK VERMONT - VT RTE. 16 BR. 1

J. B. McCarthy, P. E.
VTrans Project Manager

2022 Hybrid Research and Innovation Symposium
September 14, 2022
Berlin, VT

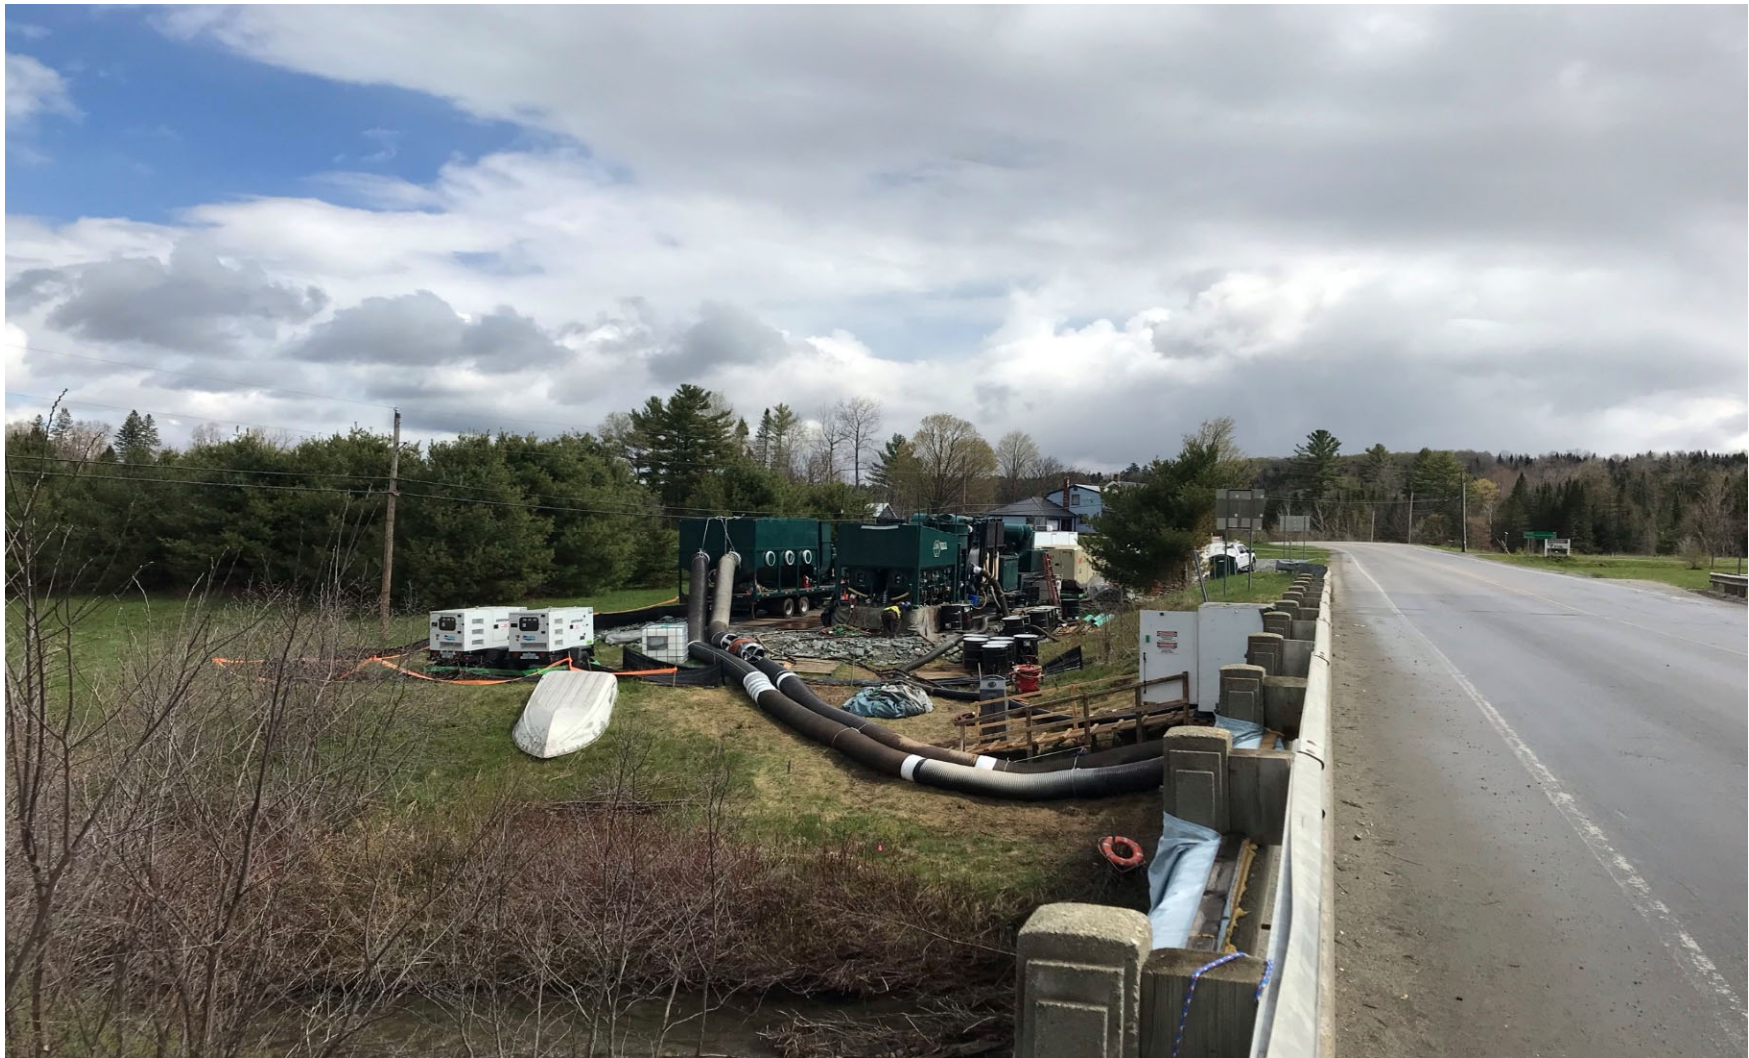
Air Filtration Ducts

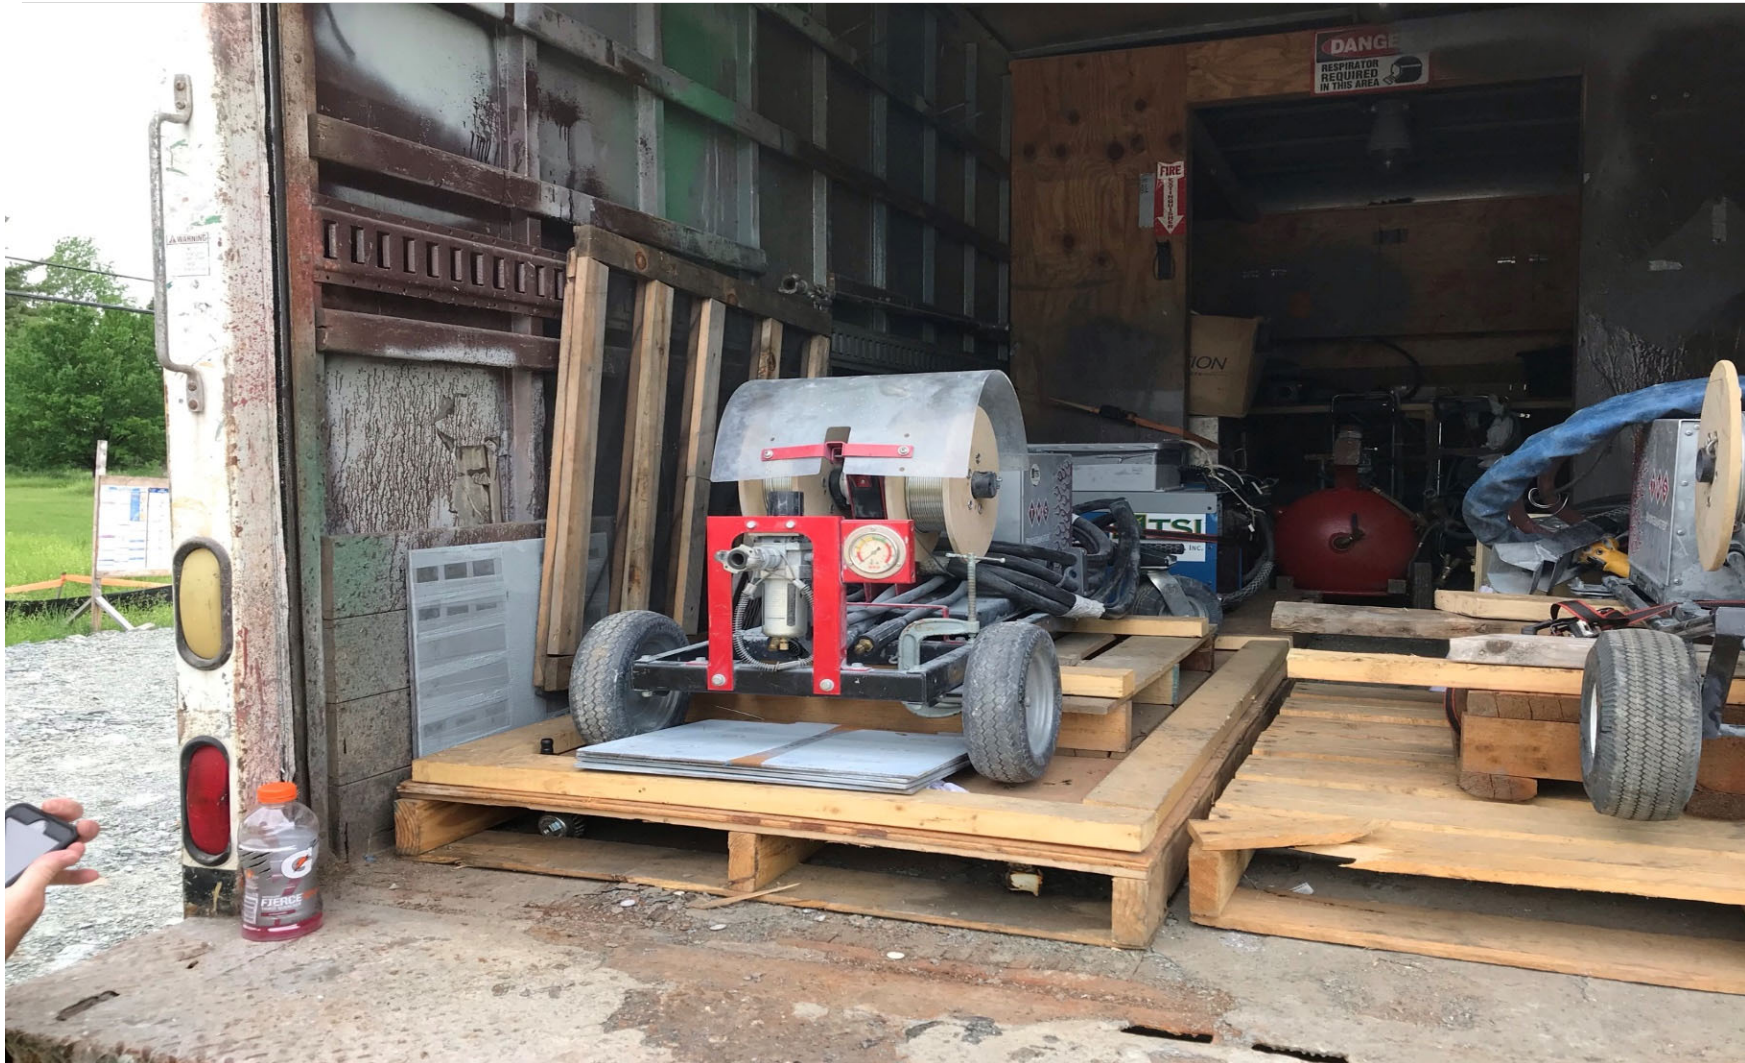
Metalizing equipment (notice spools of zinc wire)

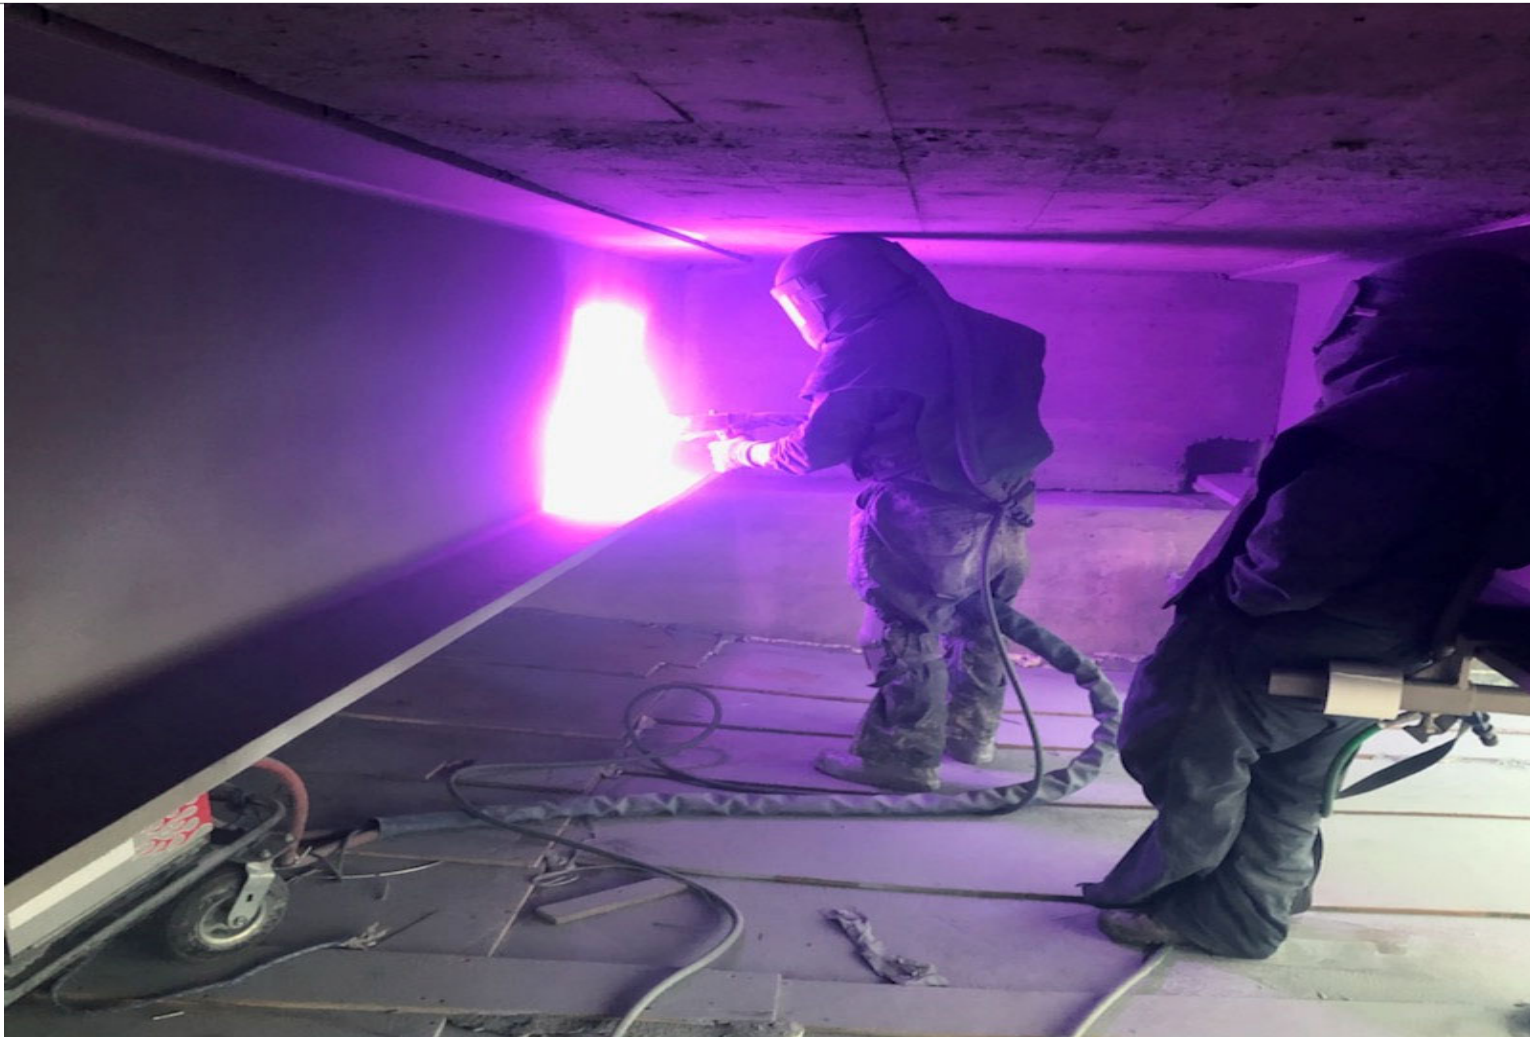
Applying the metalizing

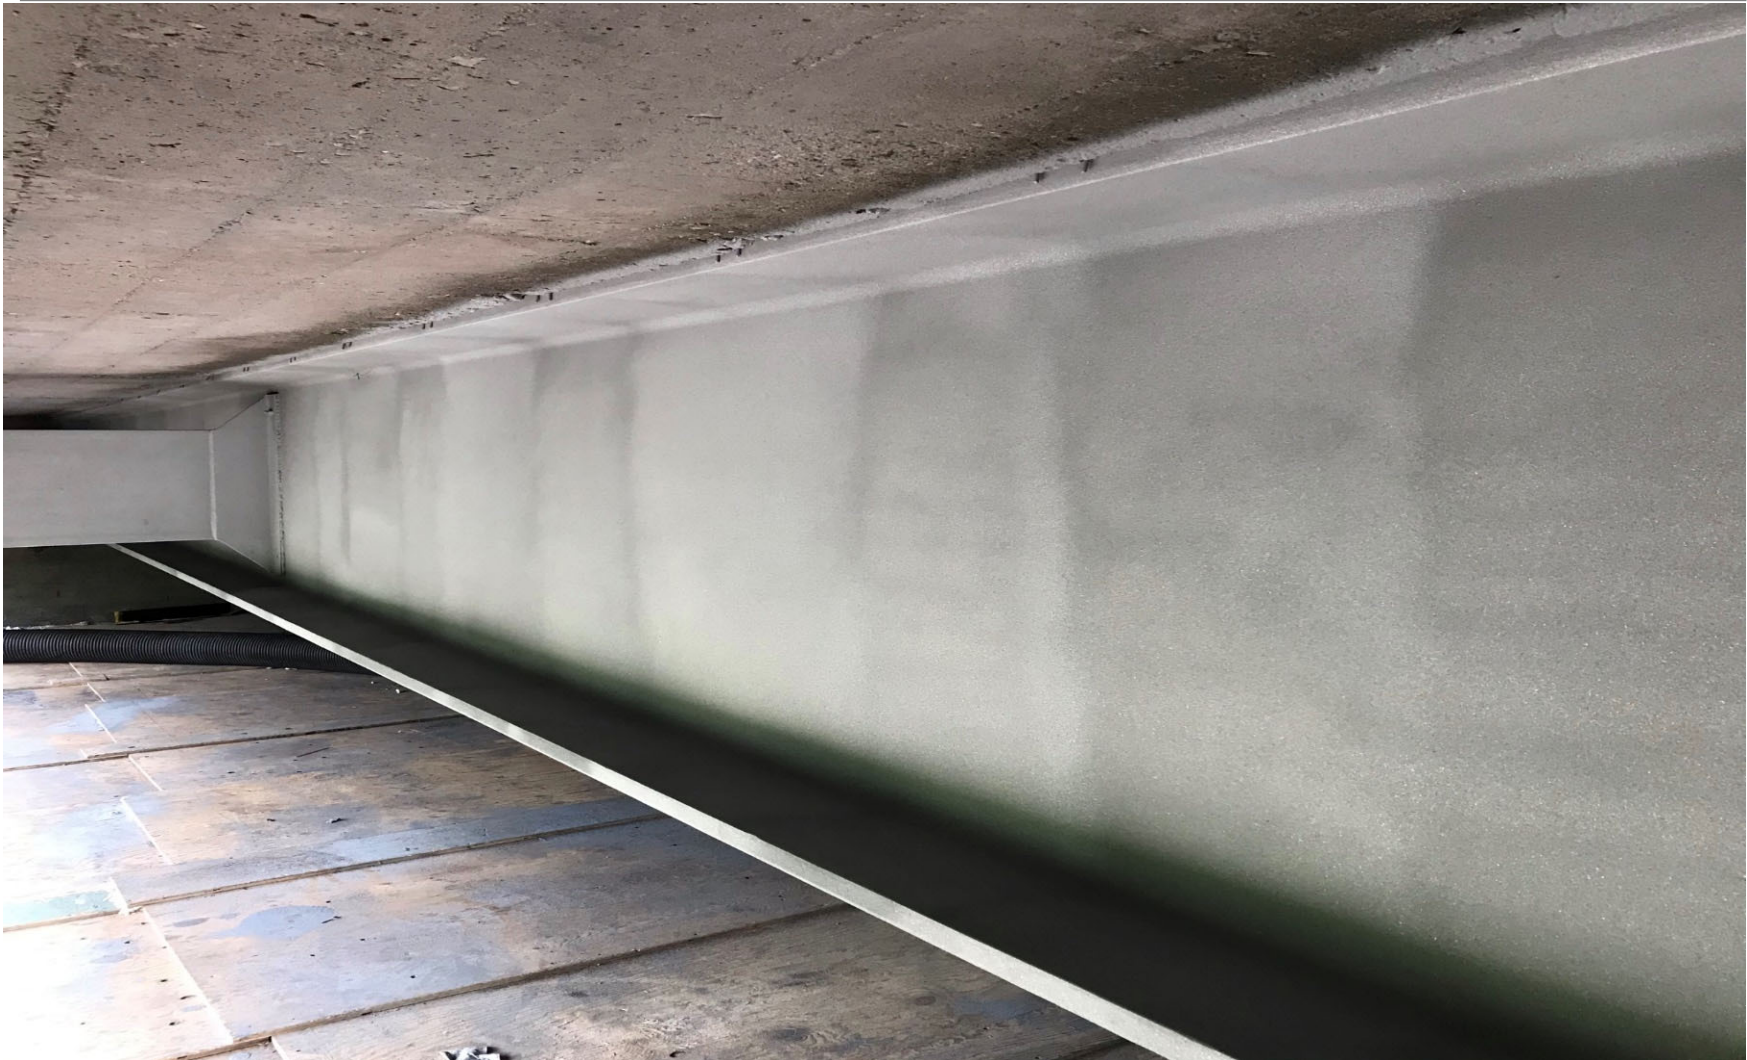
Streaking due to metalizing pattern and potentially variable sealer application

- A considerable amount of the zinc wire simply rebounds off the substrate creating a dusty environment.
- There was relatively poor visibility inside the enclosure during the metalizing even with dust collectors and air scrubbers running.
- Perhaps the uneven final appearance was a result of this poor visibility or uneven application of the sealer.
- Different color sealers are available, and the final surface can be painted in areas where aesthetics is a concern.
- Overall weather conditions were good during the metalizing with no rain or damp humid weather to contend with.
- Construction engineering cost was higher than expected given the amount of review and resubmittals required to arrive at acceptable documents to perform the work.

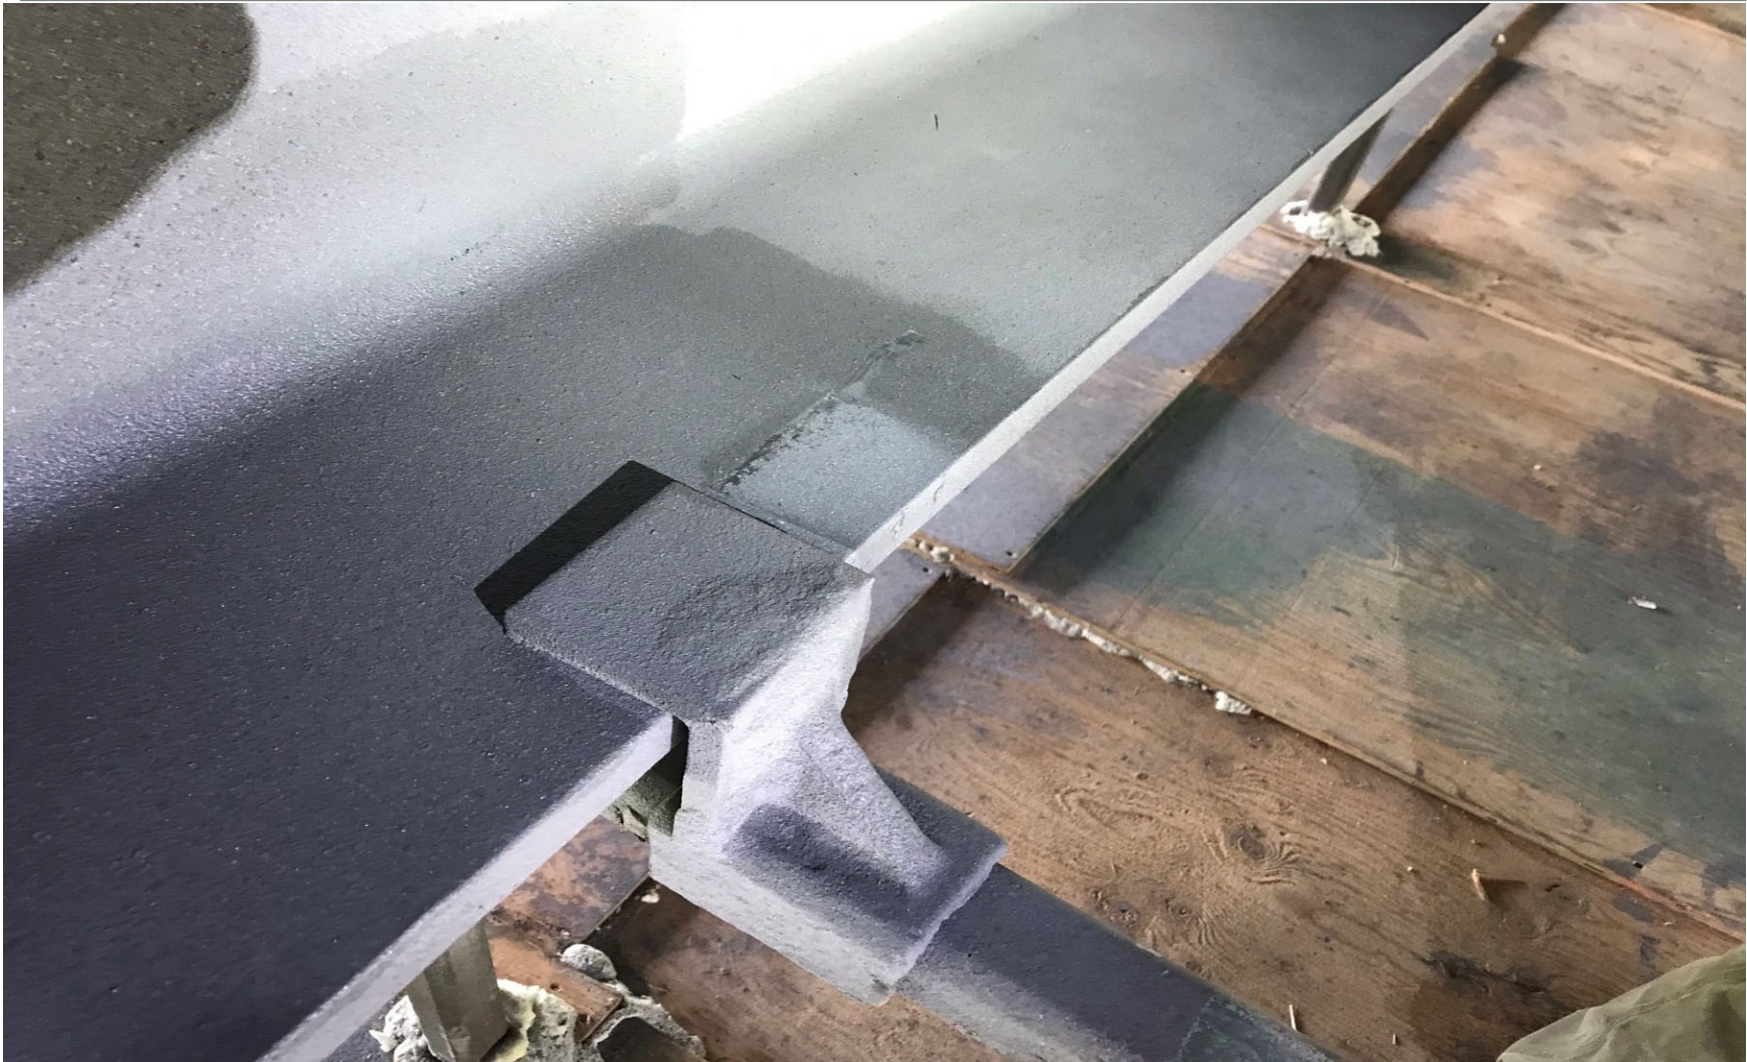
Hanger brackets need to be moved to complete the metalizing and sealer

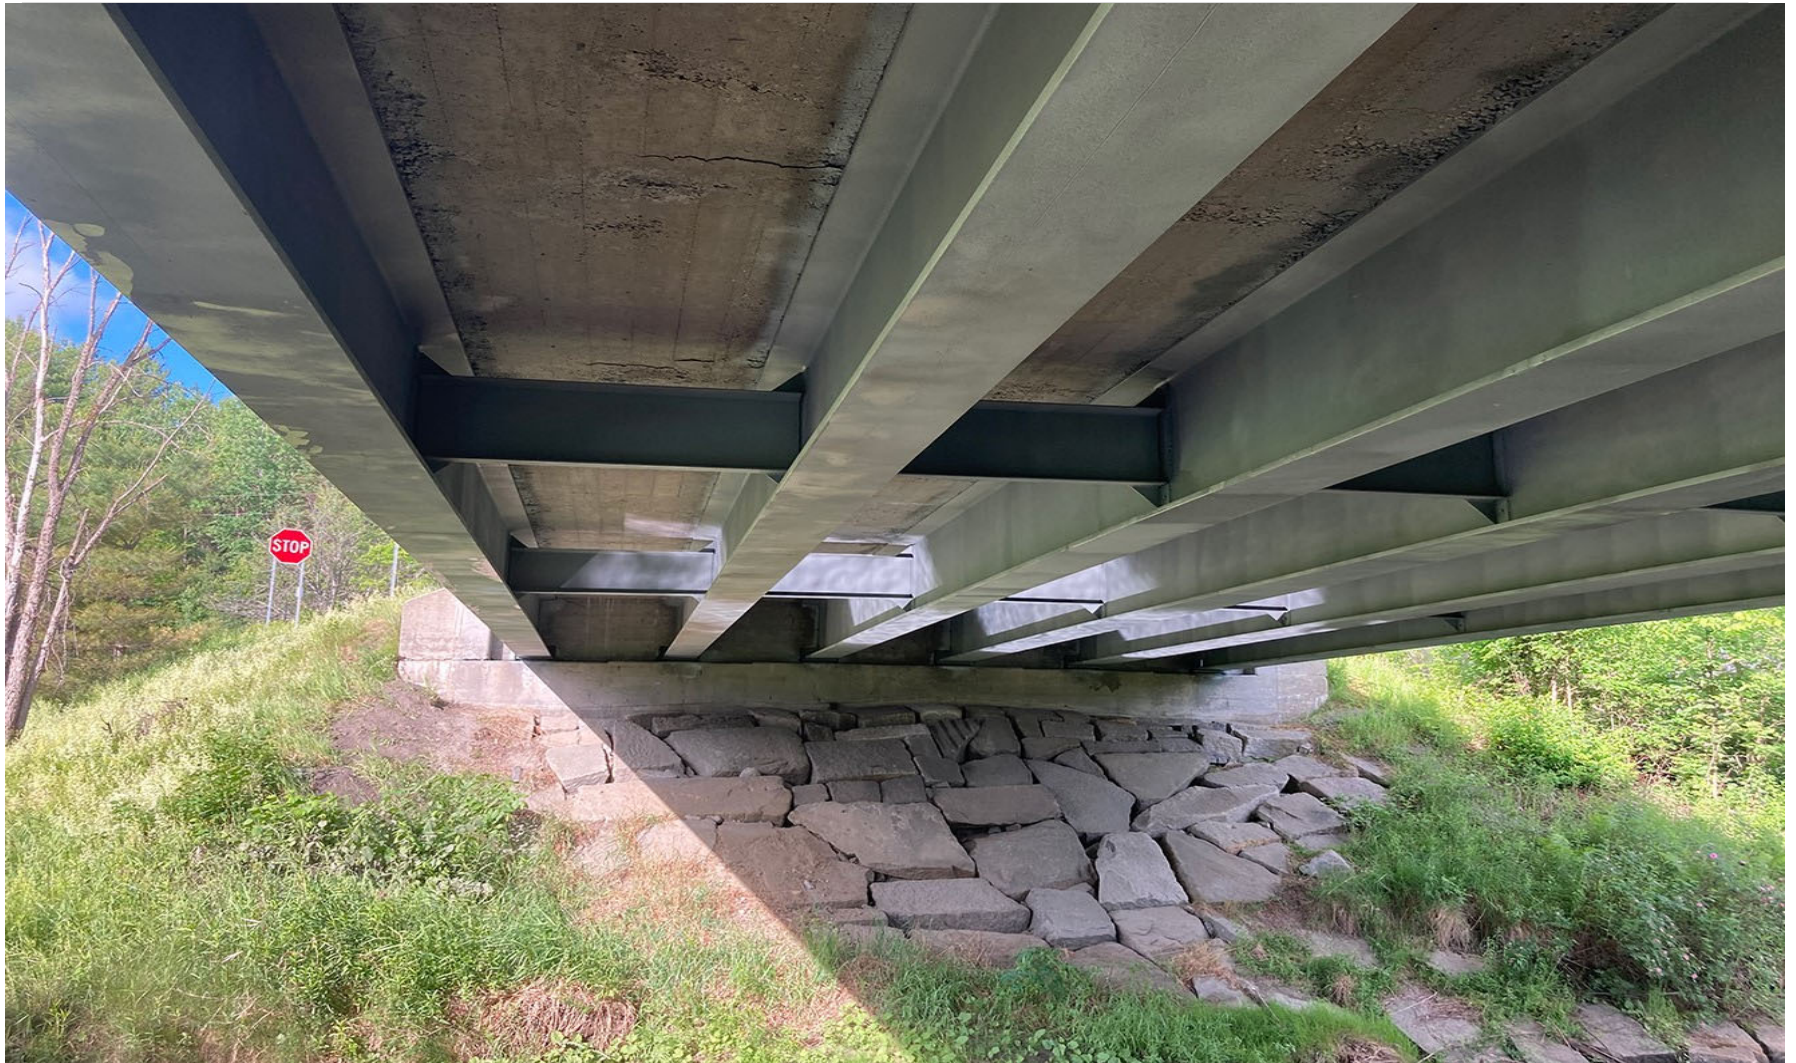
Finished Product
