Stainless Steel Coated Rebar for Chloride-Resistant Concrete Highway and Bridges

Sam McAlpine, PhD
Allium Engineering INC

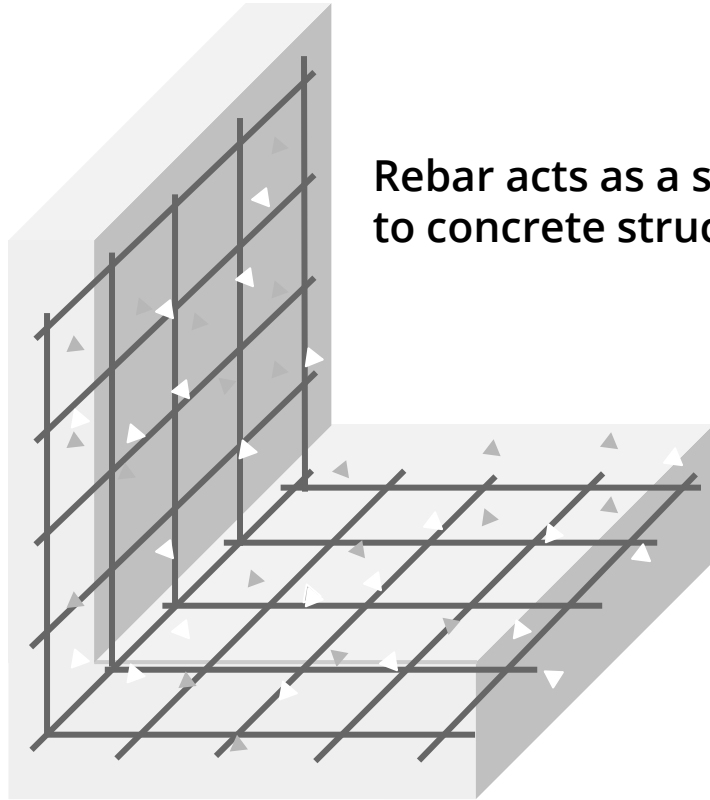
Problem: Rebar corrosion causes concrete degradation

Rebar acts as a steel skeleton
to concrete structures

Rust weakens the steel rebar,
expands and breaks the concrete

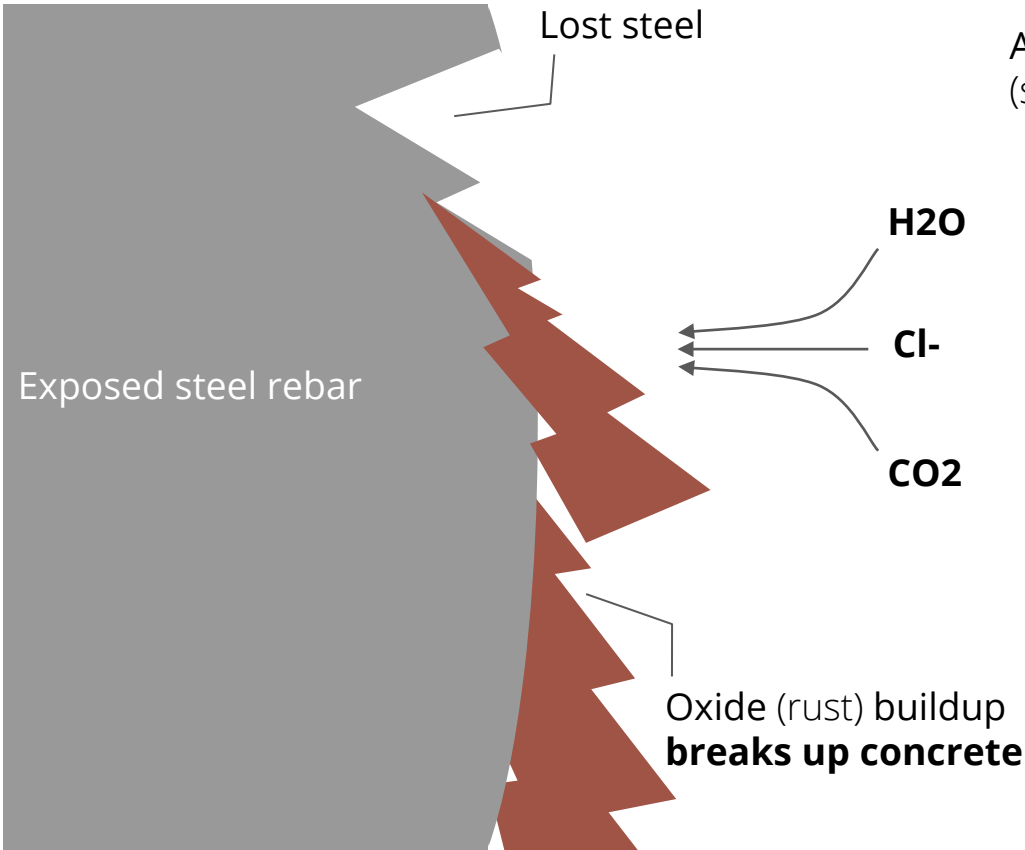
Plain rebar

Allium protected rebar

Allium metal coating
(stainless steel)

Protective
oxide barrier

Protected steel rebar

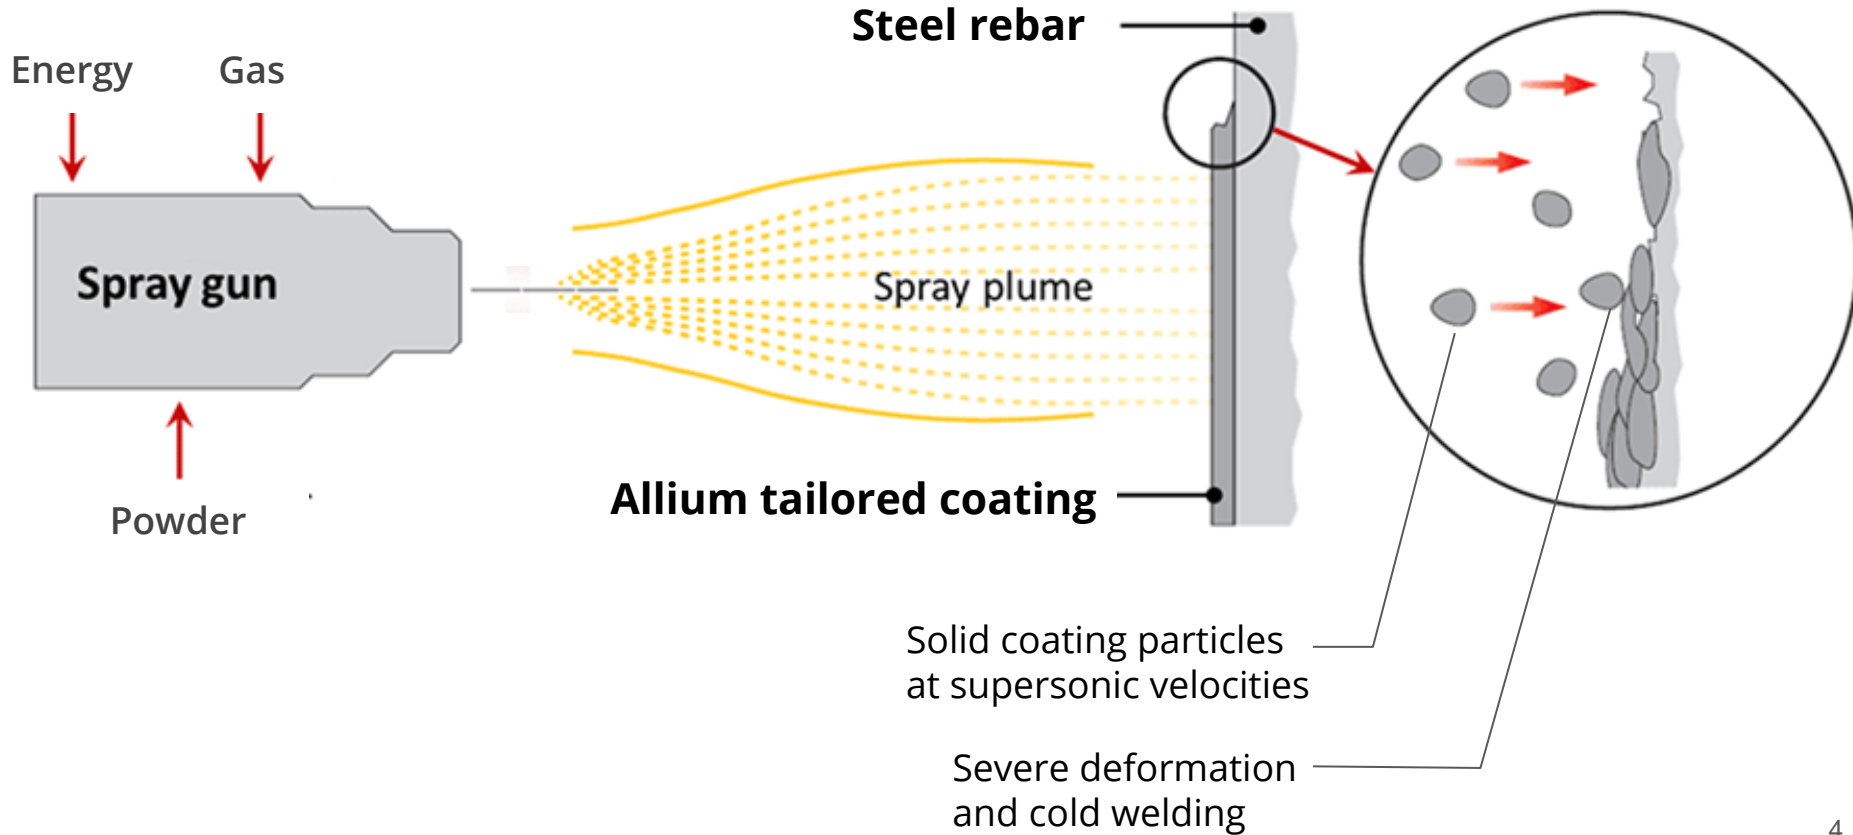
Our in-line coating uses cold spray technology

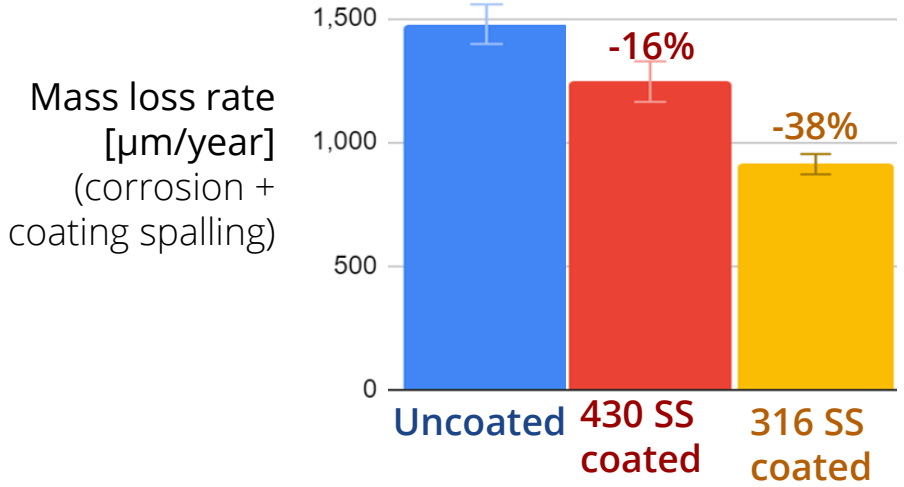
Aggressive corrosion test 1:

salt spray prototype 1
Coating delamination reduces effectiveness

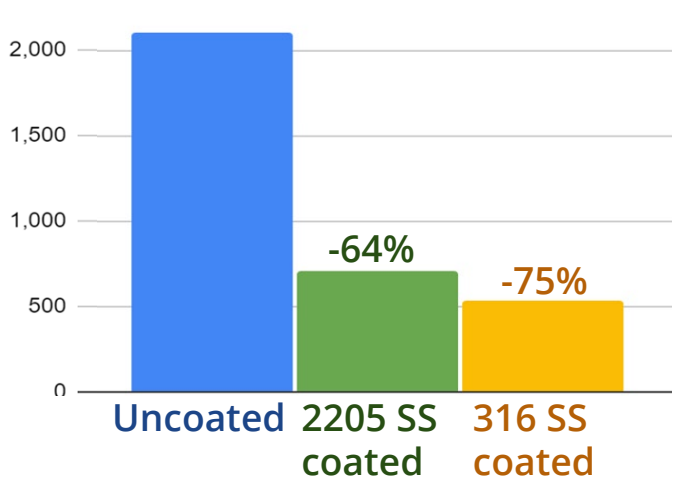
Aggressive corrosion test v2:

salt spray prototype 2
Improved spraying boosts effectiveness

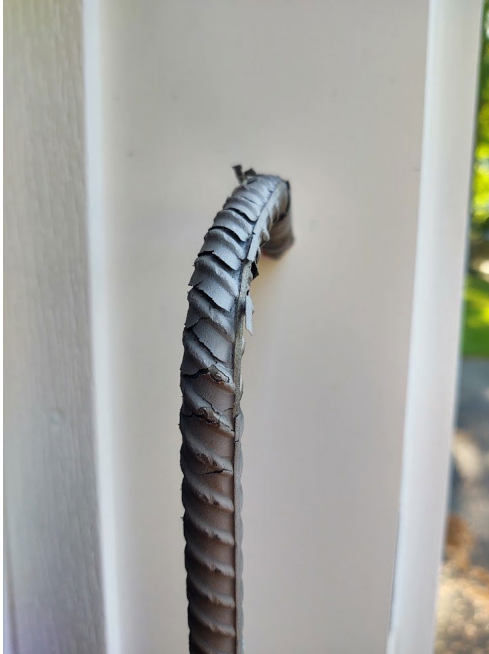
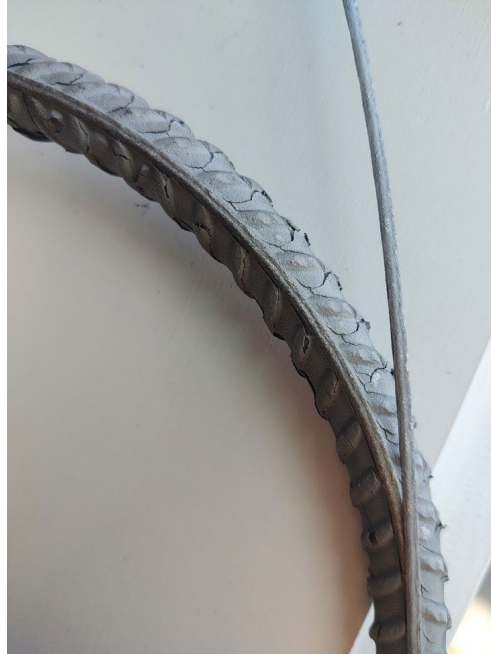
Cracking in as-sprayed bars

Cracking is an issue, but can be solved

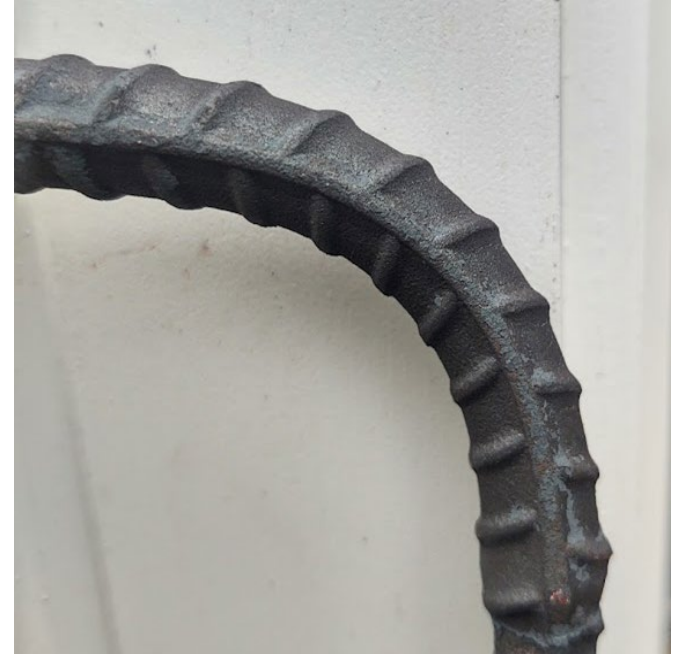
Annealed 1 hr @ 1100C, quenched,
tempered 1hr @ 600C

No cracking in annealed bars
