Vermont Stone Matrix Asphalt Trial Project

T2 Grant/EDC-6 TOPS

Stone Matrix Asphalt

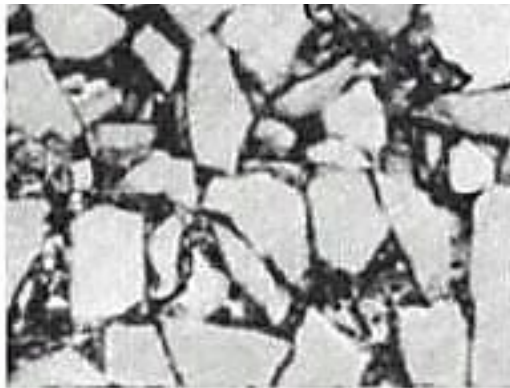
SMA deviates from the conventional dense graded mixture, it relies on high quality gap graded coarse aggregates to form an interlocking structure of stone-on-stone contact, bound and filled by a heavy asphalt mastic. Fibers are often used to prevent drain down, which is a concern. SMA is thought to offer both rut resistance through its stone skeleton, and flexibility from the high asphalt content.

Stone Matrix Asphalt

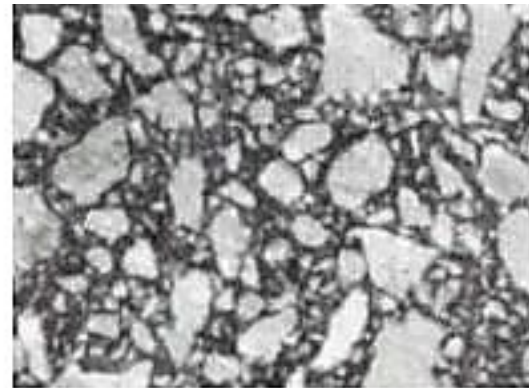
Dense Graded HMA

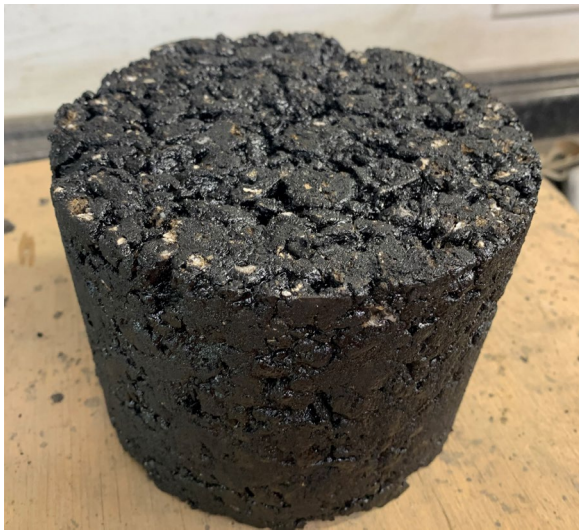
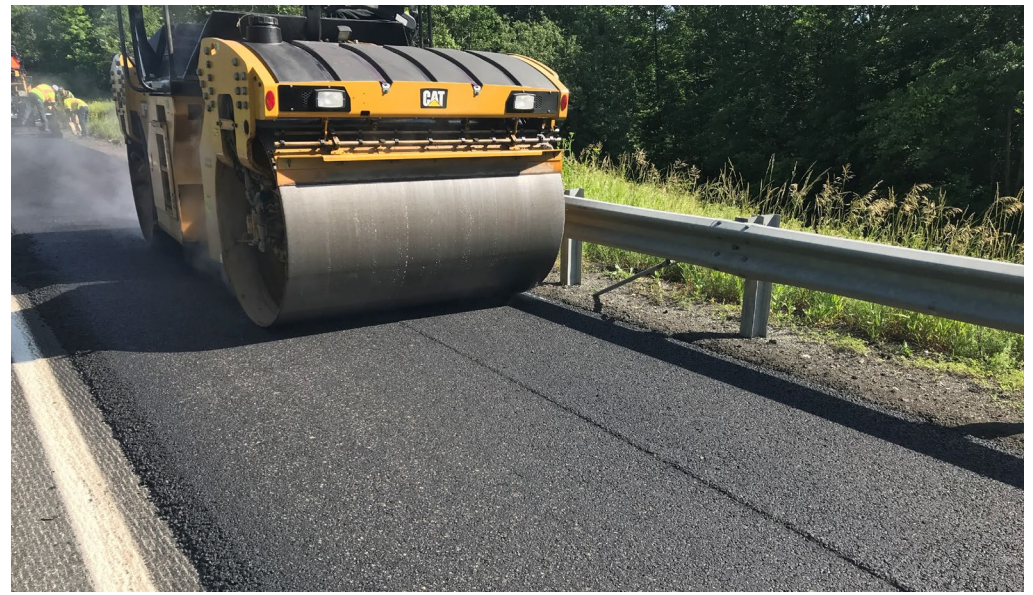
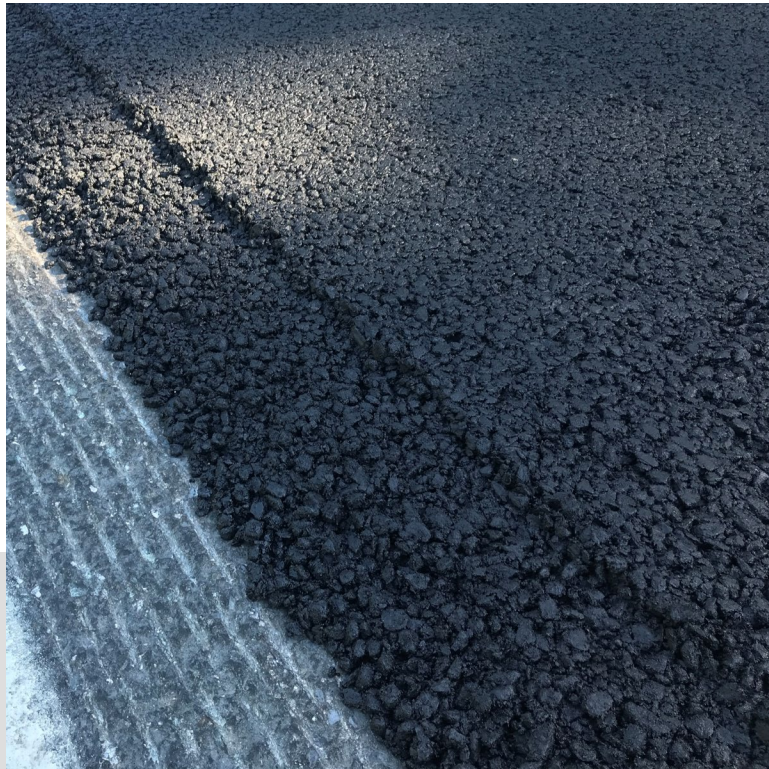
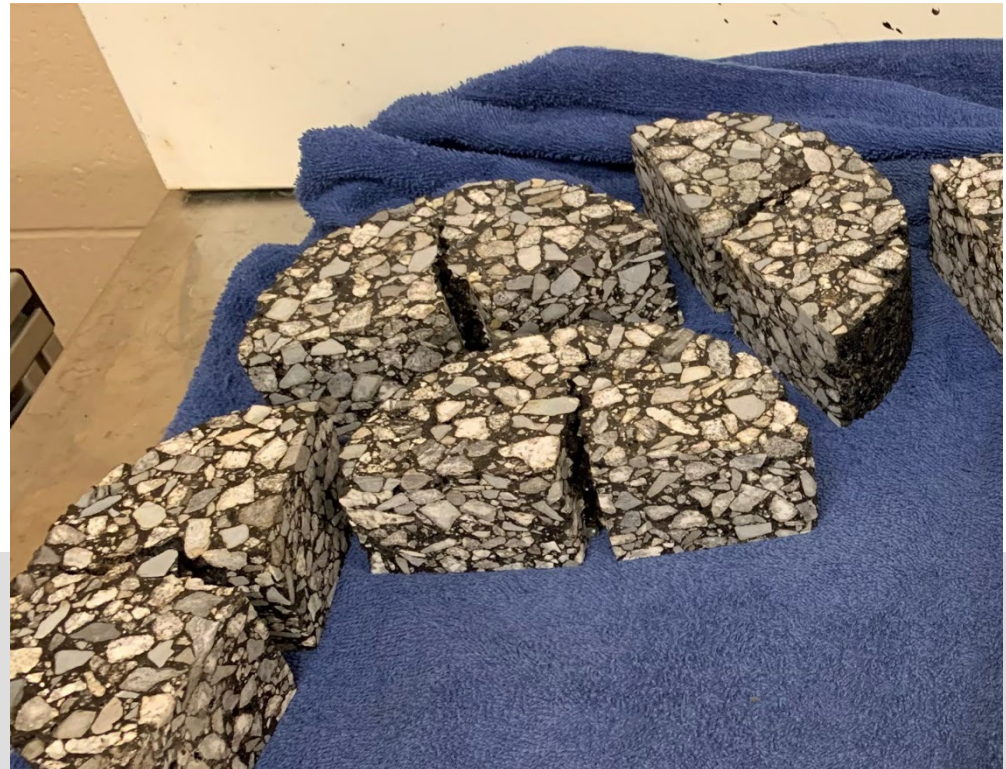
Performance Testing

HWT VTrans (FHWA)	IFIT VTrans (FHWA)	IDEAL-CT VTrans (FWHA)
VTrans SMA Spec	<10 mm	>10	
Mix Design SMA	2.9 mm	10.6	
Mix Design HMA	2.0 mm	12.3	
Production SMA	4.56 mm (3.2 mm)	19.8 (11.9)	312.9 (176.6)
Production HMA	2.63 mm (1.9 mm)	11.8 (8.7)	193.9 (93.2)
2021 HMA Average	3.18 mm	12.4	208
