Accelerated Innovation Deployment (AID) Demonstration Project
Field Metalizing of a Steel Beam Bridge
Vermont Agency of Transportation
Structures Design Section
Final Report
J. B. McCarthy, VTrans Project Manager
August 11, 2023

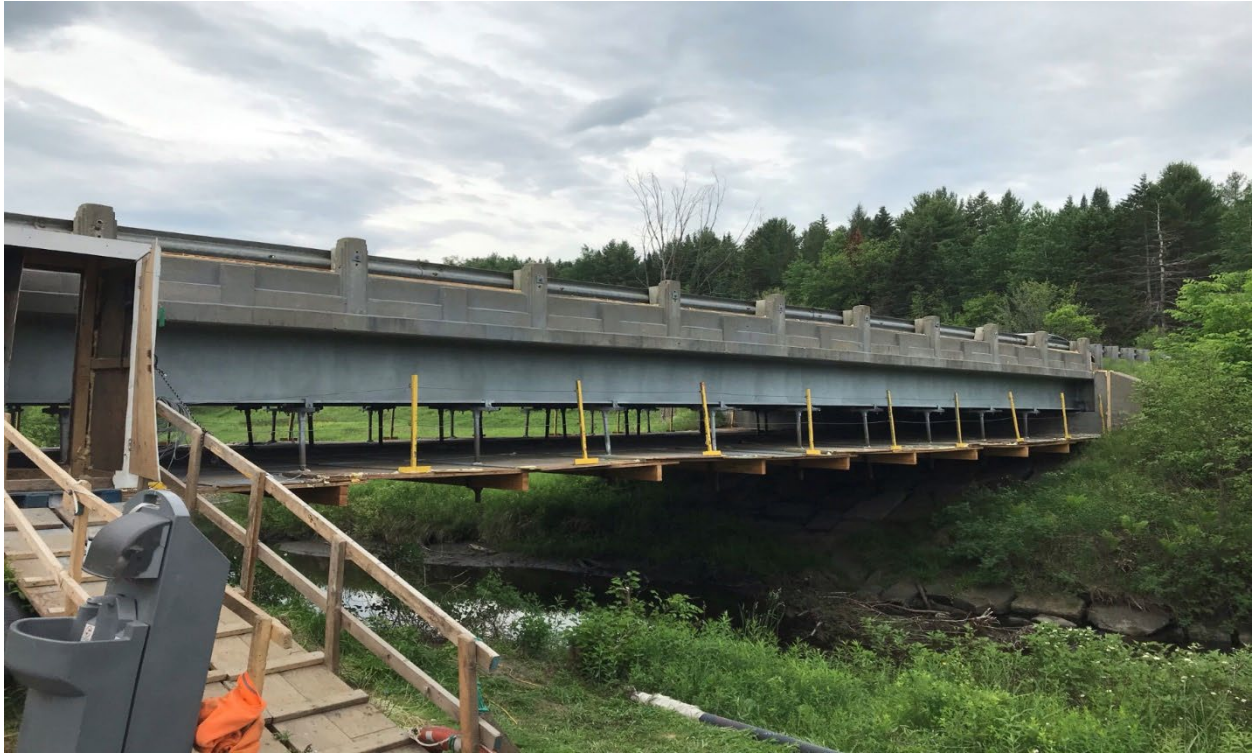
Work Platform Suspended from Beams

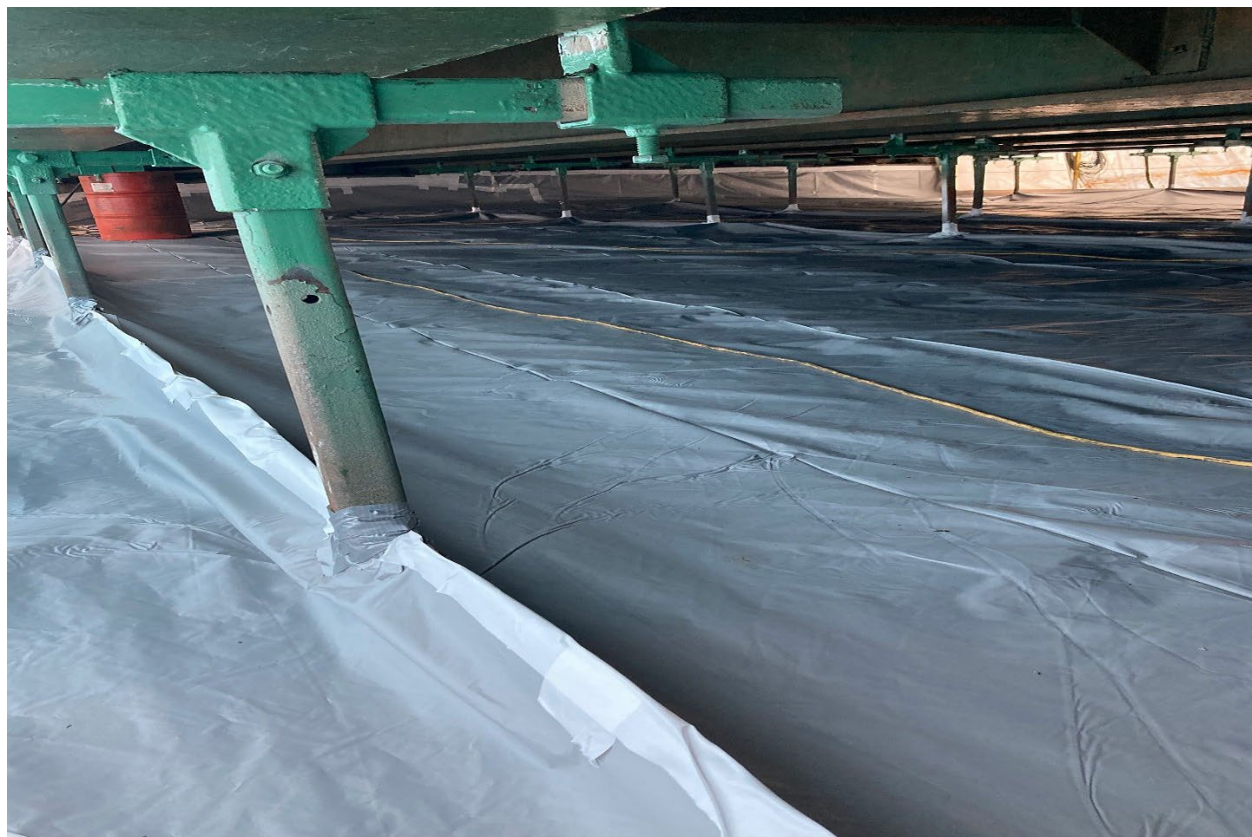
Bottom of Sealed Work Platform

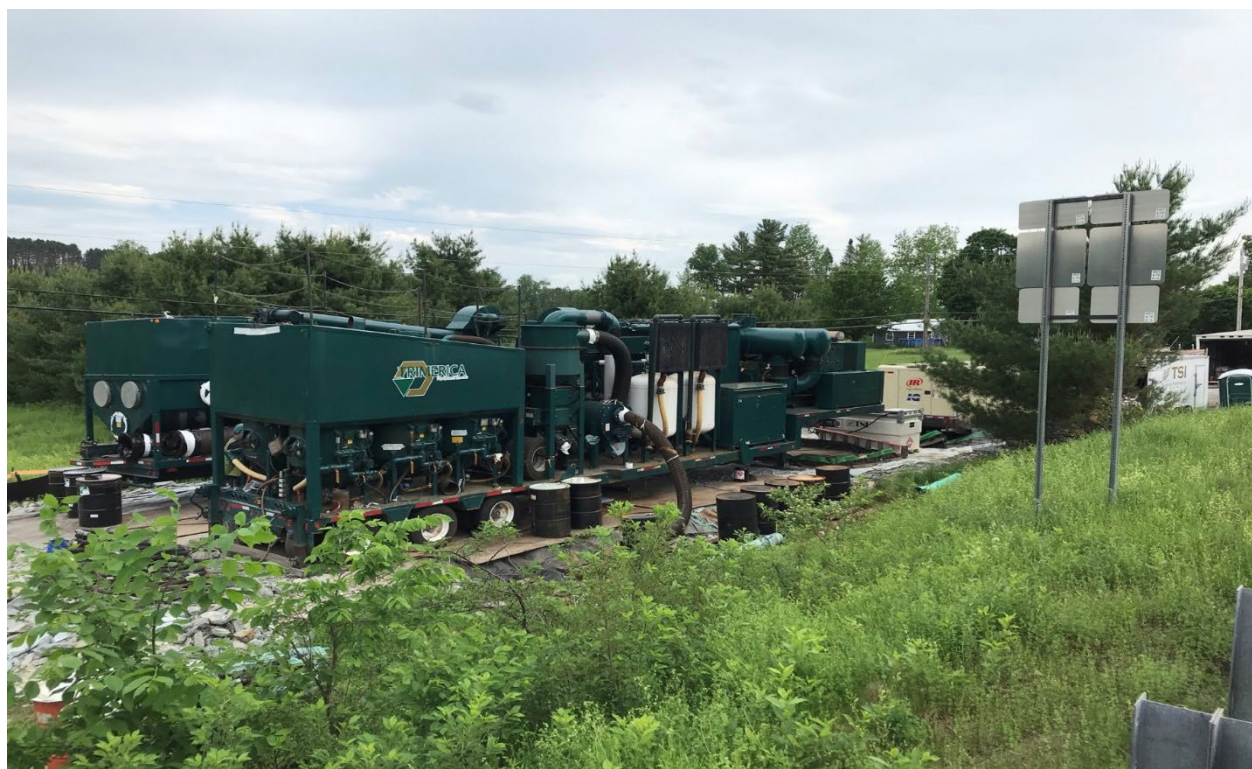
Air Filtration Equipment

- There was relatively poor visibility inside the enclosure during the metalizing even with dust collectors and air scrubbers running.
- Perhaps the uneven final appearance was a result of this poor visibility or uneven application of the sealer.

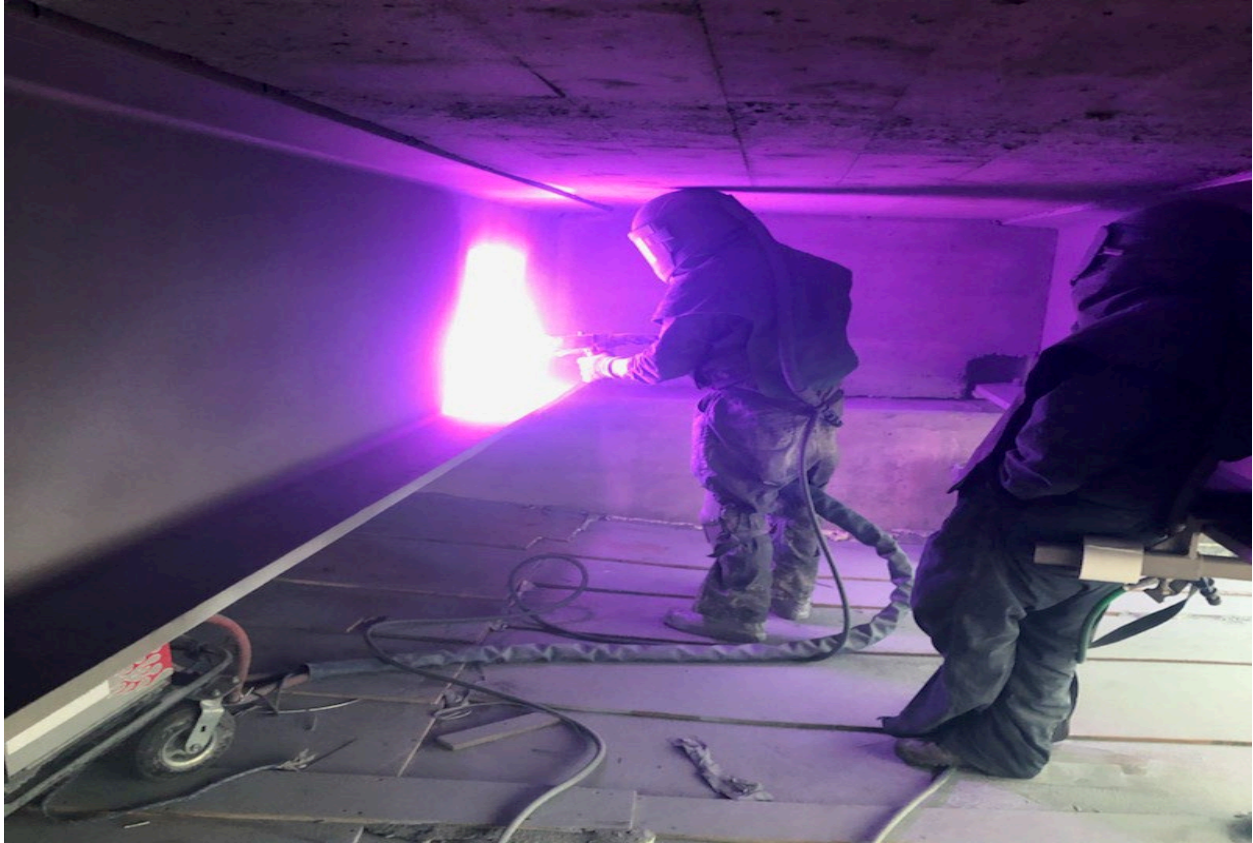
Metalizing Inside the Enclosure

- Sealer shall be applied by spray and supplemented with rolling or brushing.
- Metalizing inside the enclosure is relatively difficult as compared to metalizing in the shop due to tight dark conditions.

- The contractor used 1/8" zinc wire. Using 3/16" wire would increase the rate of production but may be more costly.
- A considerable amount of the zinc wire simply rebounds off the substrate creating a dusty environment within the enclosure which may have contributed to the final streaks in the coating.

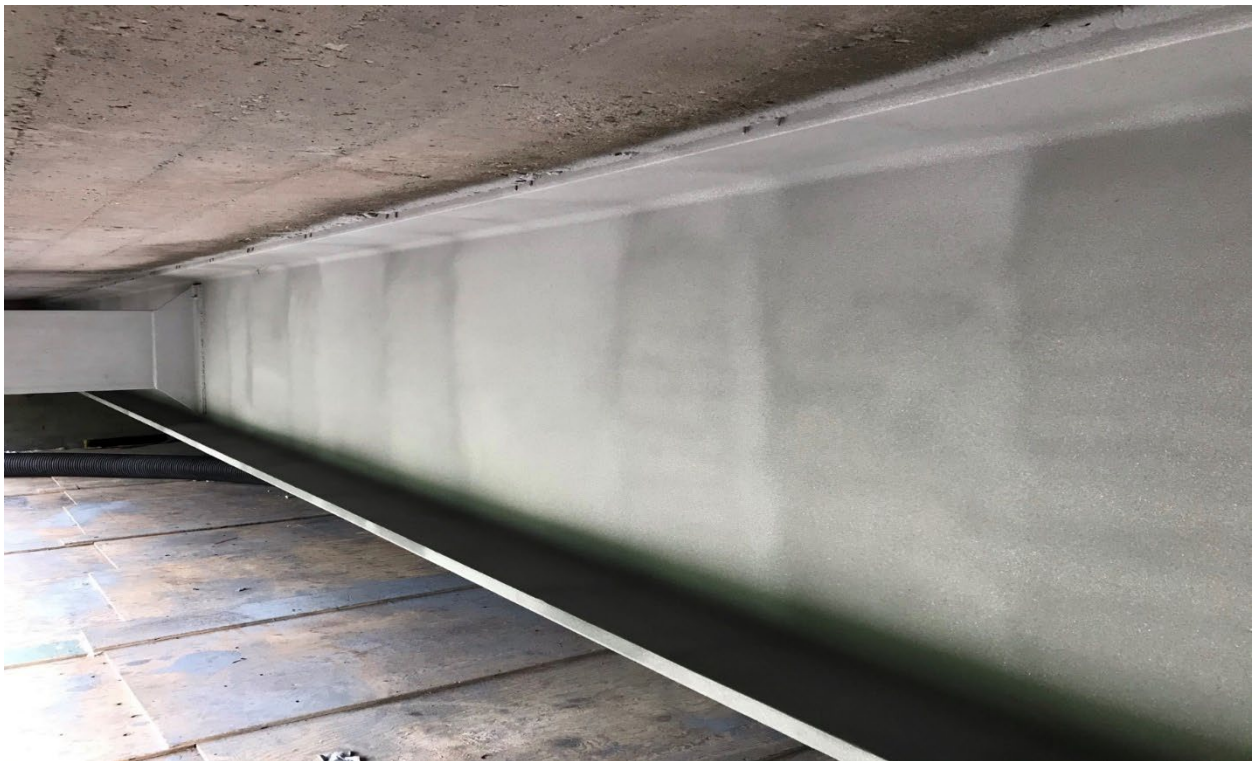
Streaks in the Final Coating

- Different color sealers are available or the final surface can be painted in areas where aesthetics is a concern.
- Overall weather conditions were good during the metalizing with no rain or damp humid weather to contend with.

Aesthetic concerns were not an issue for this bridge. The streaks in the final coating can be corrected with a colored seal coat or subsequent coats of paint.
