Damien Garland¹, Zahra Ameli², Yi Liu¹, Eric Landis², Tzuyang Yu³,
Robert Blunt⁴, Tian Xia¹, Dryver Huston¹

¹University of Vermont, ²University of Maine, ³UMass Lowell, ⁴VHB

Sounding the Underside of Bridge Decks

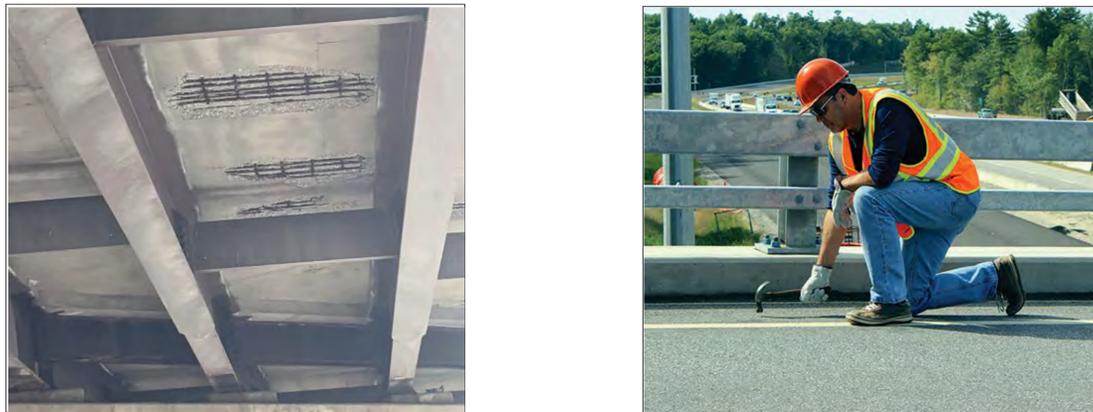
Figure 1. Delaminated Underside of Bridge Deck (left)
Technician Uses Hammer to Inspect Bridge (right)

Monitoring the underside of bridge decks is costly, requiring special equipment above and beyond the disruption of traffic and the time of road crews. This project uses a combination of acoustic and microwave sensing methods to inspect the underside of bridge decks without having to shut down traffic.

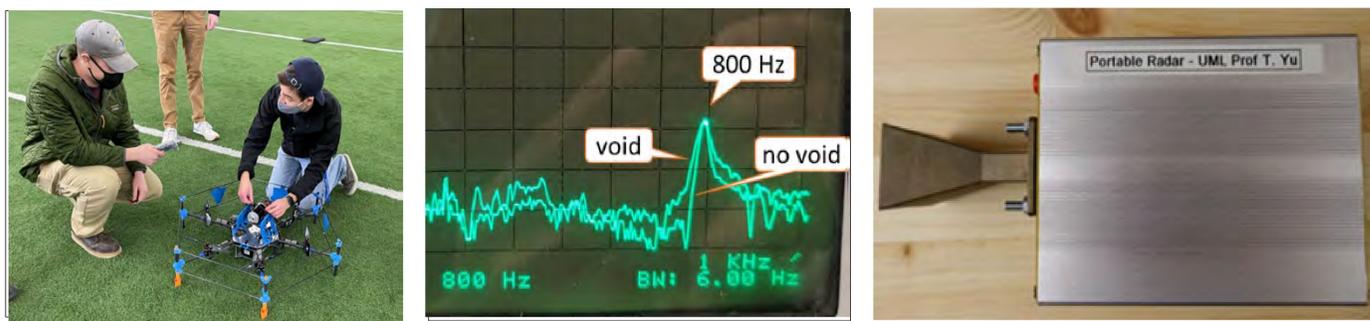
Figure 2. Custom UAV as AAS technology platform (left), Frequency spectrum analysis of known void (center), Compact 10 GHz microwave radar sensor (right)

The goal of this project is to combine unmanned aerial vehicles (UAVs) with active acoustic sensing (AAS) and microwave sensing to provide an early detection technique of subsurface delaminations before they develop into surface cracks, increasing operator safety, saving time, and ultimately extending the life of the bridge.
