## **SECTION 106 PROJECT REVIEW MEMORANDUM**

Subject: NO ADVERSE EFFECT

Project Name: Bridge No. 4 Rehabilitation

Project Number: BF 0145(13)

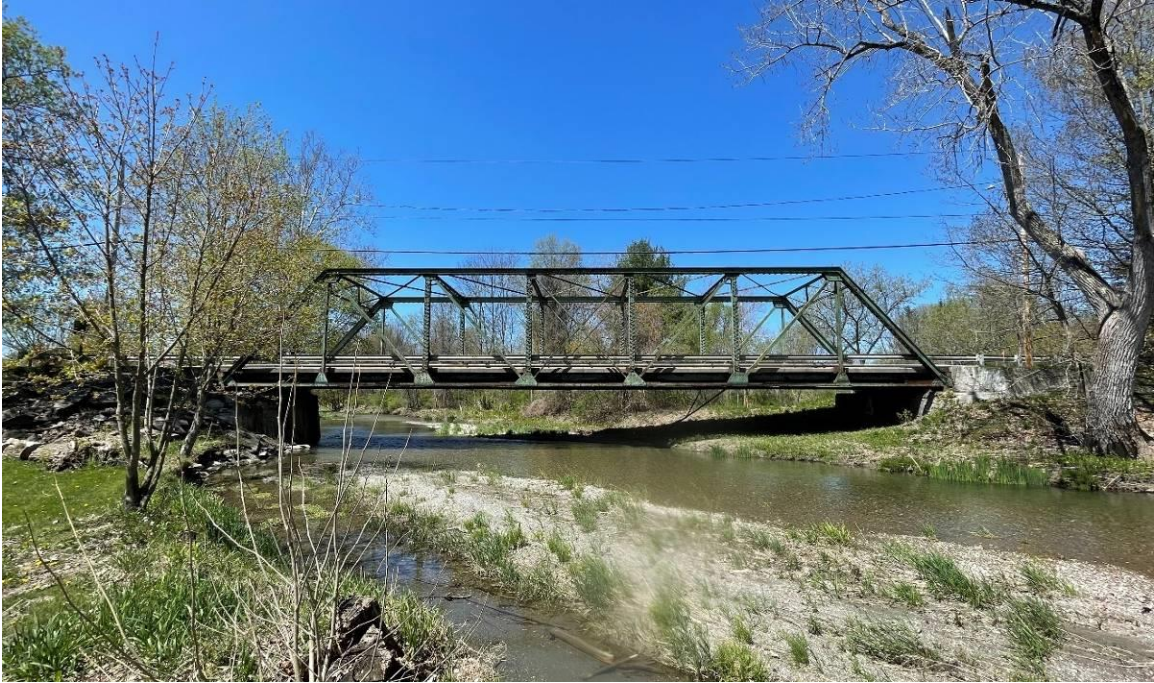
Photograph 1: Bridge No. 4, east elevation. Map ID 1.

Bridge No. 4 (South Street Bridge) was individually listed in the National Register of Historic Places in 2009. Bridge No. 4 was fabricated in 1923 by the Palmer Steel Company of Holyoke, MA. It is a 126' single span steel Pratt through truss with trapezoidal profile. While a common design, Bridge No. 4 is one of a small number of pre-1927 flood Pratt through trusses remaining in use on Vermont's road network. Bridge No. 4 is eligible for listing under the Metal Truss, Masonry, and Concrete Bridges MPDF as a rare survivor of a once common type [Steel Through Truss – Type 310]. Original plans were designed by Frank W. Garran, an engineer who worked briefly for the VT Dept. of Highways. The clear span is 126' with a width of 23' (20' roadway).

<b>Map ID</b>	<b>Address</b>	<b>Photo #</b>	<b>Brief Description</b>	<b>Integrity</b>	<b>NR Eligibility Recommendation</b>
1	Bridge 4	1-6	1923, Pratt through truss bridge with trapezoidal profile fabricated by the Palmer Steel Company of Holyoke, MA. Original plans were designed by Frank W. Garran, an engineer who worked briefly for the VT Dept. of Highways. The clear span is 126' with a width of 23' (20' roadway). The bridge is significant for its period of construction, one of the few pre-1927 truss bridges to survive in Vermont.	Retains integrity of setting, location, design, materials, workmanship, feeling, and association.	Eligible/listed in the NR under Criterion A and C.
2	154 Grove Street	7	Ca. 1880, 2-story, 2x3 bays, L-plan main block with 1-story rear wing. L-plan consists of perpendicular gable rooflines, vinyl siding and windows.	The house retains its form but has lost character defining features due to replacement of windows and siding resulting in a loss of integrity of materials, design, workmanship, feeling, and association.	Ineligible due to alterations.

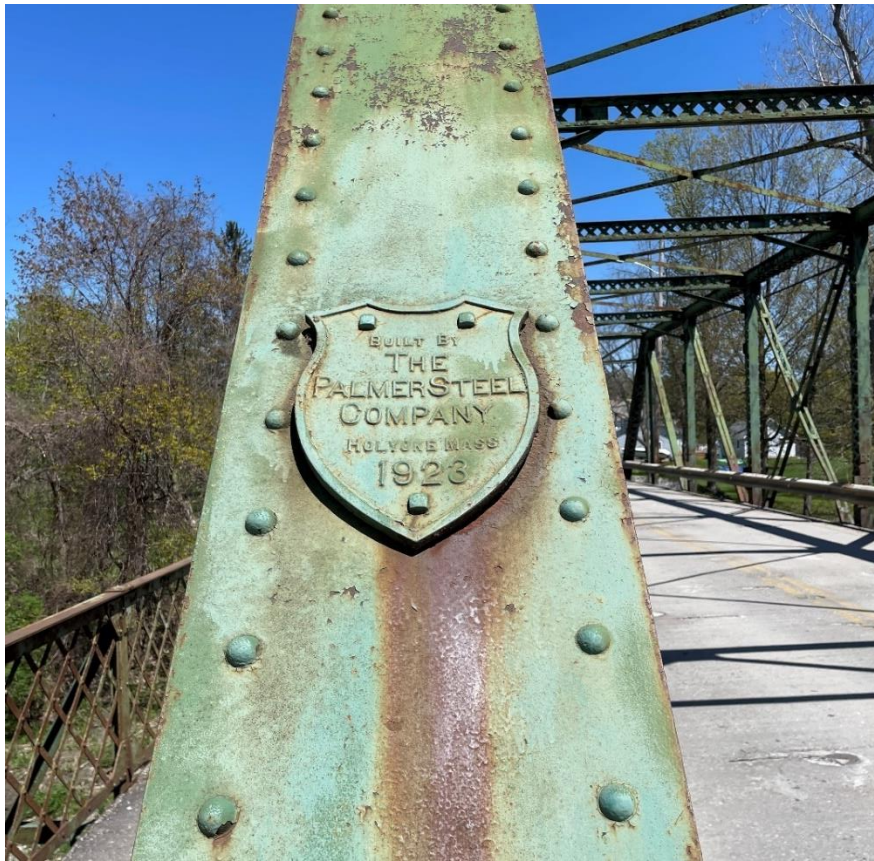
Photograph 5: Bridge plaque, southwest quadrant. Map ID 1.

1. "Palmer Steel" bridge plaques c. 1923, at bridge ends must be removed without damage, safely stored during construction, and re-installed after rehabilitation as close to their current locations, as possible. These plaques read: Built by the Palmer Steel Company, Holyoke Mass 1923.

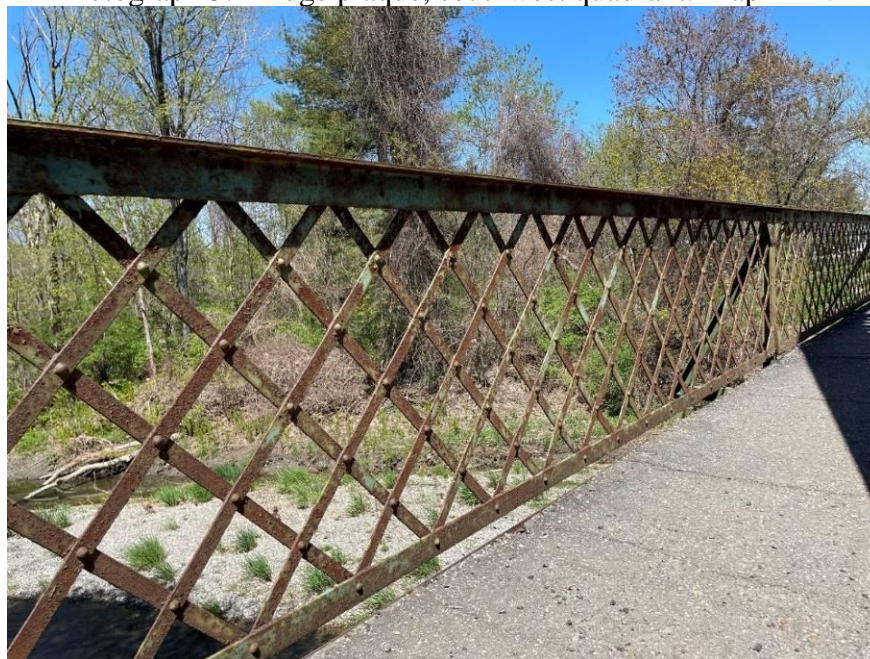
Photograph 6: Bridge pedestrian railing. Map ID 1.

On the downstream side of the existing truss is the cantilevered sidewalk. The sidewalk will be replaced, including the steel outrigger. The existing lattice railing will be rehabilitated and replaced. Connecting to the bridge sidewalk, a new 5' wide concrete sidewalk will be installed on the western side of the southern approach to the bridge, connecting to the bridge sidewalk. Currently the sidewalk across the bridge ends at the southern end of the bridge. This will improve pedestrian access to/from the bridge. *See Figures 6 – 7, Layout Plan Sheets 1-2 and Figure 8: Typical Roadway Section 1 of 2.*

cantilevered sidewalk lattice railing will be rehabilitated and reinstalled on the new cantilevered sidewalk. The bridge will be repainted green, which is the existing color and a common truss bridge color in Vermont. The box beam guardrail installed on the bridge is compatible with the historic design and more appropriate than the current w-beam railing that spans the bridge. The fence selected for the back of the sidewalk is simple, black, and metal. It is compatible with the historic truss bridge.
