EVALUATION OF ULTRALINER PVC ALLOY PIPELINER

Report 2013 – 13

December 2013

Jason Tremblay, M.S., P.E., Research Engineer
George W. Colgrove III, Research Administrator

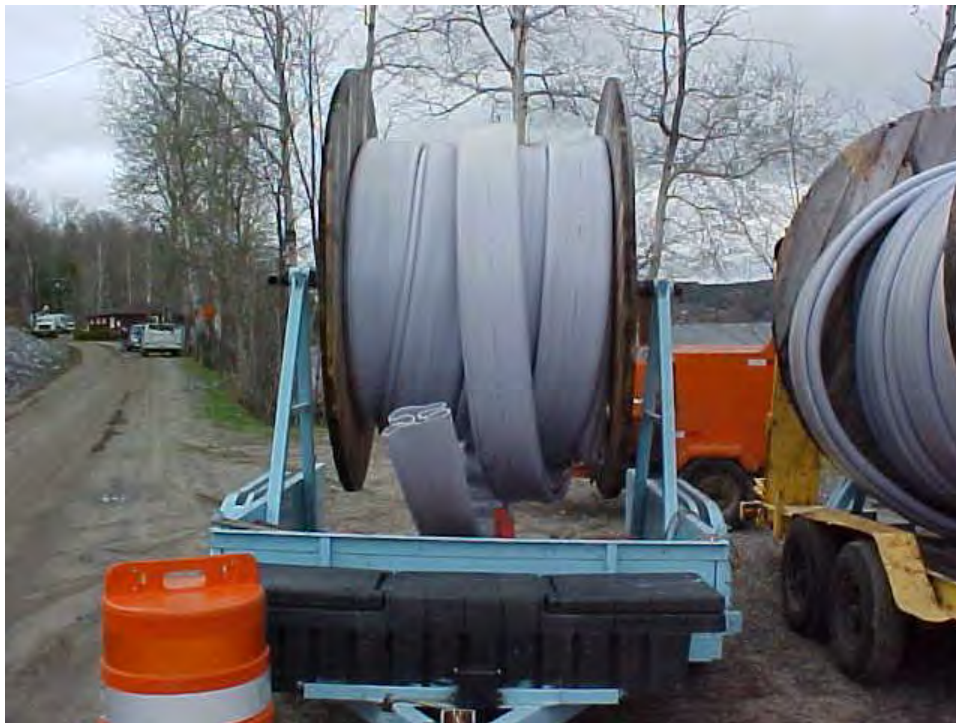
The Ultraliner PVC Alloy Pipeliner is a continuously extruded polyvinyl chloride pipeliner tube with a specified nominal wall thickness to dimension ratio of 35. The pipeliner is folded into an ‘H’ shape and rolled onto a spool as a final step in the fabrication process. See Figure 1. The pipeliner is designed to return to its extruded round tubular shape upon the application of heat and to be formed tightly against the host pipe by “blow molding” with steam. The result is a permanent tight-fitting liner that conforms to the irregularities and corrugations of the inner surface of the culvert. Upon cooling, the liner will not shrink away from the wall of the culvert, thereby locking it in place. It can be supplied in diameters from three to thirty inches. The liner conforms to three industry standards, including:

Figure 1 Spooled Ultraliner on the project site.

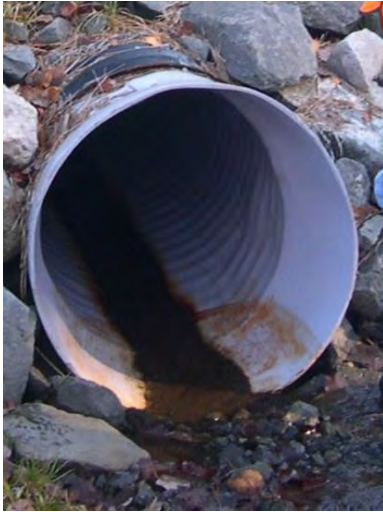
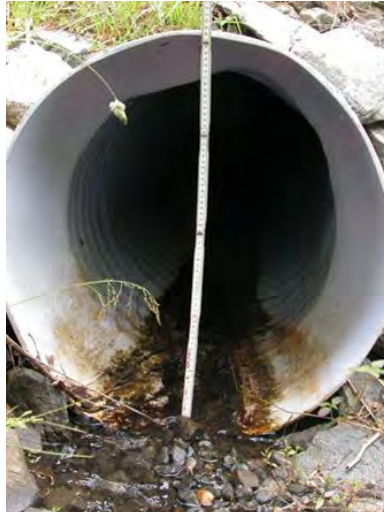
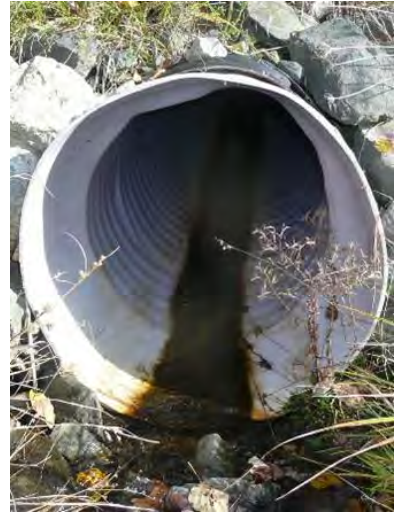
Periodic site visits were performed to the two culverts after installation to assess the condition of the liners. Visits were made on November 23, 2004 and again on July 5, 2007 with a final visit on October 19, 2010. Side-by-side photographs of the inlet of the 24-inch liner and the outlet of the 18-inch liner at each of the site visit dates can be seen in the Figures 2 through 7. These photographs show little, if any, change between the year of installation (2003) and seven years of age (2010).

Figure 2: Inlet of 24-inch pipe, 2004

Figure 3: Inlet of 24-inch pipe, 2007

Figure 4: Inlet of 24-inch pipe, 2010

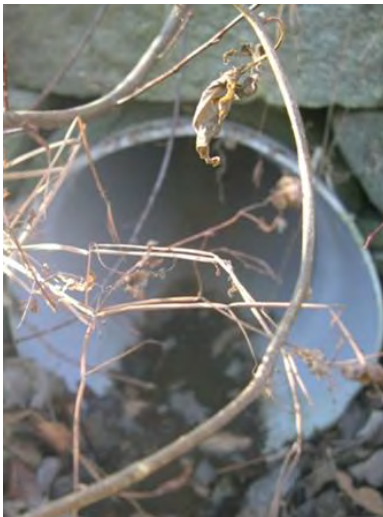
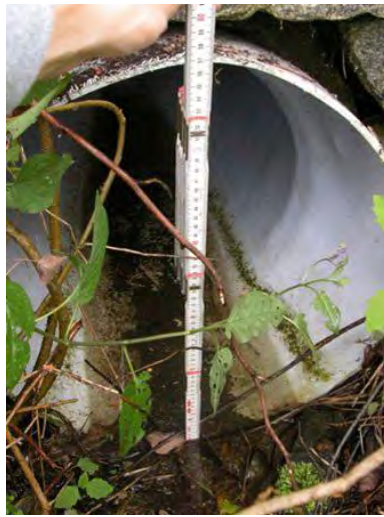
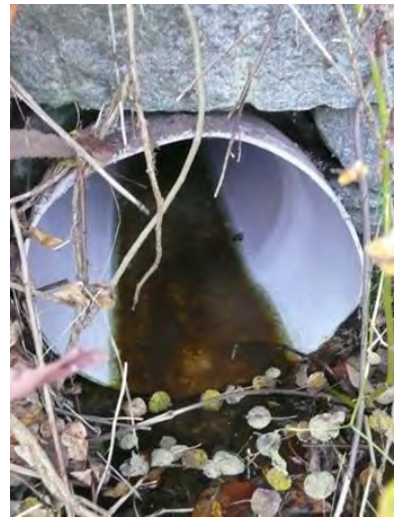
Figure 5: 18-inch pipe outlet, 2004

Figure 6: 18-inch pipe outlet, 2007

Figure 7: 18-inch pipe outlet, 2010

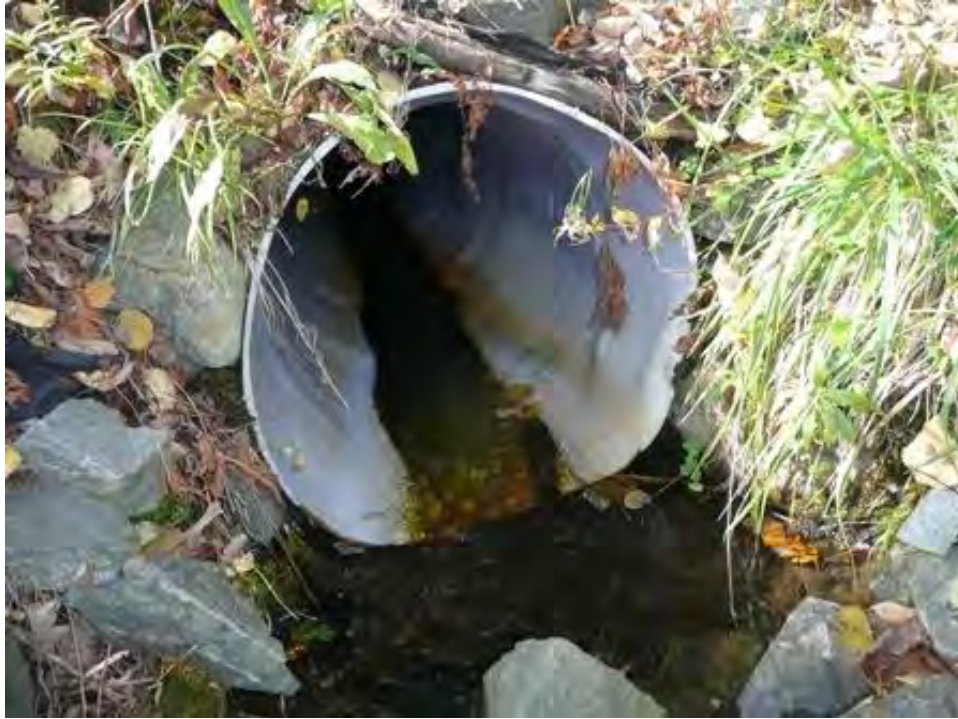
Figure 8 shows the outlet of the 24-inch liner in 2010 while Figure 9 shows the inlet of the 18-inch liner in 2004.

Figure 8: Photograph of the outlet of the 24-inch liner in 2010.

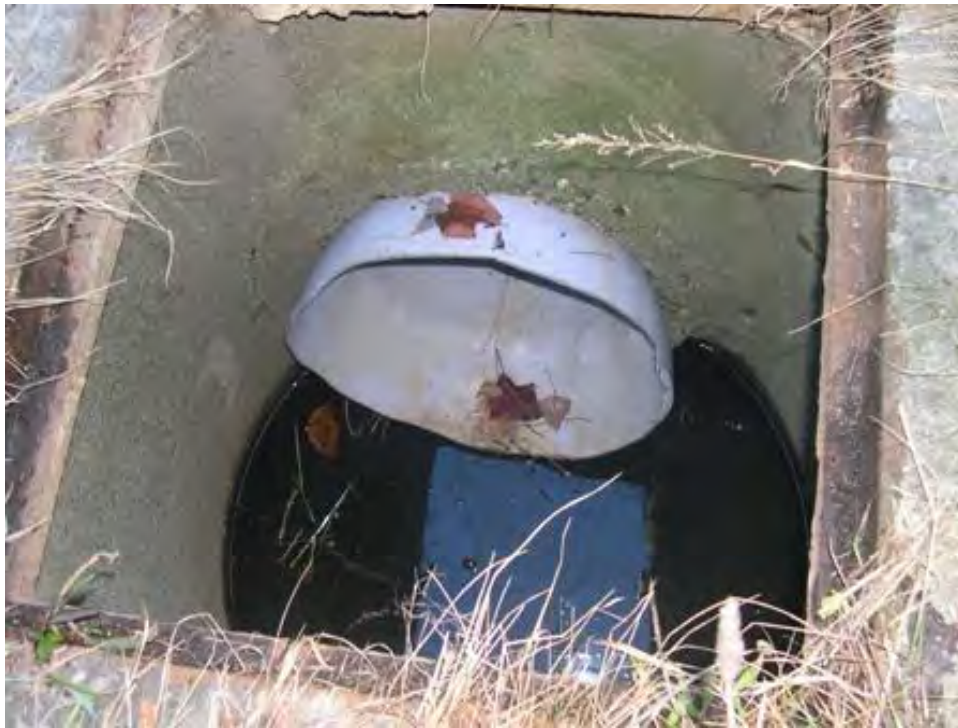
Figure 9: Photograph of the inlet of the 18-inch liner in 2004.
