**STATE OF VERMONT
AGENCY OF TRANSPORTATION
MATERIALS AND RESEARCH DIVISION**

PRODUCT EVALUATION REPORT P2006-2

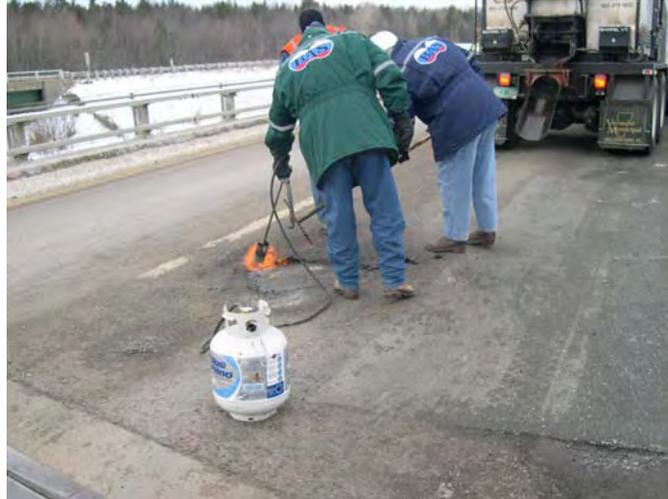
Figure 1: Surface Preparation

Prior to application, each of the ten pothole locations was heated through the use of a propane heater in order to remove any excess moisture and any loose pieces of membrane as shown in figure 1 below. This slightly differs from a typical BASphalt installation such that, under normal conditions, the delaminated pavement area would have been prepared by grinding the failed pavement into a square patch to a typical depth of 2". The BASphalt hot mix was then applied to the delaminated areas from a chute at the back of the transport vehicle. The material was then hand leveled with rakes.

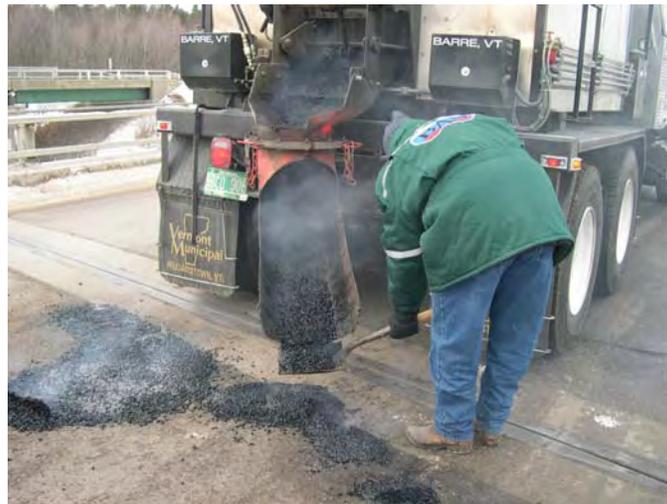
Figure 2: Application

According to the producer, the application temperature of the mix heats up the underlying pavement resulting in a bond between the two materials. The product did not require any compaction which can be attributed to the mastic asphalt. Additionally, it contains approximately 10% asphalt as compared to specified amount of 5% +/- 1% for standard hot mixes. During installation, the aggregate appeared to descend down to the bottom of the pothole while the liquid asphalt appeared to remain at the top. According to the manufacturer, this is a normal observation and explained that the asphalt layer would wear off over time, eroding down to the aggregate resulting in a textured surface. The material cured in approximately 15-20 minutes as a function of the ambient air temperature. Figure 2 provided below displays the typical application of the product:

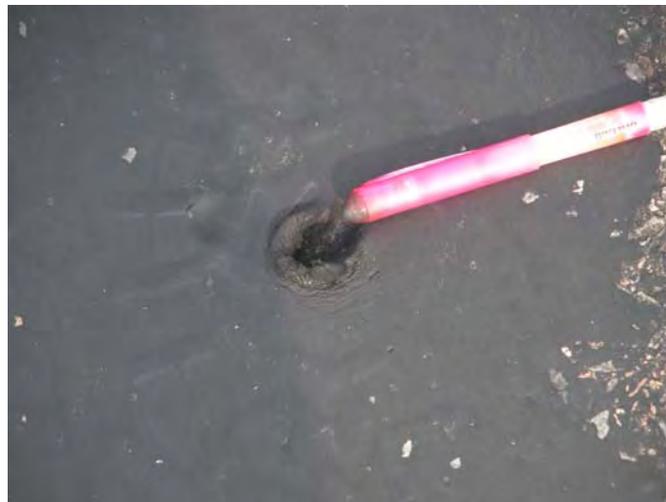
Figure 3: Displacing the Pot Hole Patch Material

During the July inspection, some bleeding of the mastic asphalt was observed. A pen could easily displace the surface of the patch and the soles of shoes became imprinted on the patches as well. Figure 3, provided below, contains an image of this phenomenon. However, each of the patches continued to retain their shape. In December, there was not much new to report in regards to material performance with the exception of some concerns raised by District personnel relating to winter maintenance of these patches. It was mentioned that the edge of the plow must be lifted when removing snow due to the raised elevations of the patches. There was also some concern regarding lower skid resistance.

A low temperature liquid asphalt hot mix provides a durable alternative to the commonly employed throw and roll method with cold mix. The evaluated material has performed well over the past year with regards to adhesion, fatigue and thermal cracking, and rutting. However, there are some concerns regarding bleeding and snow plow removal which may be attributed to improper installation. A cost analysis could not be performed as there were no costs incurred by the Agency and none was supplied by the distributor. Although the material is not recommended for use as a wearing course, the low temperature liquid asphalt hot mix is recommended for winter time patching with the caveat that proper installation and application is performed and the material is not heated above 180°C. Further evaluation is recommended so that optimized material qualities are achieved.
