**Pavement Marking Durability
Statewide**

**December 2005
2005-2**

State of Vermont
Agency of Transportation
Materials and Research Section

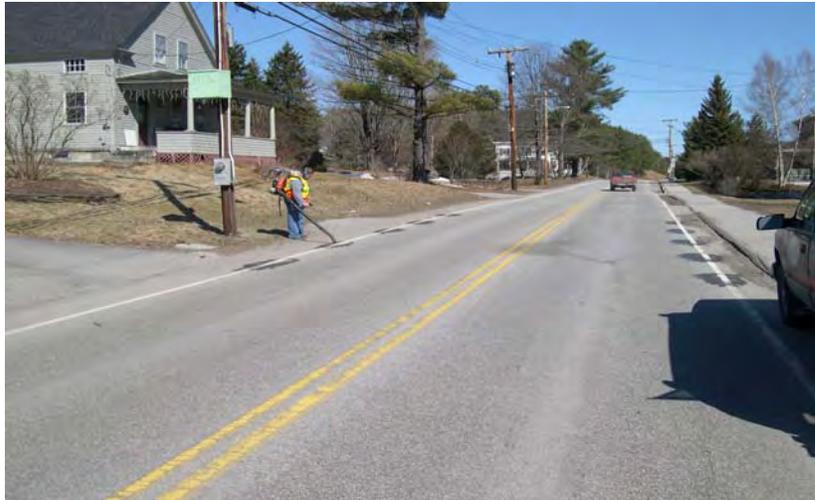
The subsequent photograph illustrates how the lines are dried after they are cleaned

Figure 1. Winter Cleaning Protocol (Drying of the Lines)

During those periods of time when winter readings are required, a modification to section 9 of ASTM E1710 is followed to ensure that the lines are cleaned before sampling. This protocol for this is to clean the lines by dispensing a 50/50 mixture of water and windshield washer fluid via a portable sprayer to remove large particulate matter, such as residual salt, dirt and other debris. Then the lines are thoroughly rinsed with the water dispenser which removes the windshield washer mixture. A squeeze mop or sponge is used to remove as much excess water as possible, followed by a rag wipe of the surface to clear away any remaining debris and moisture. The lines are then dried with an air compressor or similar device. Retroreflectivity testing is completed following the methods as indicated in E1710.

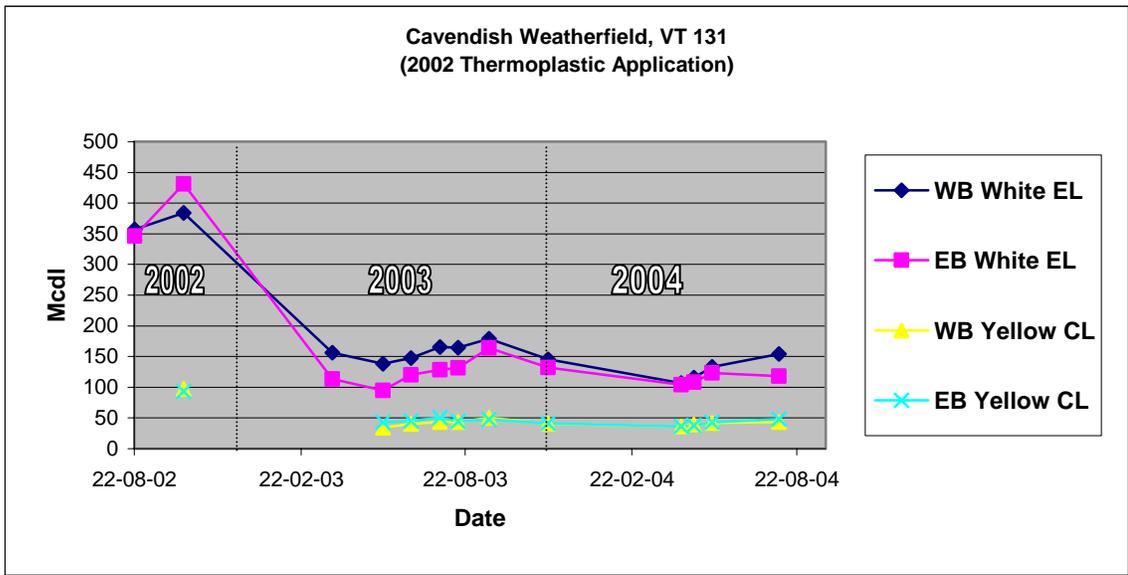
The SG-70 hydrocarbon thermoplastic was applied in 2002. Initial retroreflectivity values obtained just after the markings were applied averaged 350 mcdl for the white edge line markings, rising slightly after a two month period. After the winter maintenance season the retroreflectivity values dropped significantly to 117 mcdl (average for all white edge line readings) but then rose 47 % to 172 mcdl. Eventually the readings leveled off at approximately 140 mcdl after two years of service. The yellow center lines on this project exhibited lower retroreflectivity values than the white as exhibited in figure 1. It should be noted that, this pattern is evident in some fashion in all the marking materials reviewed in this study. While the overall durability rating is 8 on a 1 to 10 scale, actual retroreflectivity readings would indicate a somewhat lower rating, based upon night time visibility.

Figure 2 – Cavendish/Weathersfield Retroreflectivity Values

Figures 2 through 5 display retroreflectivity data collected on thermoplastic markings applied on roadway sections throughout the State of Vermont. Figures 2 and 3 are derived from “Non-Freeway” test sections, which consist mainly of two lane roads with AADT’s that vary from approximately 600 in Grande Isle on VT 314 to 11600 in Rutland on US 4. Figures 4 and 5 are from “Freeway” test section, which consist of multilane roads with AADT’s that vary from 6700 in Northern Vermont to 17900 from Brookfield to Montpelier on I-89.

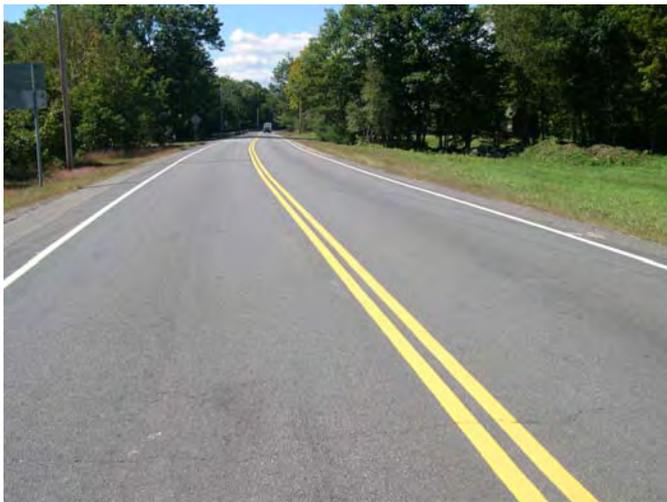
Figure 3 -2002 Cavendish/Wethersfield – Test Site 1

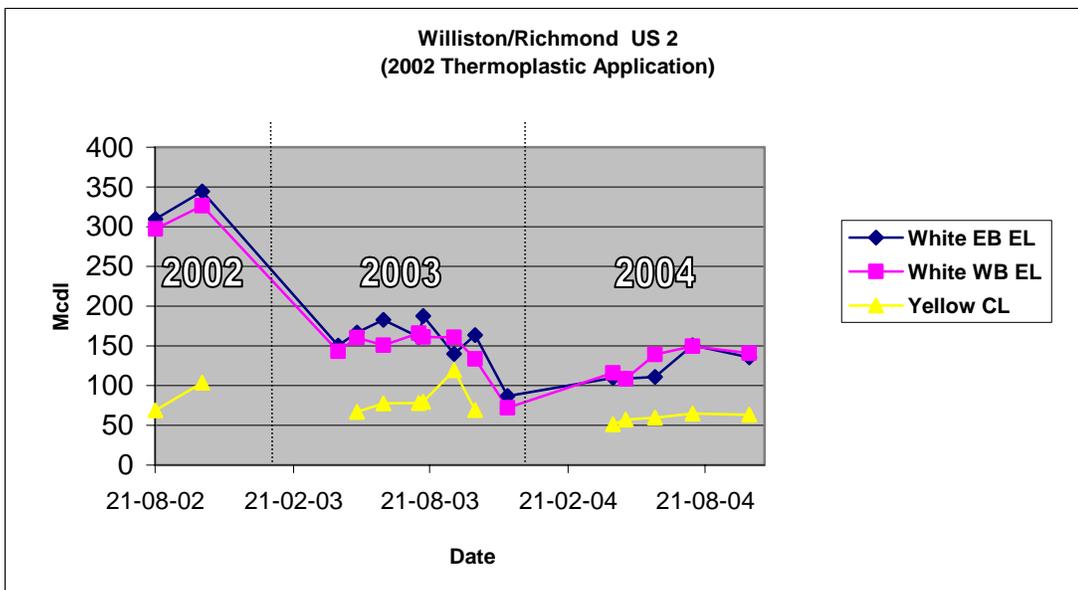
Another project which was marked with thermoplastic is on US 2 in the towns of Williston and Richmond. This road is a heavily traveled two lane roadway with an AADT between 10,700 at Taft's Corners (US 2/VT 2A) in Williston, to 3,700 at the junction of VT 117 in Richmond. The first test site is located in the higher AADT area, with the others in the lower traveled section. Snowfall in this area is about 80" – 100" per year making snow removal frequent during the winter months. As seen on the graph below, initial readings began at 300 mcdl then rose slightly in two months. The readings then fell sharply after the first winter. Readings leveled out around the 150 mcdl range in 2004. Overall durability for the white markings was 8 while the durability readings for the yellow markings were 7 after two years.

Figure 4 - Williston/Richmond Retroreflectivity Values

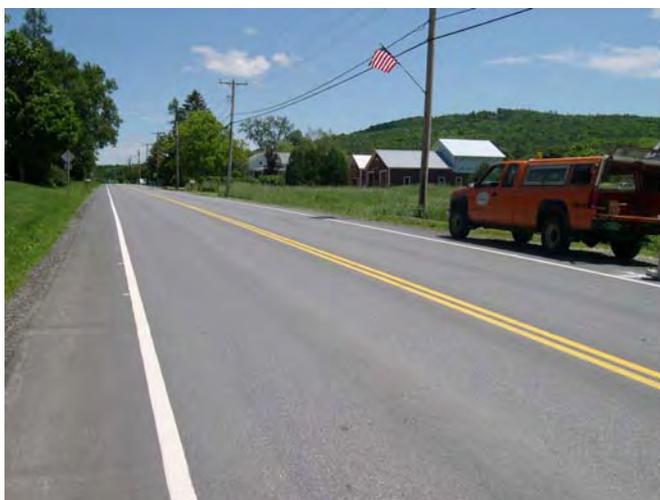
Figure 5 -2002 Williston-Richmond Test Site 2

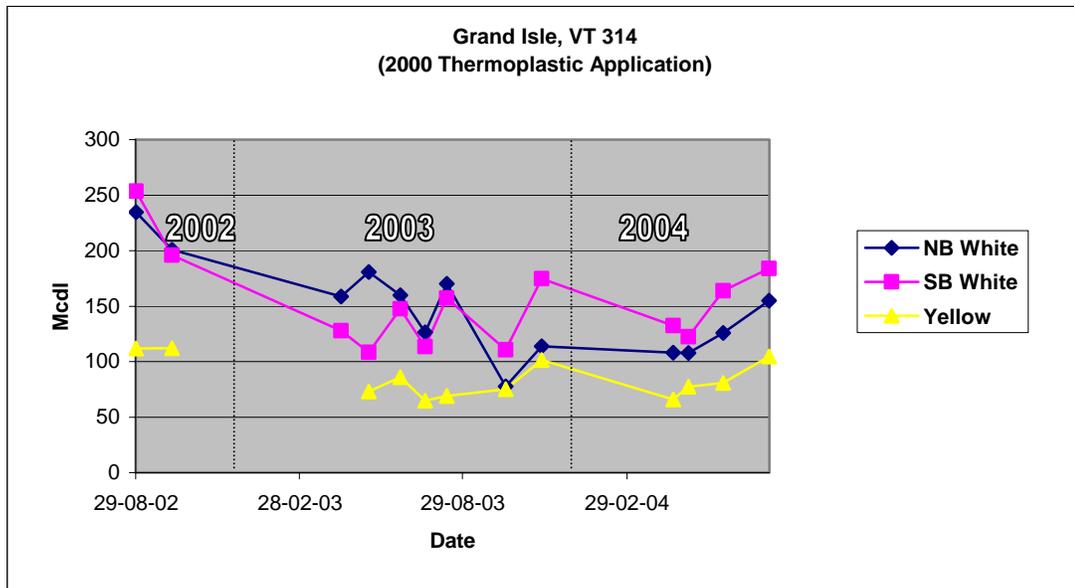
The trend of readings recovering after winter is somewhat less evident on projects with a lower AADT. For example, in 2000 thermoplastic was applied on VT 314 in the town of Grand Isle. This road is a two lane roadway with a low traffic count (AADT 960). This is mostly due to local traffic, but also includes commuters who access the ferry to New York State. The average yearly snowfall for this area is 70 inches per year. Initial readings are not available, but two year readings were in the 250 mcdl range. Readings fluctuated widely in 2003 and started to level off in the mid 100 mcdl to 125 mcdl range by May 2004. The overall durability reading in May 2004, for the white and yellow markings was 7 on a 1 to 10 scale. The retroreflectivity readings confirm the subjective rating.

Figure 6 - Grand Isle Retroreflectivity Values

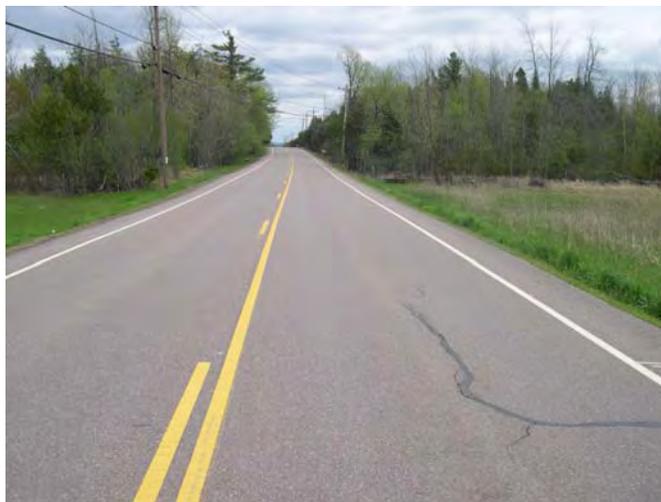
Figure 7 -VT 314 Grand Isle (2000) Test Site 2

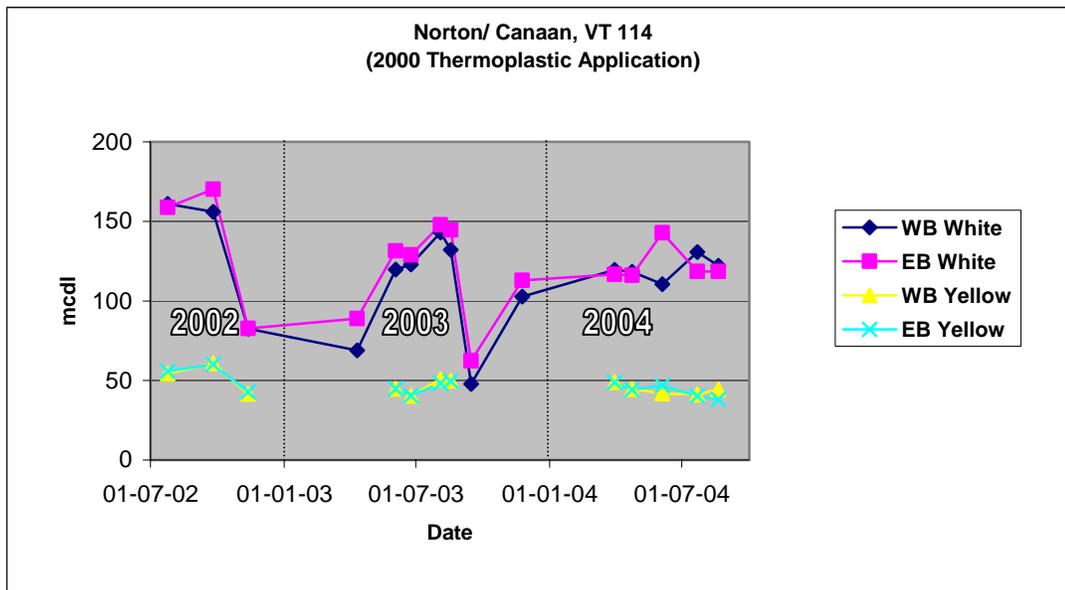
Another lower traffic volume road is Vermont 114 in the towns of Norton and Canaan. The AADT is considerably lower than in other areas of the state with values ranging from 960 to 1000 over the length of the project. The average yearly snowfall in this area is greater than 130" which is comparable to that that on VT 131 in Cavendish/Weathersfield, but more than that in Williston/Richmond and Grande Isle. Retroreflectivity readings were extremely varied this project, with the average values originating at 160 mcdl, falling to 80 mcdl in four months. Rebounding of the readings took place after the winter as the average values rose to 140 mcdl range by July 2003. The readings dropped sharply 40-60 mcdl in September 2003 and then to level off at around 120. At this time it is unclear whether equipment problems or data collection errors caused this anomaly.

Figure 8 Norton/Canaan Retroreflectivity Values

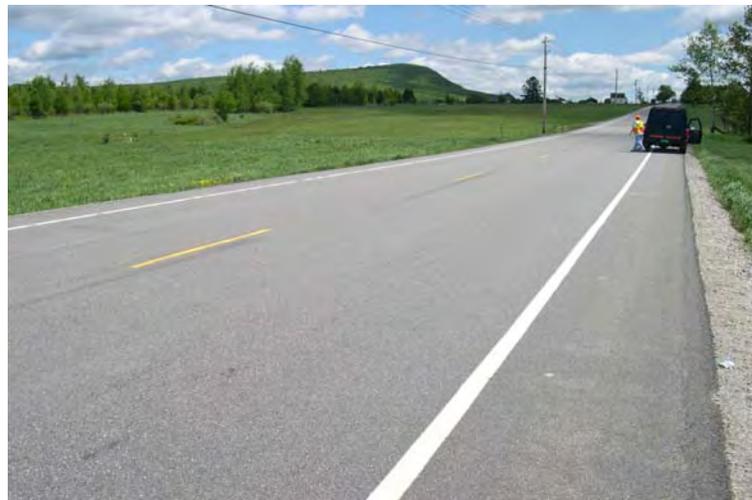
Figure 9 - 2001 Norton-Canaan Test Site 1

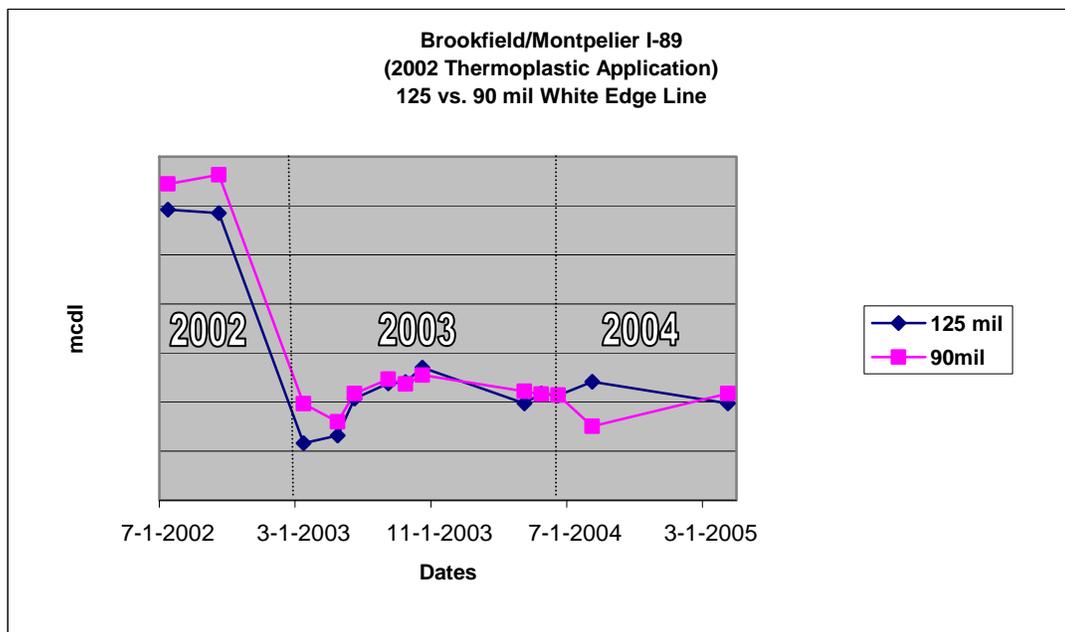
In 2002 two different application thicknesses of thermoplastic markings were applied on the Brookfield/Montpelier I 89 project. Three miles of the project consisted of 125 mil white edge lines and skip lines, while the rest of the project had markings installed with Vermont’s standard thickness of 90 mils. The two year performance of these markings (white edge line) are shown in the graph below.

Figure 10 – Brookfield/Montpelier Retroreflectivity Values

In reviewing this data, it is interesting to note that the except for one set of readings in August 2004, the retroreflectivity values between the differing thicknesses did not differ significantly, However, further data will need to be collected into the spring and summer of 2005 to verify this trend.

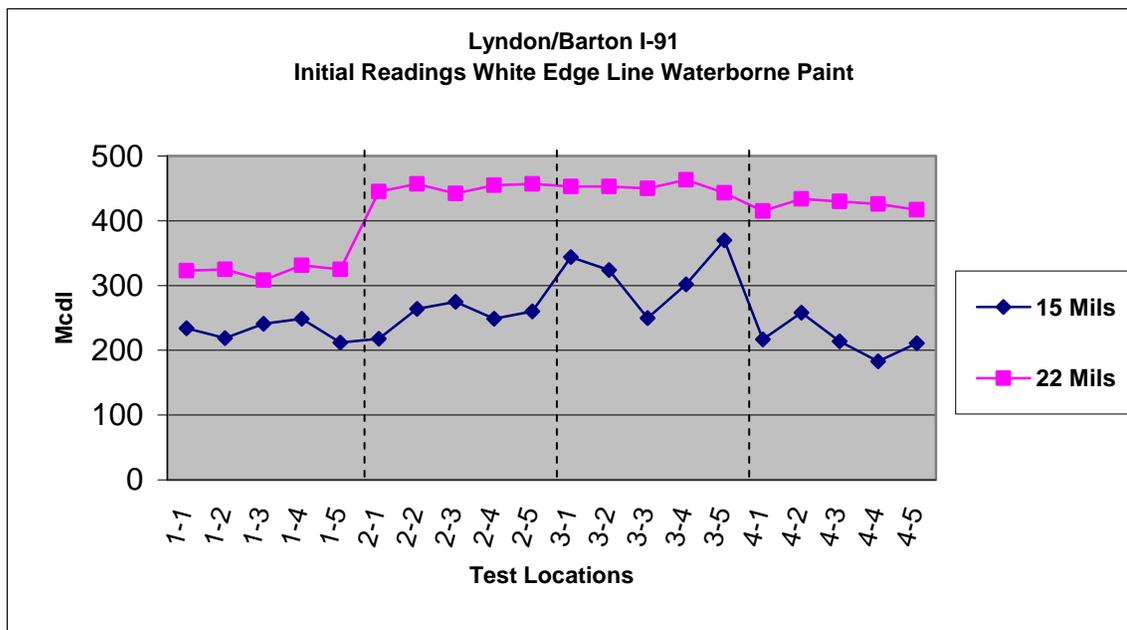
In an effort to quantify the performance of these materials data has been collected on paint applications on I-91 in Lyndon/Barton, between MM 146.1 and 150.0. This is adjacent to a polyurea marking experimental site. The data collected in this application is interesting as it appears that the readings associated with the 22 mil thick paint pavement markings were more consistent in thickness than those that were applied at 15 mils. It also appears that the 50% increase in thickness has resulted in an initial 100 mcdl increase in retroreflectivity. However, at this time there is not enough data to draw any conclusion. Once additional data is gathered in the early spring of 2005, it will be better able to compare the performance of both paint thicknesses.

Figure 11- Initial Readings on White Paint, I-91 Lyndon/Barton

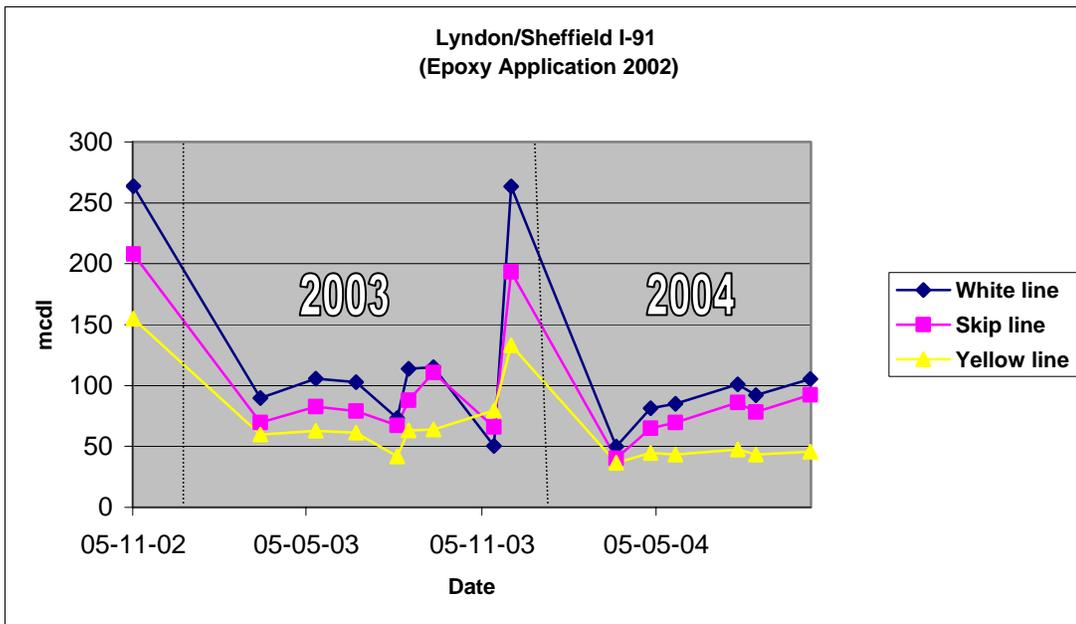
The performance of the epoxy markings follows a pattern similar to the thermoplastic in this study, as the initial readings are relatively high (250-325), and then drop to below 100 mcdl. After a sharp spike in November 2003, values for the epoxy markings remain somewhat consistent, remaining close to 100

mc dl for white and 50 mc dl for yellow markings. . The average durability is 7 (good) for the white markings and 6 for the yellow. At this point in time it is unclear what reasons may exist for the sudden upturn in the readings in December 2004.

Figure 12 – Lyndon/Sheffield Epoxy Retroreflectivity Values

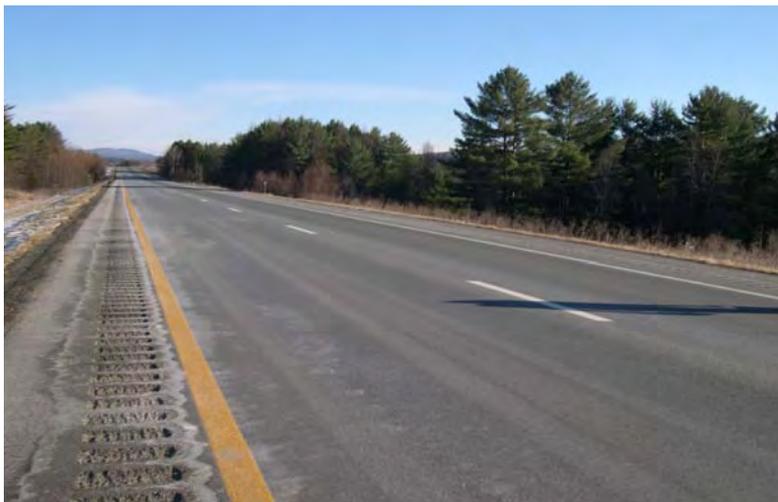
**Figure 13 -2002Lyndon- Sheffield Test Site 3
I 91 Southbound, Epoxy**

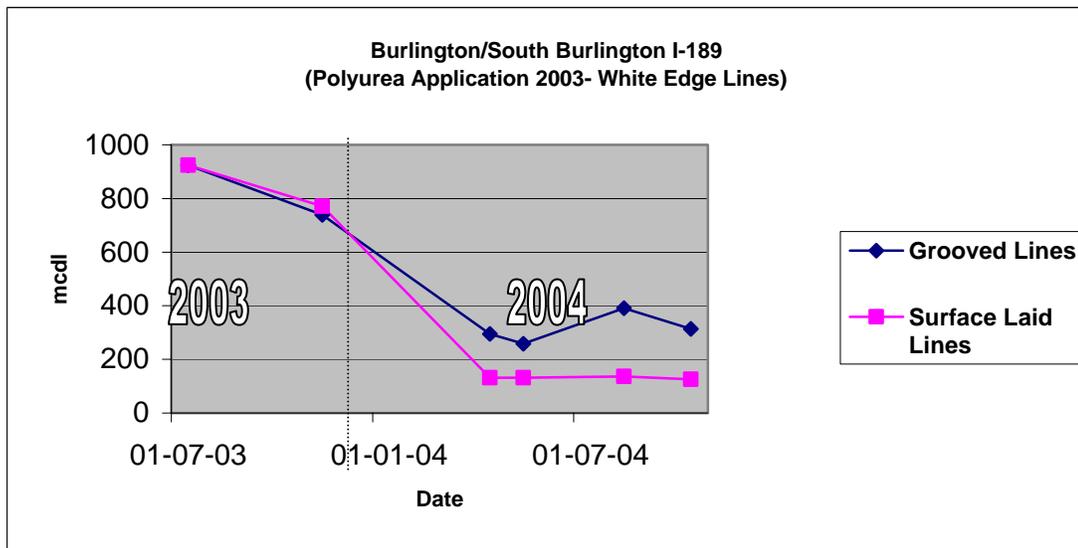
The test site on I-189, in South Burlington, is a heavily traveled area with an AADT of 39,600. It is the major link between I-89 and US Route 7 also known as Shelburne Road. On this test site approximately one half of the pavement markers were inlaid and one half was surface laid (conventional application). After one winter the inlaid polyurea markings test locations retained higher retroreflectivity for a greater time than the surface applied material. Although both surface-applied and recessed markings had readings of 900 mcdl after application (July 9, 2003), the recessed markings (with an average value greater than 200 mcdl) was 220% better the surface applied material(with an average value of 90 mcdl) after nine months of service (April 7, 2004). Even though these higher readings only include evidence from one winter’s maintenance season, the inlaid markings appear to be performing much better than the surface laid material at this time.

Figure 14 – Burlington/South Burlington Retroreflectivity Values

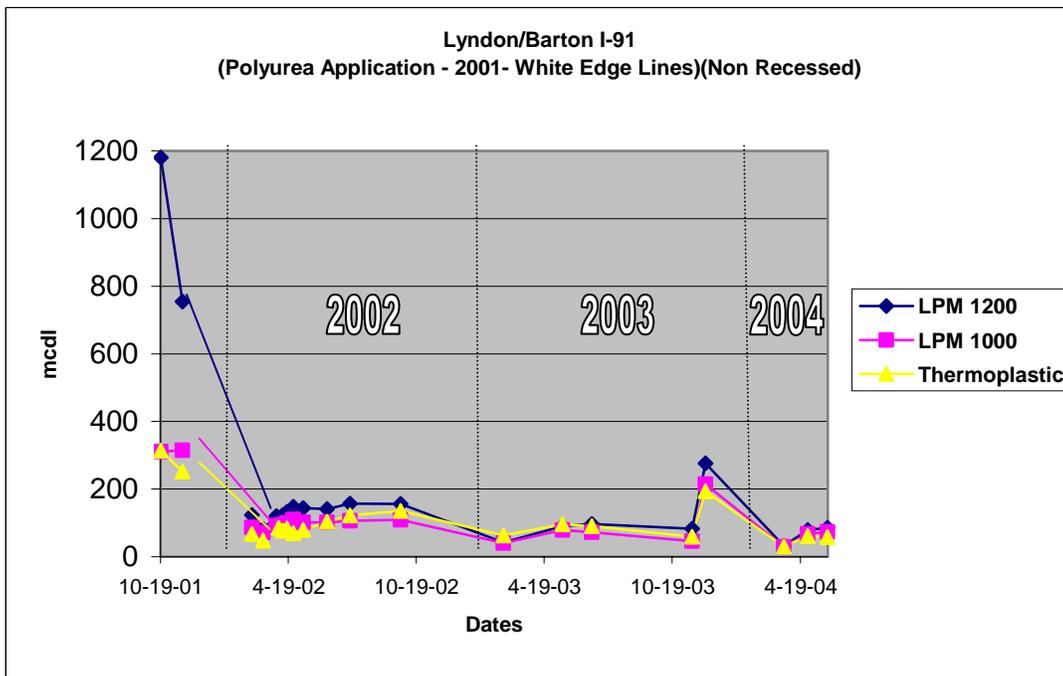
Figure 15, from the Lyndon-Barton I 91 test sites, can be used as a comparison of marking systems. As seen on the graph, all products applied begin with relatively high readings with the 3M LPM Series 1200 having the highest readings, and all lower through the winter. In the graph below all test materials are in the same geographic area with the similar traffic patterns, snowfall, snow removal and other conditions, with each exhibiting a similar retroreflectivity pattern after 3 years.

Figure 15 - Lyndon –Barton Average Yearly Retroreflectivity Readings

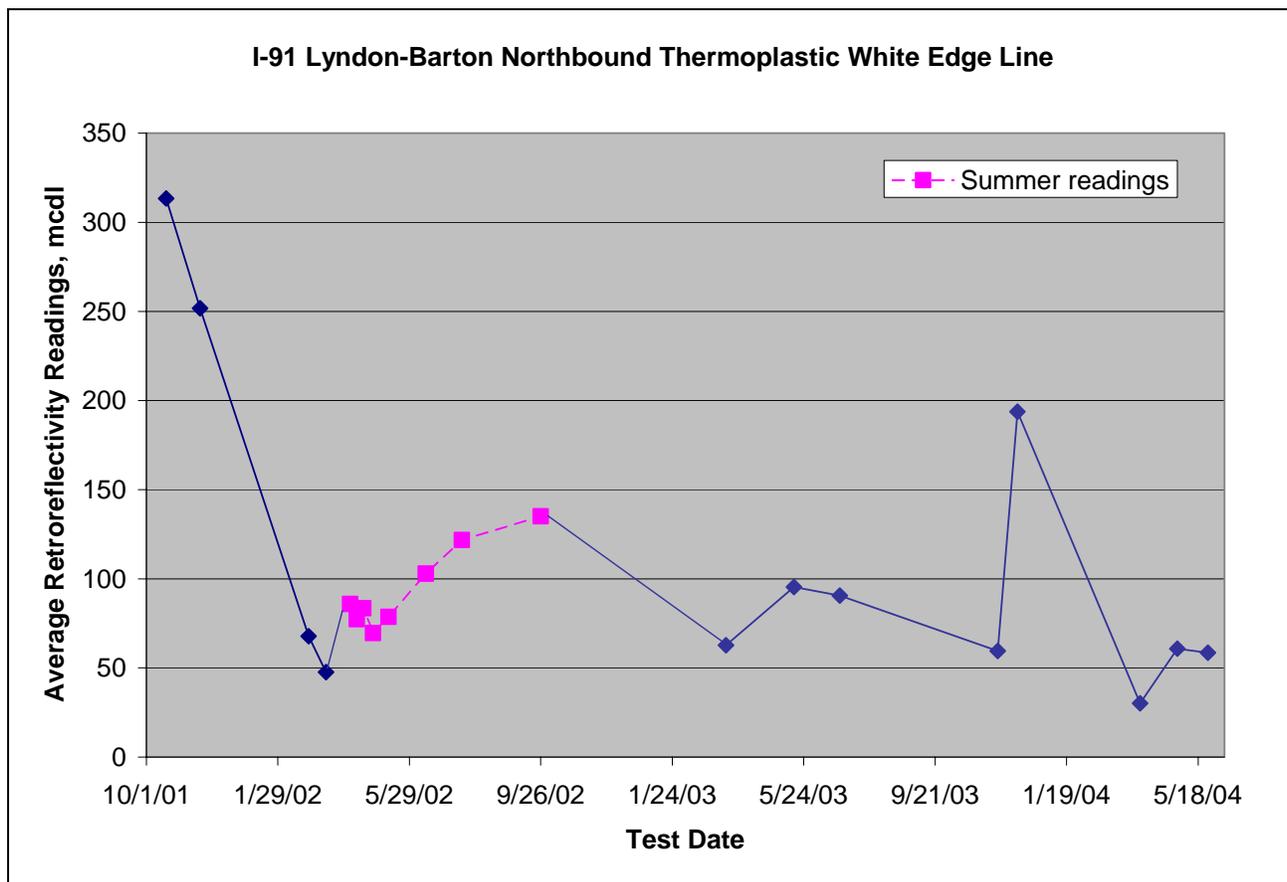
The data collected to date reveals a significant amount of variability in the R_L values of the individual test sites within roadway sections. As the variability increases, the level of statistical confidence in any trends or models decreases, therefore it is important to examine the variability upon which the service life and degradation analyses are based. Figure 15 displays the average retroreflectivity reading across all test sites within a roadway section on I-91 between the towns of Lyndon and Barton for the entire duration of the study. The test section consisted of a durable thermoplastic westbound white edge line that was applied in October of 2001. Readings were expected to display little variability during summer months, as indicated on the graph, where environmental conditions are relatively constant. However, the average retroreflectivity readings measured in the test sections during the summer of 2002, one year subsequent to application, ranged from 70 and 135 mcdl with an average of 94 mcdl. The standard deviation of the average retroreflectivity readings was approximately 23 mcdl. This is a relatively large standard deviation displaying the significance of the variability of the data set. Figure 17 is provided below:

In examining the graph it is also important to note the seasonal trend of the retroreflectivity of the pavement markings. The markings display a sharp decline during the winter months and appear to rebound during summer months, peaking in late summer to early fall. According to the Vermont Fire Prevention Division, the average annual snowfall accumulation in Vermont varies from approximately 60” along the southeastern edge of the state to as much as 150” in the Town of Stowe. Pavement markings may be damaged during winter maintenance snow removal practices resulting in an increased rate of pavement marking degradation. Each freeze thaw cycle may damage the lines by causing delamination, bead popout, and general wear and tear. The varying climate during winter in Vermont may cause the lines to endure many freeze thaw cycles. Areas that are subject to greater annual snowfall amounts are more susceptible to winter maintenance damage. This factor combined with any moisture or debris remaining on the markings following the winter cleaning protocol, prior to the collection of data, accounts for the seasonal trend of the reduction of retroreflectivity during winter months. Typically, the average peak values of the retroreflectivity reading during summer months continue to decline each year following application. Note however that the snowfall amounts were not taken into account for the degradation analysis as the majority of the annual snowfall amounts were within 10” of one another.

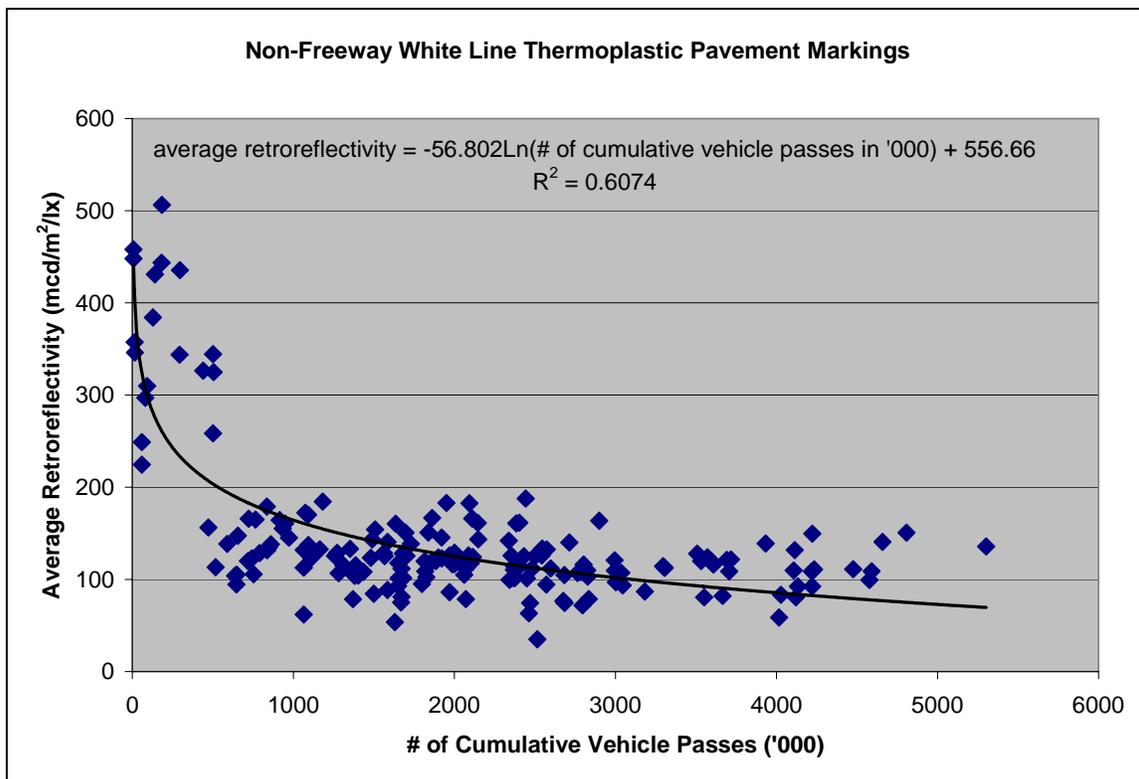
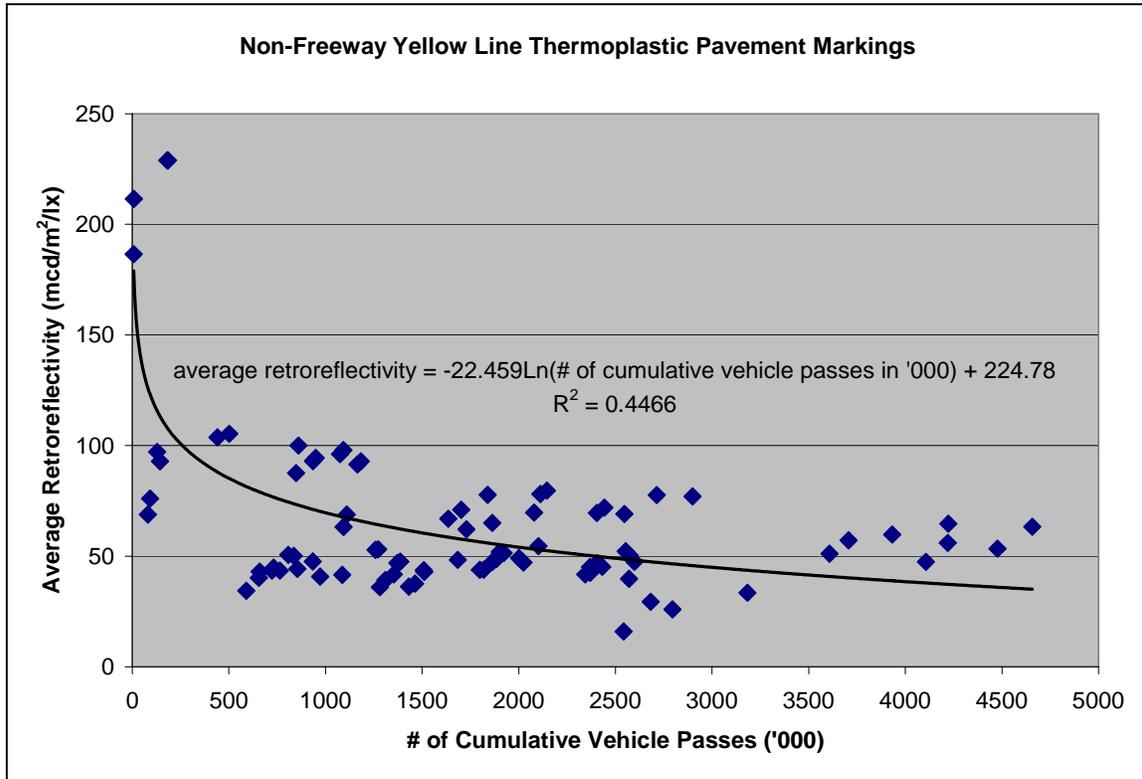
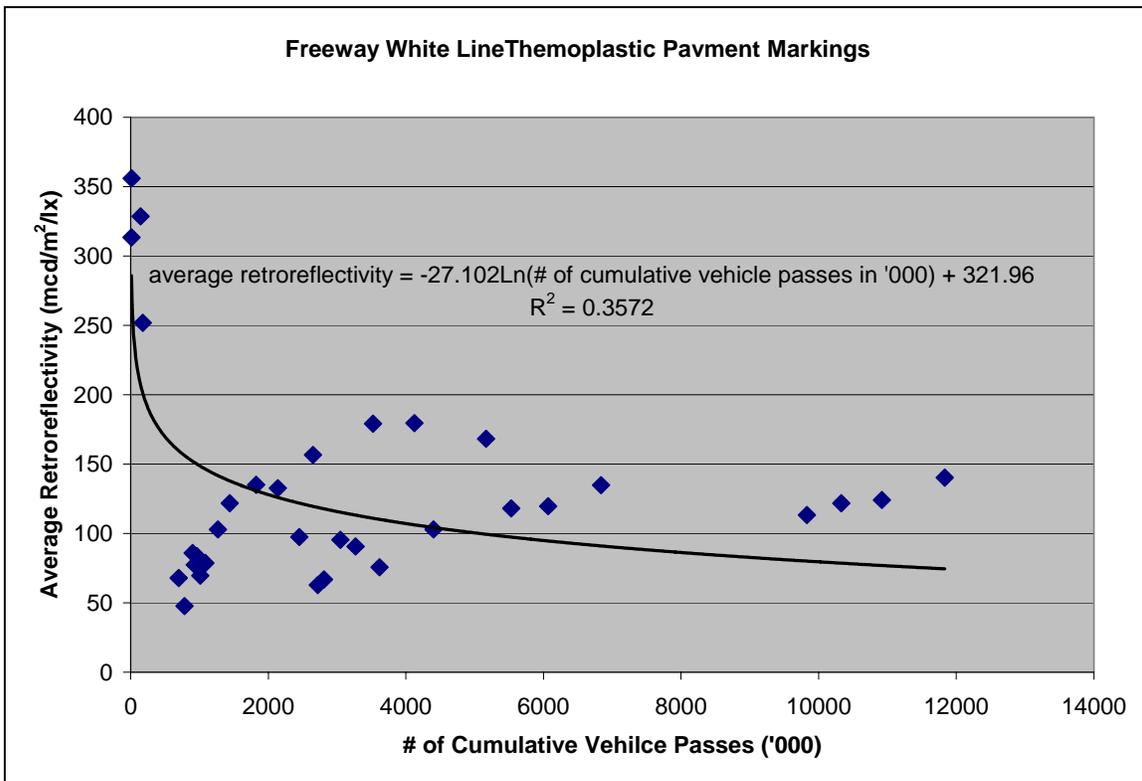
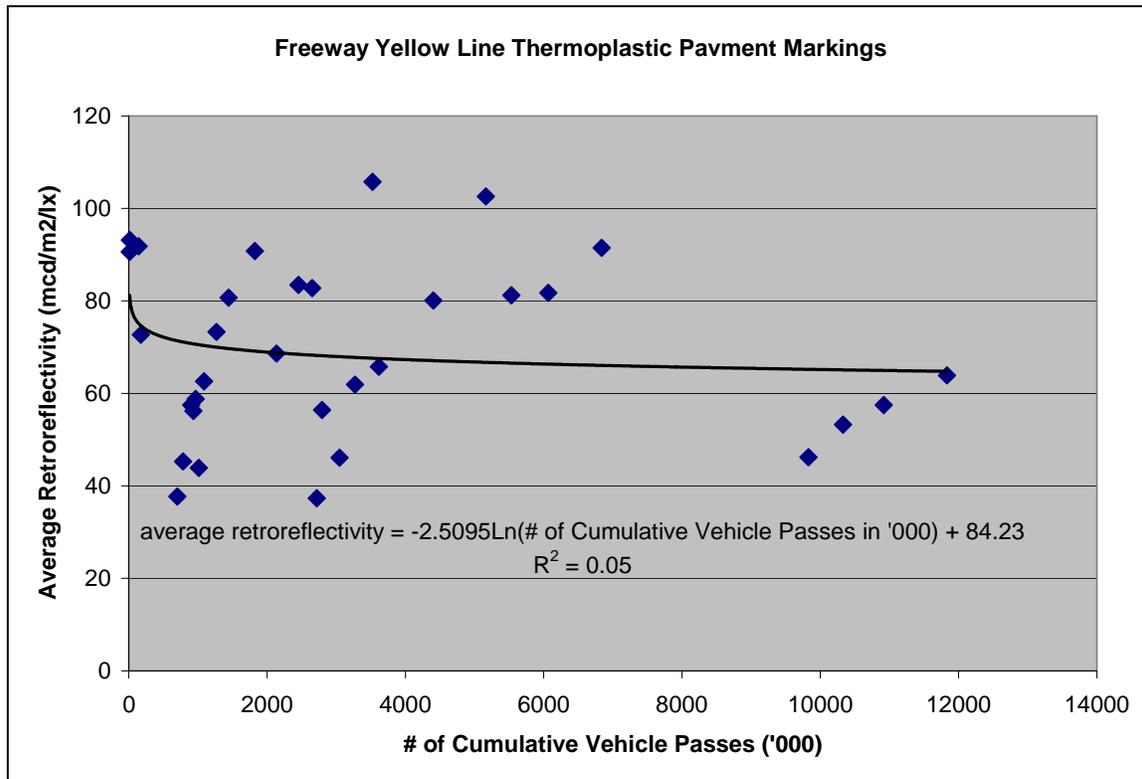
As a final step, all of the calculated average retroreflectivity reading and correlating cumulative AADT in thousands of vehicles were compiled into a larger data set by line type and color, grouped by non-freeway and freeway FHWA classifications as indicated above. These data points were then plotted on a graph with the cumulative AADT on the x-axis and correlating retroreflectivity readings on the y-axis. Once the points were plotted, a regression analysis was performed using the trend line function in Excel in order to provide a logarithmic equation that predicts the degradation of the reflectivity of pavement markings as a function of time and traffic flow. Note that an R^2 value, or coefficient of determination, was also presented below each equation that demonstrates how closely the estimated values for the trend lines compared to the actual data. Given as a number between 0 and 1, the closer the R^2 number is to one, the more accurate the trend lines and resulting degradation equations.

As depicted in Figures 18 through 21, the larger data sets appear to have more accurate degradation models as the coefficients of determination are closer to 1. Non-freeway degradation models are shown to more accurately depict the actual data sets than the freeway models. This may be attributed to a number of factors, including a large variation in the AADT values for the test roadway sections, differing traffic patterns over straight a ways vs. curved sections of roadways altering the degradation rates, and the potential for increased danger from on coming traffic with higher posted speed limits.

The models were solved for the number of cumulative vehicle passes utilizing the equations of the degradation models, along with the recommended retroreflectivity values from the FHWA of white and yellow pavement markings for different classes of roads. The result gives the number of cumulative vehicle passes until the line degrades to the recommended retroreflectivity value, as follows:

- Non-Freeway White Lines: $x = 3100$
- Non-Freeway Yellow Lines: $x = 1230$
- Freeway White Lines: $x = 570$
- Freeway Yellow Lines: $x = 540$
