**Evaluation of ATM 400 Permanent Durable Tape
Essex, Vermont
Final Report**

**Report 2010 – 8
Reporting on Work Plan 2007-6**

State of Vermont
Agency of Transportation
Materials and Research Section

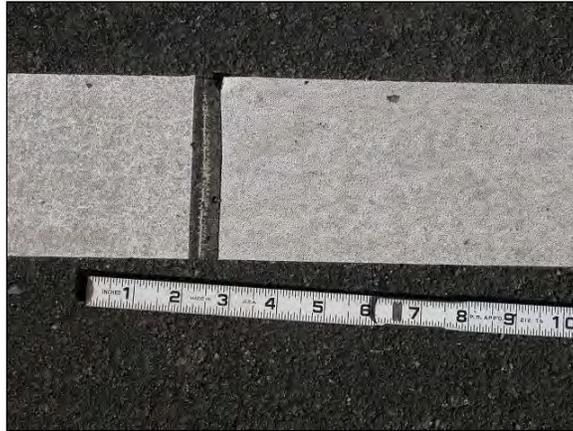
Figure 2. Void evidenced between tape segments.

According to the Resident Engineer's daily reports "this method worked well although there were some areas that seemed to be applied at too hot a temperature as the tape stretched and then when it cooled it pulled the mix apart which left a void." Figure 2, displayed below, depicts a spot where shrinkage (or void) occurred during application. As stated previously, the manufacturers recommended surface temperature for application is 120°F to 175°F. Theoretically, this shrinkage should be minimized by applying the tape at proper pavement temperature. However according to the RE, Greg Wilcox, all temperature readings were well within the manufacturer's specifications (125°F to 163°F). According to correspondence, Greg Wilcox wrote "my observations lead me to conclude that the tape could/should be laid down at even lower temperatures, say nothing above 140°F. Also the contractor should have a plan to fix areas that stretched and then cooled." [3] Interestingly, application literature states, "if tape distorts or wrinkles, surface temperature may be too hot or roller speed may be too fast."

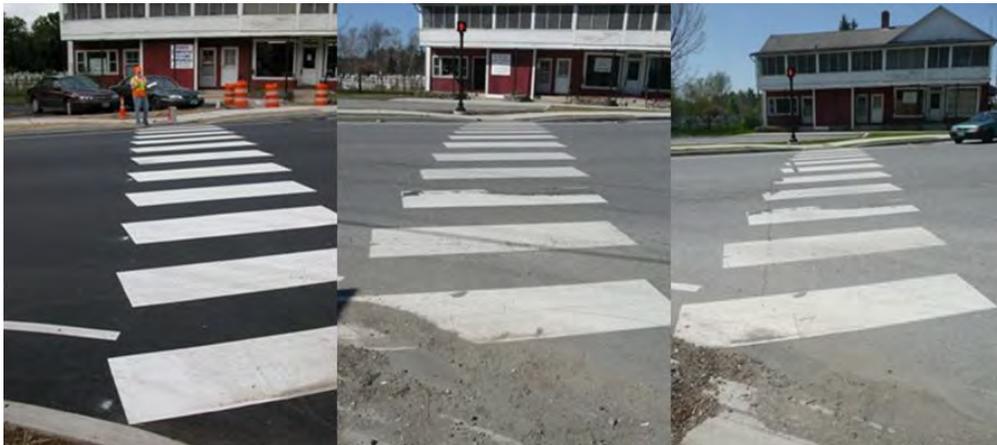
The values in the table indicate that the appearance and wear rates of all markings degraded at similar rates the exception of a portion of the crosswalk within TS 4 (ATM 300 Tape). It is interesting to note that as of July 28th, 2009 the permanent tape markings of TS 4 displayed almost twice the wear as compared to the crosswalk markings of TS 1 and 2 (ATM 400 Tape). In accordance with data collected on July 28th, 2009, the ATM 400 markings were slightly more resistant to wear as compared to the ATM 300 markings on average. However, this trend was not consistent over the evaluation period. Supposedly, the ATM 400 tape should have been more durable due to the grade and greater mil thickness. However the readings collected from April 17th, 2008 through May 12th, 2009 do not support the manufacturer's claim as the wear readings of the crosswalk markings are roughly equivalent. However, these wear patterns are likely attributed to associated traffic characteristics, as the AADT within TS 1 and 2 (12,500 and 16,500, respectively) is far greater than TS 4 (1,600). And although some portion of the markings wore over time, no catastrophic failures were observed during the monitoring period. Figures 3 and 4 below show the progressive wear on test sites 1 and 3, respectively. The left hand image in each figure shows the initial appearance of the sites, the second at 8 months (following the first winter), and third at 19 months.

Figure 3. Progressive wear characteristics of test site 1, from left to right, at 0, 8, and 19 months post construction.

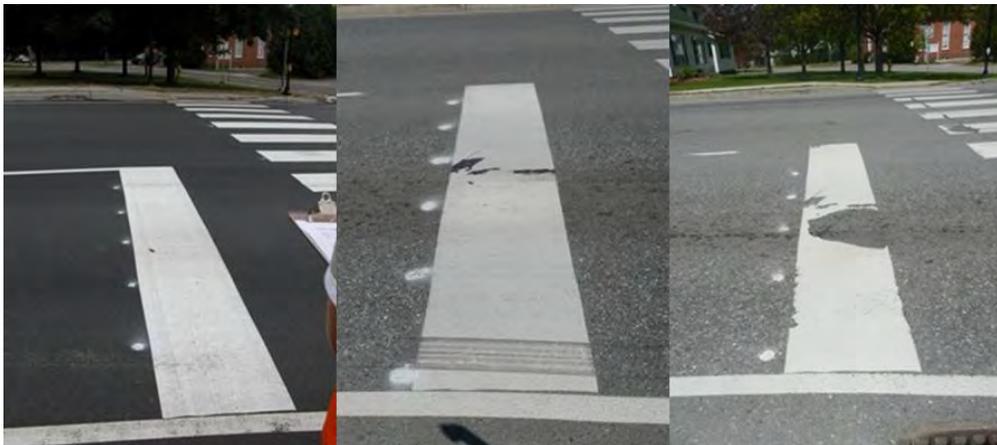
Figure 4. Progressive wear characteristics of test site 3, from left to right, at 0, 8, and 19 months post construction.

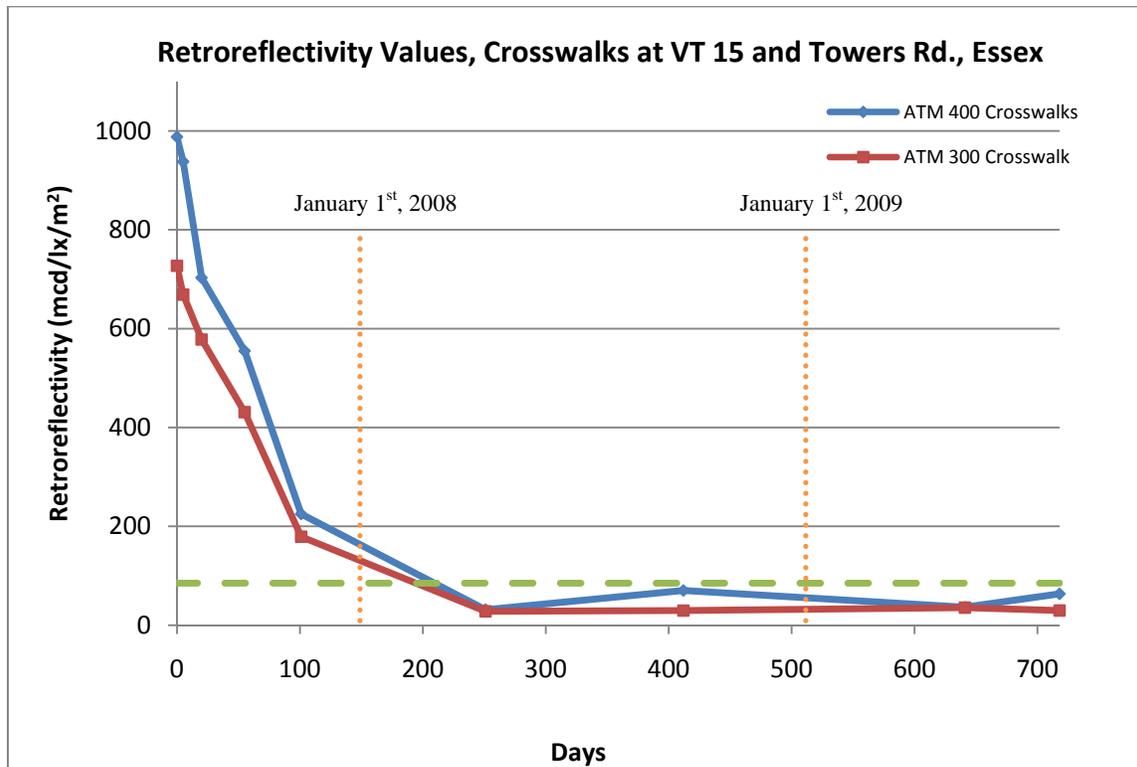
Service life estimates for the white crosswalk markings could not be determined due to the large extent of time between data collection events. Therefore, a scatter plot of the data was generated in order to establish the approximate amount of elapsed time before retroreflectivity values fell below 85 $\text{mcd}/\text{m}^2/\text{lx}$, as shown in Figure 5. Please note that only white crosswalk markings are modeled for this analysis due to the inherent variability comparing various marking types.

Figure 5. Plot of retroreflectivity values versus time for test sites comprised of crosswalks. Vertical orange lines indicate a date of January 1st, while green indicates the day when retroreflectivity values fell below the minimum.

The graphical representations clearly display a strong positive correlation between winter maintenance practices and pavement marking decay. The effects of the first winter season appear to result in the greatest decay over the monitoring period whereas the second winter season appears to have minimal impact on pavement marking retroreflectivity. It is likely that the majority of the bead loss occurred during the first winter season and any remaining beads were sufficiently embedded into the marking tape as to be protected from subsequent plowing events. In addition to a decrease in values during the winter, a very sharp decrease was also observed well before snow plowing began. In any case, the average retroreflectivity values for the crosswalk markings comprised of the ATM 300 and ATM 400 were below FHWA recommended minimums roughly 200 and 216 days following construction, respectively. These decay rates are likely largely influenced by traffic volumes along each roadway as markings along VT 15 (with a moderate AADT) were anticipated to wear more readily as compared to those

Carolina at Charlotte concluded “that nighttime luminance levels provided by pavement markings that may be adequate for younger drivers may be less than adequate for older drivers” [9]. Therefore, rather than examining the amount of time until retroreflectivity levels fall below a minimum recommended level, the following assessment accounts for the retroreflectivity readings over time above minimum recommended levels as a net benefit. The net benefit is calculated by a summation of the area between the averaged retroreflectivity readings and FHWA recommended minimum in Figure 5, until readings fall below the minimum value.

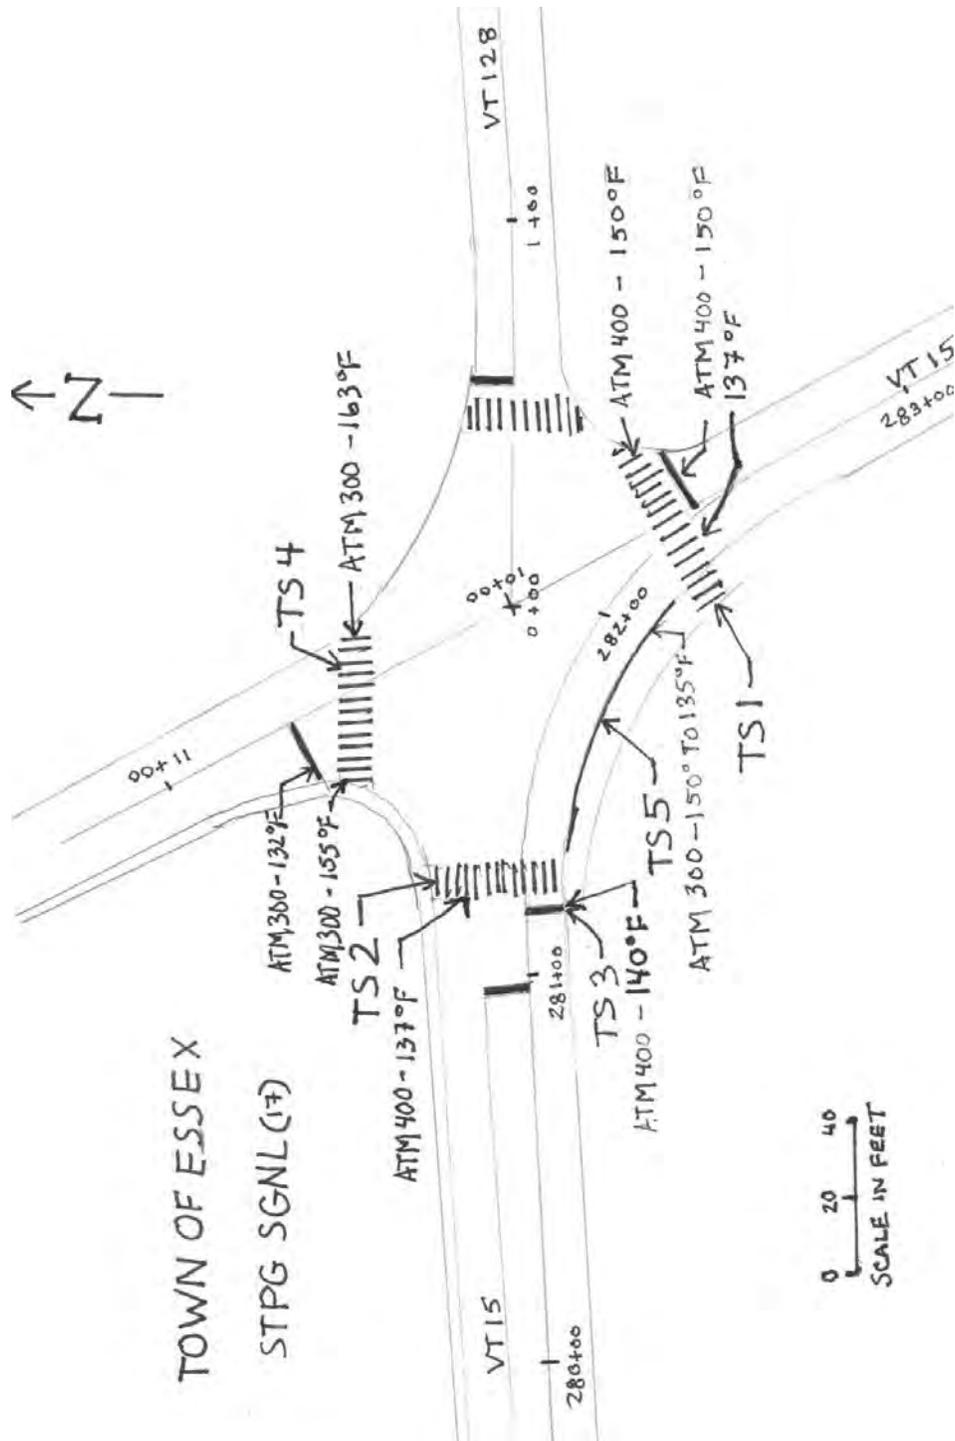
Figure B1 – Diagram of VT 15 and VT 128 intersection

A diagram of the entire project is provided in Figure B1. Included in the diagram are the locations of the five test sites selected for retroreflectivity measurement, along with the associated pavement temperatures at the time of ATM tape installation at each site.
