**Activated Approach Flasher System
Final Report**

**Report 2009 - 11
Reporting on Work Plan No. WP 2006-R-1**

State of Vermont
Agency of Transportation
Materials and Research Section

1. Report No. 2009-11	2. Government Accession No.	3. Recipient's Catalog No.	
4. Title and Subtitle Activated Approach Flasher System Castleton, VT		5. Report Date October 2009

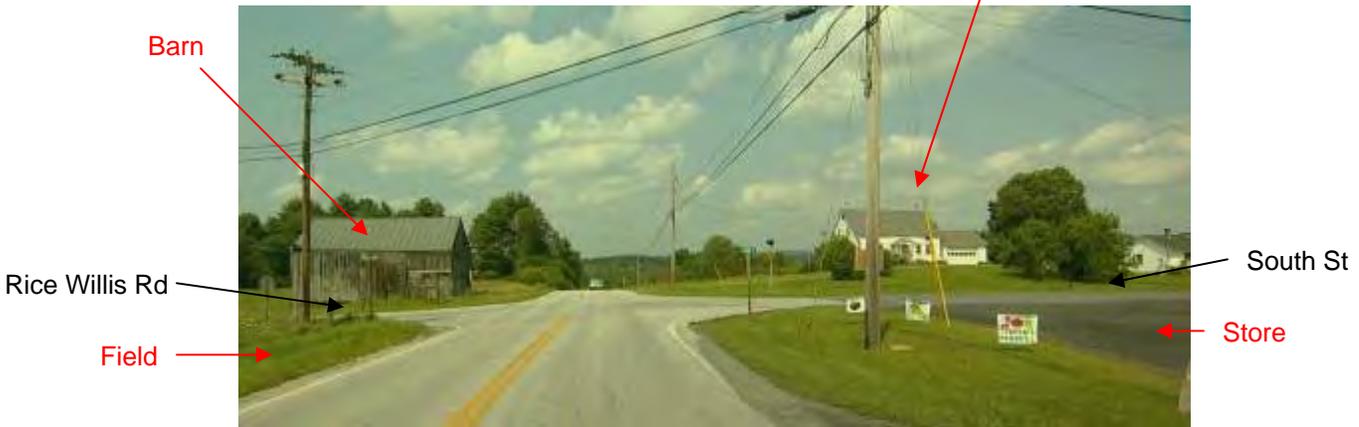
The land use at this intersection consists of a country store on the southeast corner, a house on the northeast corner, a barn on the northwest corner, and a field which is part of a residential property on the southwest quadrant.

A wide open entrance, approximately 100 feet in length, provides access to the country store from the south approach of VT Route 30. The country store is also accessible from South Street. The house on the northeast corner has a drive on South Street as well as another one on VT Route 30 about midway between the intersection and the crest. The barn on the northwest corner is accessible from any direction. **House**

Figure 2: Surrounding land use (looking North on VT Route 30).

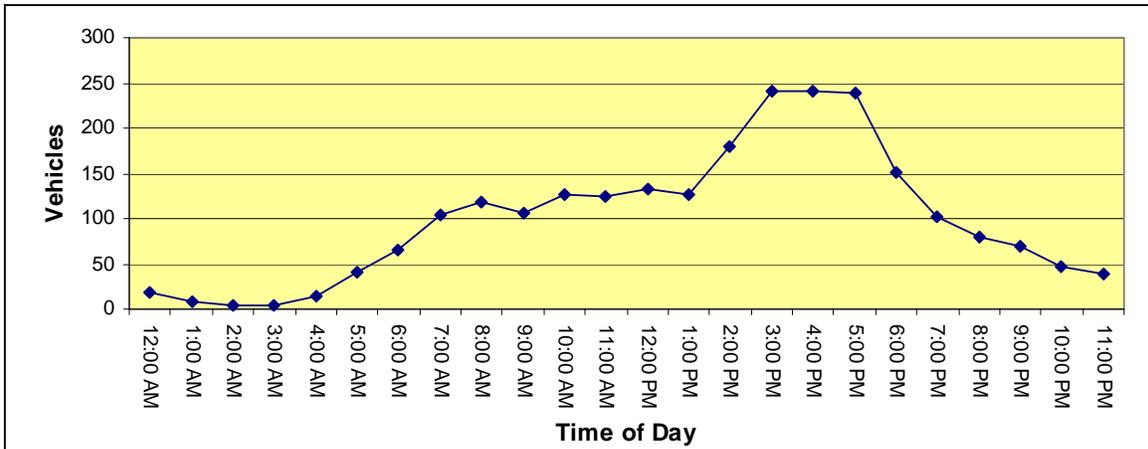
The 2006 estimated average daily traffic (ADT) on VT Route 30 south and north of the intersection was 3,800 and 4,600 vehicles respectively. The average traffic flow sorted by time of day on VT Route 30 in both directions is shown in Figure 3.

Figure 3: VT Route 30 traffic flow.

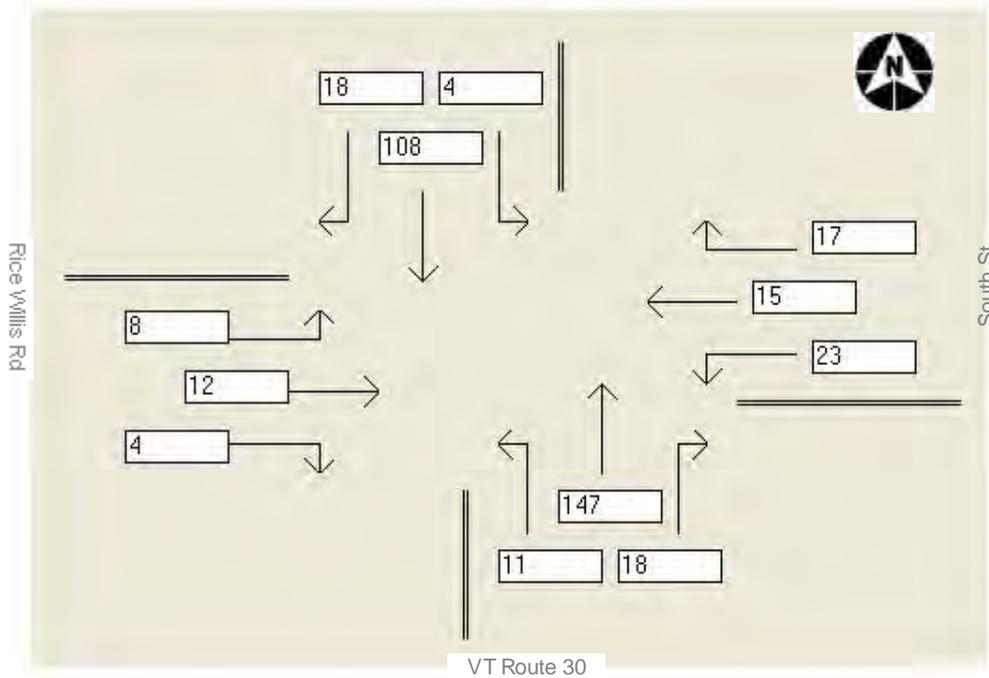
According to the turning movement counts, traffic entering this intersection is the heaviest during the afternoon peak period between 3:00 pm and 5:00 pm. Figure 4 displays the peak hour traffic volumes between 3:30 pm and 4:30 pm.

Figure 4: PM peak hour volumes (3:30 pm to 4:30 pm).

Turning movement counts performed in 2006 and 2008 show, for a ten-hour daytime period, about 1,200 vehicles traveling in each direction along VT Route 30. For the same ten-hour period, there are approximately 300 vehicles approaching the intersection from South Street, and about 200 vehicles approaching the intersection from Rice Willis Road. Throughout the day, 56% of the traffic along Rice Willis Road travels through the intersection and onto South Street. Conversely, the majority of traffic along South Street (40%) turns left onto VT Route 30 while only 31% travels through the intersection onto Rice Willis Road.

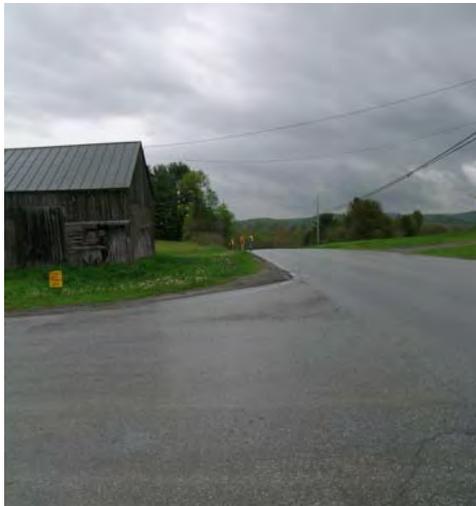
The available corner sight distance, or length of roadway a driver can see at any particular time, was measured in the field to be 228 ft when looking to the north from Rice Willis Road and 250 ft when looking north from South Street as shown in Figures 5 and 6.

Figure 5: Intersection site distance – looking North from Rice Willis Road.

In accordance with the 2004 edition of the “Geometric Design of Highways and Streets”, “intersection sight distance criteria for stop-controlled intersections are longer than stopping sight distance to ensure that the intersection operates safely.” As shown in Case B1, recommended intersection sight distance is provided for traffic approaching from either the right or the left for left turns from the minor road onto the major road for intersections with stop control on the minor road. As shown within the guidance, an intersection sight distance of 660 ft and 610 ft along the major road is recommended when passenger cars travel at speeds of 59 mph and 55 mph along the major road, respectively. These speeds represent the 95th and 85th percentile speeds along VT Route 30. Therefore, the current intersection sight distance for passenger cars making a left hand turn onto VT Route 30 is not acceptable.

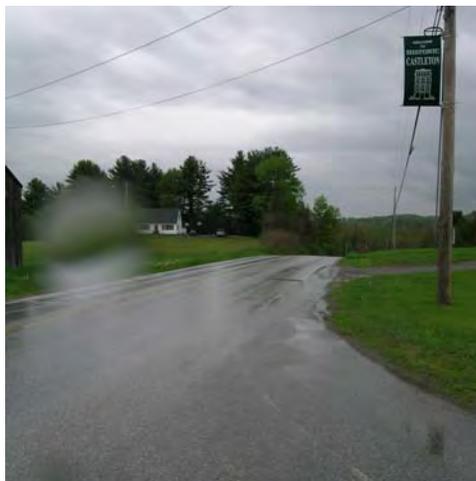
Figure 6: Intersection site distance – looking North from South Street.

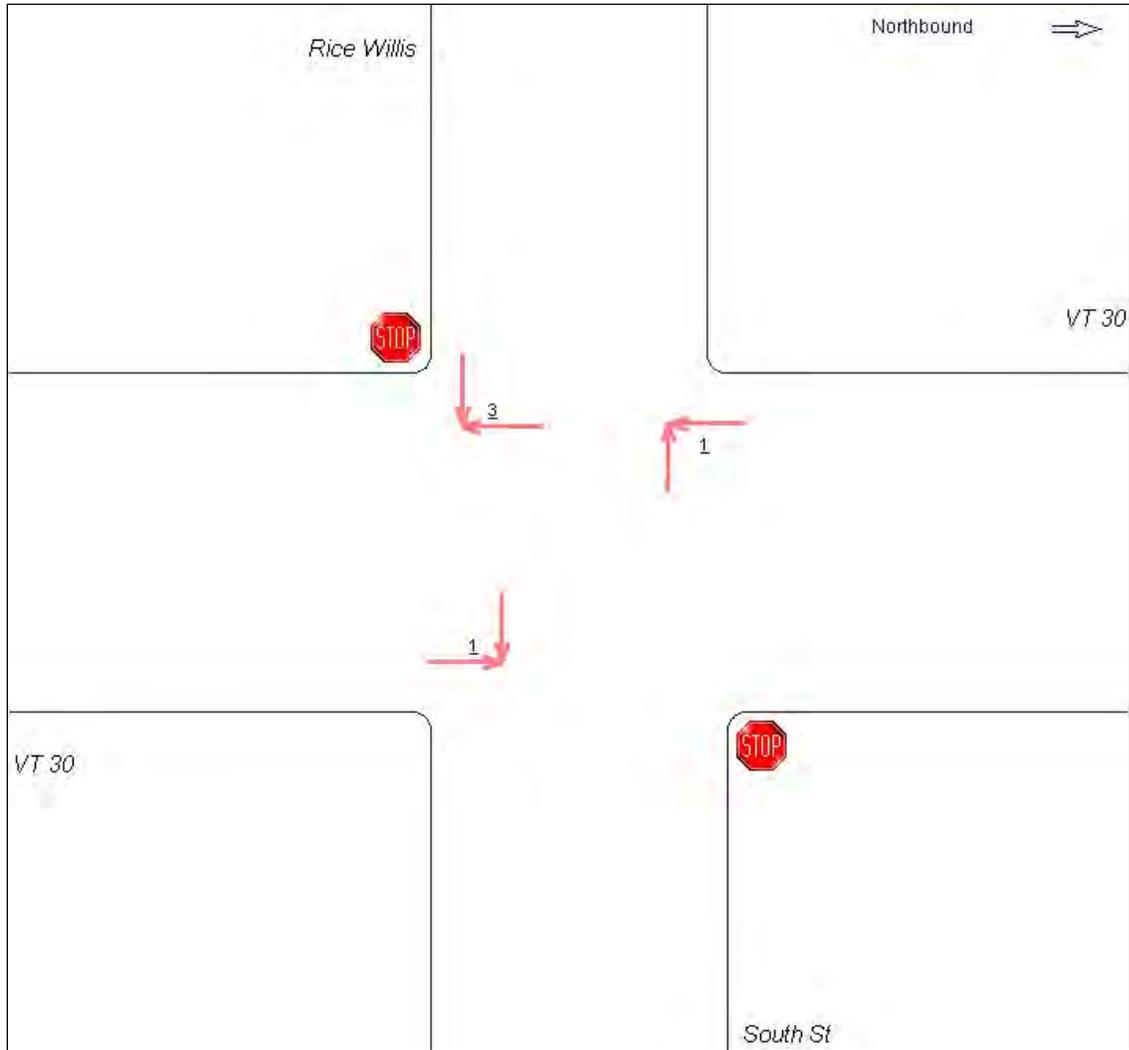
Figure 7: Reported crashed (January 2001 through September 2007).

The five crashes reported during this period are shown in the collision diagram presented in Figure 6 (in this diagram, the numbers next to the arrow symbols represent the number of crashes for that crash type). As shown in Figure 6, the five crashes were all right-angle crashes. Four of these crashes involved vehicles traveling southbound along VT Route 30 and traffic approaching from Rice Willis or South Street. All five crashes took place in the afternoon, between 2:30 pm and 6:00 pm, and mostly on a weekend (80%). From the statements taken at the scenes, the motorists on the side roads had stopped at the stop signs prior to proceeding, indicating that the amount of corner sight distance may have been inadequate to accurately warn traffic of oncoming traffic.

From January 1, 2001 to the time the beacon system was installed in October 2007, five crashes were reported to the Vermont Department of Motor Vehicles. One crash was reported in 2003, 2006 and 2007. Two crashes were reported in 2005. Over this period of six years and nine months, the crash rate per year was 0.72, and the crash rate per million entering vehicles was approximately 1.40.

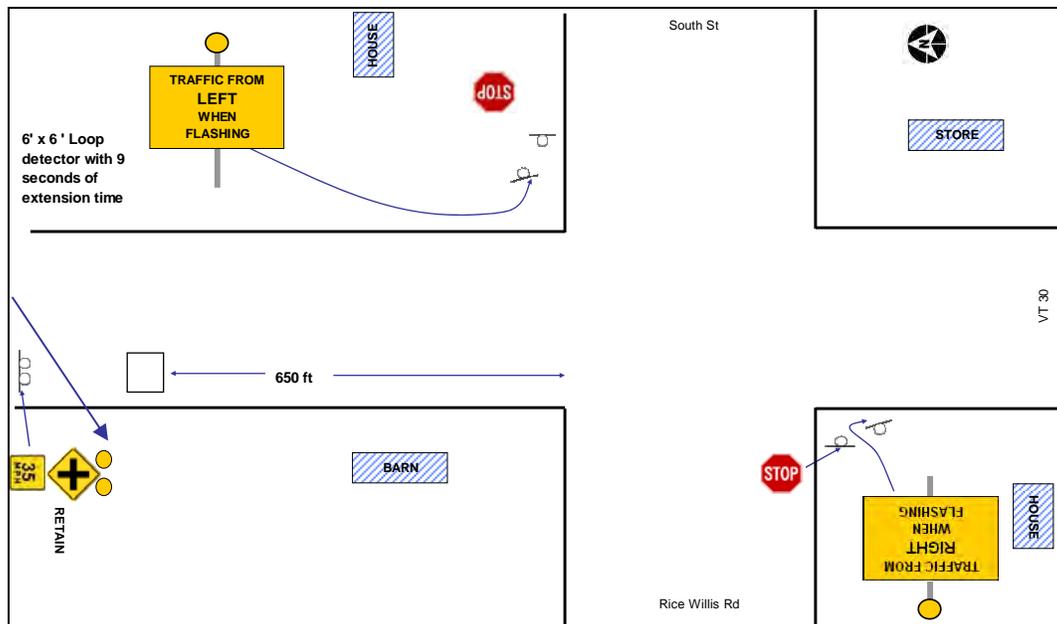
system is a detector loop buried in the pavement on the north approach of the intersection on VT Route 30. The system senses the presence of approaching vehicles and activates beacons to warn drivers waiting on the side roads that traffic is approaching the intersection.

Two beacons were installed at the intersection. These beacons were installed above a warning sign and face the motorists found to have inadequate intersection sight distance. One beacon faces Rice Willis Road and the other one faces South Street. When stopped on Rice Willis Road, the sign informs motorists that vehicles from the left (or traffic traveling south along VT Route 30) are coming when the beacon is flashing. Similarly, when stopped on South Street and if the beacon is flashing, the sign informs motorists that vehicles are coming from the right (or traffic traveling south along VT Route 30).

A schematic of the system is illustrated in Figure 8.

Figure 8: System layout.

A 6 ft x 6 ft inductive loop was installed, 650 ft from the intersection, in the southbound lane on VT Route 30. Once a vehicle or motorcycle passes over the loop, the beacons are activated for a duration of nine seconds. If a vehicle passes over the loop while the beacons are already activated, the flashing duration is reset for an additional nine seconds.

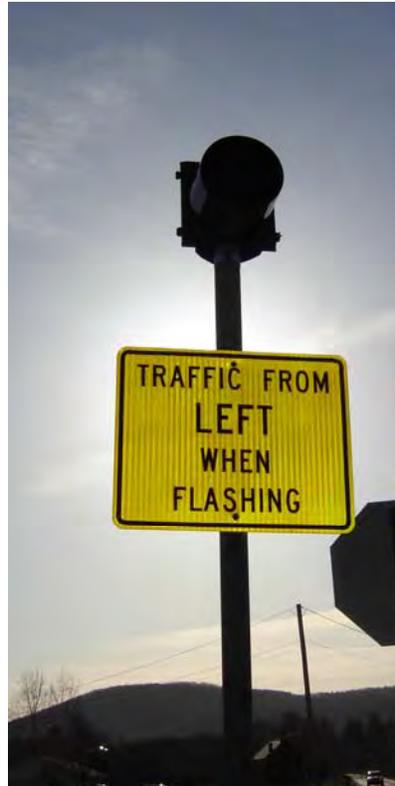
Two 30" x 24" warning signs were developed as shown in Figure 8. Two different legends, depending whether a vehicle is waiting on South Street or Rice Willis Road, are used to alert drivers of approaching traffic on from VT 30 north. The signs simply say "traffic from right when flashing" (for traffic facing South Street) or "traffic from left when flashing" (for traffic facing Rice Willis Road).

Figure 9: Example of warning sign.

The signs were made of fluorescent yellow sheeting type IX with three-inch capital letters (four-inch letters were used for the words "left" and "right"). As designed, the signs are legible for approximately 99 ft to 120 ft based on the letter height to legibility distance ratio recommended in the "Manual of Uniform Traffic Control Devices." Each sign was installed on a tubular post with a slip base to reduce the likelihood of the beacons being knocked down by large trucks.

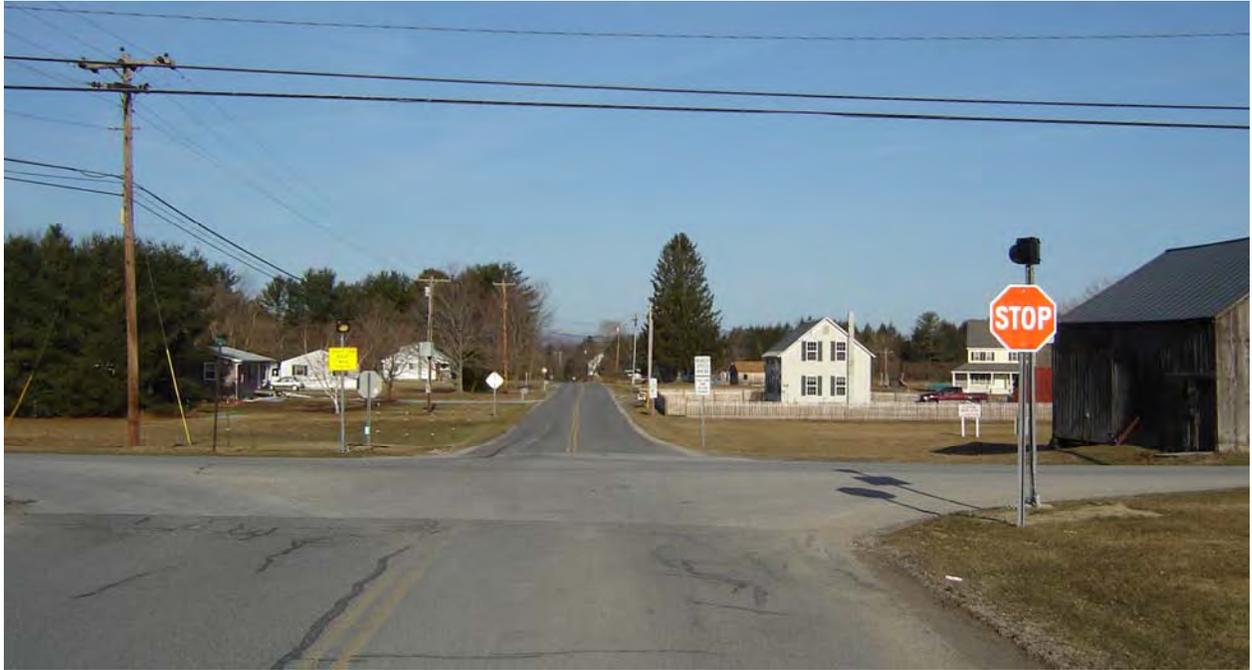
The lenses of the beacons are twelve-inch yellow light emitting diode (LED) lenses. To improve the fail safe nature of the system, the LED lenses used are of the type for which failure of a single LED results in the loss of light from only that LED.

To further increase reliability, an eight-hour battery back up system was installed inside the cabinet. In addition, if the loop is broken and cannot detect vehicles, the beacons are set to go on continuous flash.

Figure 10: Installed beacon system (view is from South Street).

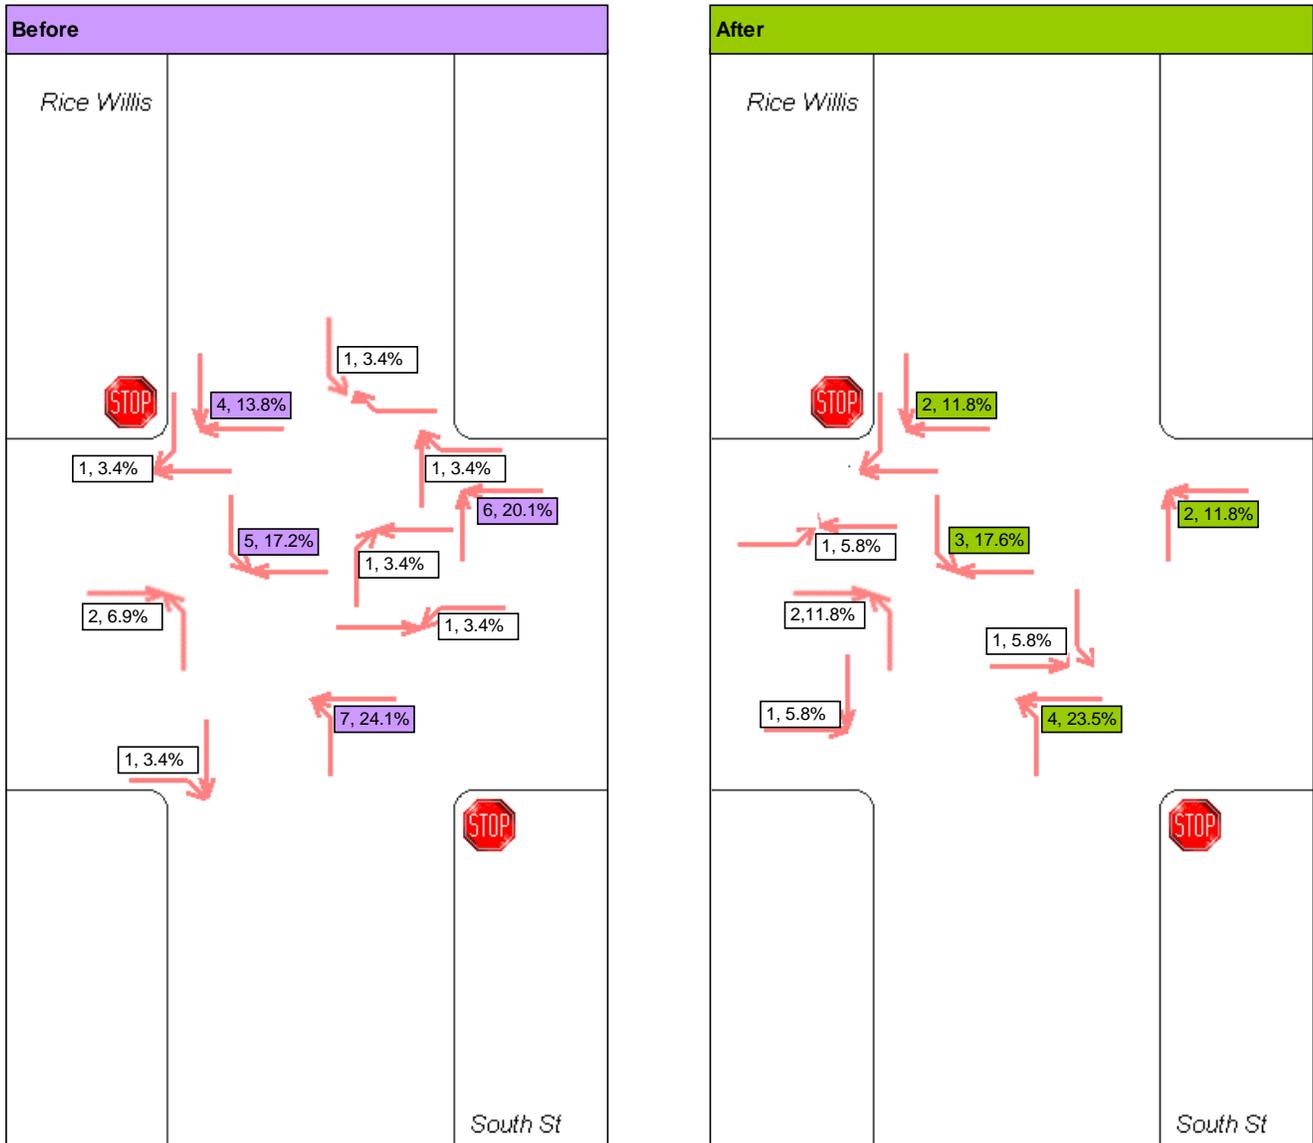
Figure 11 presents conflict diagrams for the before and after periods.

An analysis of these diagrams confirms that cross traffic conflicts are the primary types of conflicts at this intersection. There are four types of conflicts that are predominant in both the before and after periods. These are 1) a southbound through vehicle with a westbound left turning vehicle, 2) a southbound through vehicle with a westbound

through vehicle, 3) a southbound through vehicle with an eastbound left turning vehicle, and 4) a southbound through vehicle with an eastbound through vehicle.

A comparison of the diagrams further indicates that the proportions of conflicts for most conflict types remained the same in the after period. The conflict involving a through southbound vehicle on VT Route 30 and a through vehicle on South Street is the only conflict for which the proportion of conflicts was reduced by a large percentage. While the relative proportion of each major conflict type remained approximately the same, the number of occurrences for each type was found to be lower than the before study.

Figure 11: Before and after conflict diagrams.

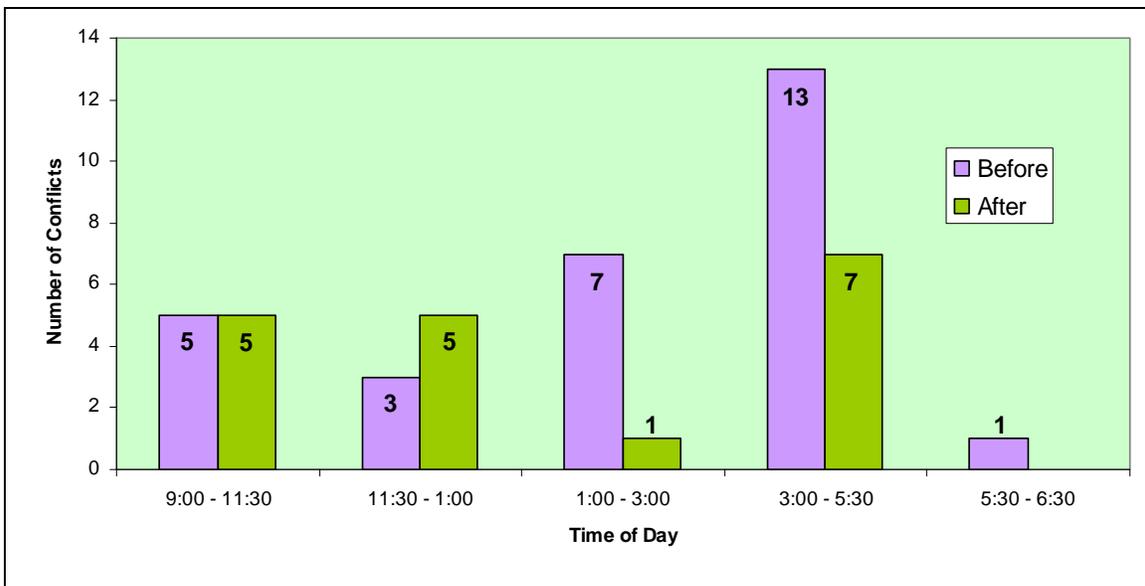
The before and after distributions of conflicts per time of day between the hours of 9:00 am and 6:30 pm, are shown in Figure 11. These distributions indicate that the number of conflicts observed between 9:00 am and 1:00 pm were approximately the same in both the before and after periods. From 1:00 pm to 5:30 pm, a larger number of conflicts were recorded prior to the installation of the beacon system. The number of conflicts is again about the same after 5:30 pm.

Figure 12: Temporal distribution of the observed conflicts.

The device seems to be most effective during periods of heavier traffic volumes.
