**Evaluation of Concrete Bridge Rail Cracking
Initial Report**

Report 2009 - 5

State of Vermont
Agency of Transportation
Materials and Research Section

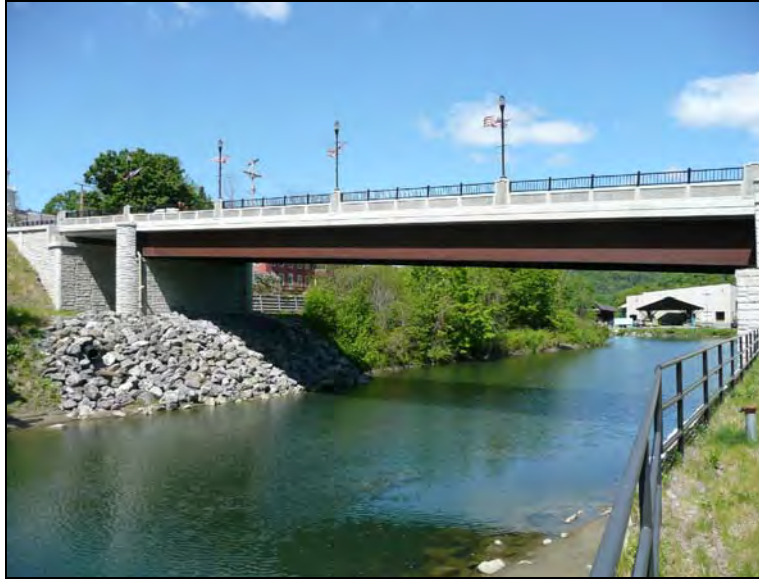
Figure 1. Overview of the Bethel bridge.

Rails were poured on four days from September 18 through September 28, 2006, with rubbing and finishing finalized on October 5, 2006. In all cases, forms were stripped off the day following casting and sprayed with a pressure washer in an attempt to expose the underlying aggregate for a ‘pebble’ finish along the exposed surfaces. This did not work as well as planned, as some panels contained an adequate ‘pebble’ finish while others retained a flat appearance. According to onsite personnel, this discrepancy was preliminarily due to insufficient construction practices as greater sufficiency with form release agents were developed during the finishing process.

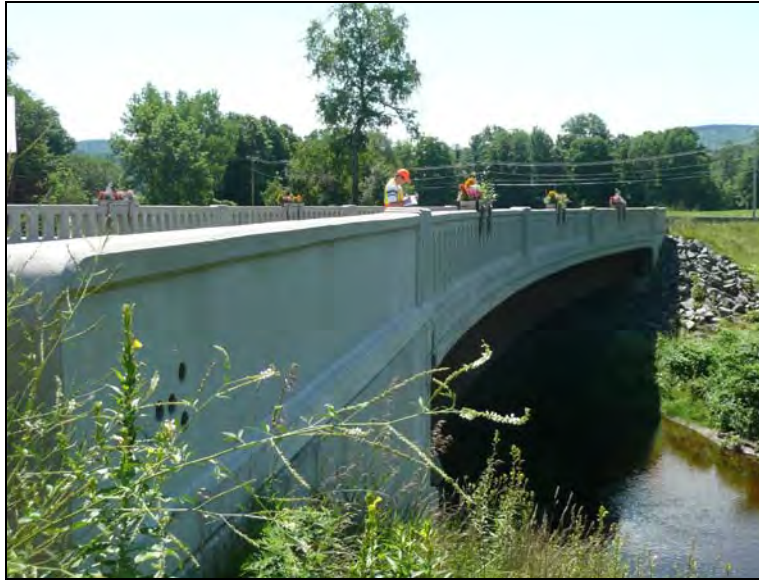
Figure 2. Overview of the Chester bridge.

Casting of the rails took place on September 10th and 21st of 2004, with forms removed within two weeks of these dates. Upon form removal, rails were rubbed periodically and

finally coated with silane for waterproofing on November 4, 2004. Figure 2 shows the finished product.

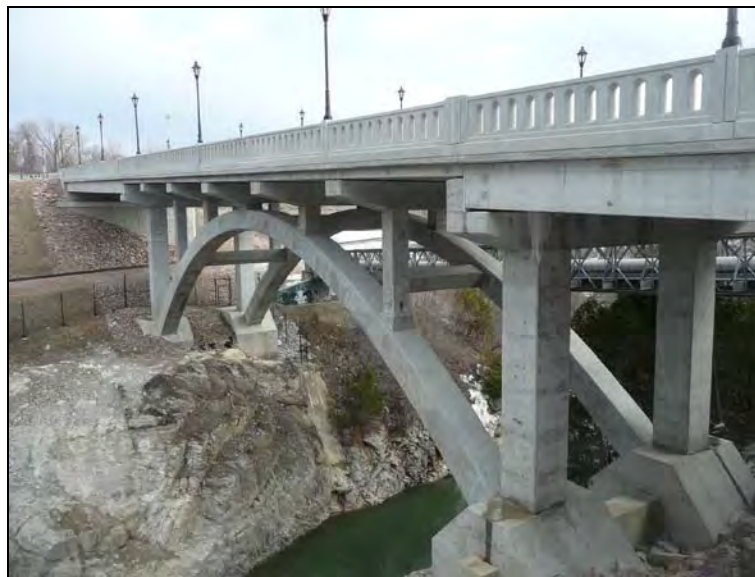
Figure 3. Overview of the Colchester - South Burlington bridge.

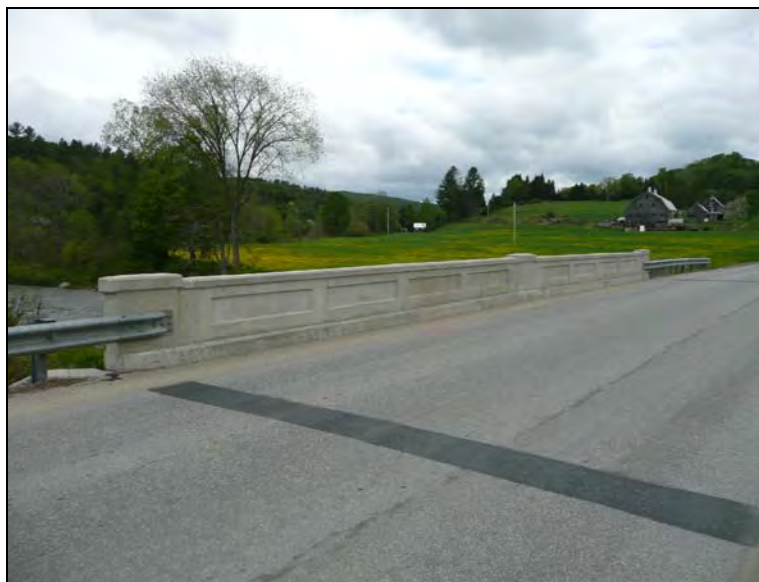
Figure 4. Overview of the Corinth bridge.

Pouring of the rails occurred on September 23 and 28 of 2004. In both cases form removal and rubbing began the day after casting and finished three days later. Silane was applied to the rails on October 27, 2004.

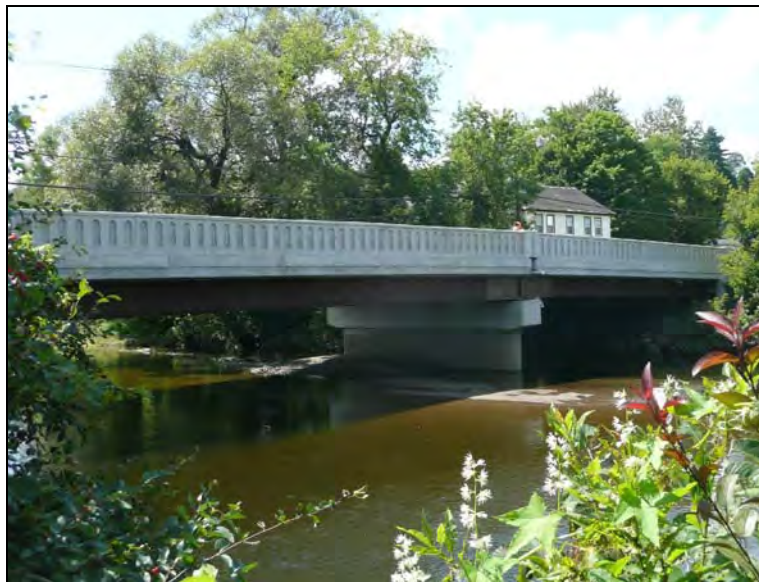
Figure 5. Overview of the Lyndon bridge.

Rails for the Lyndon bridge were cast on eight different days, beginning on November 1, 2004 and through on December 8. Rails sections were wrapped with plastic and heated to assist in curing. Exact dates of form removal, rubbing, and silane application were not available.

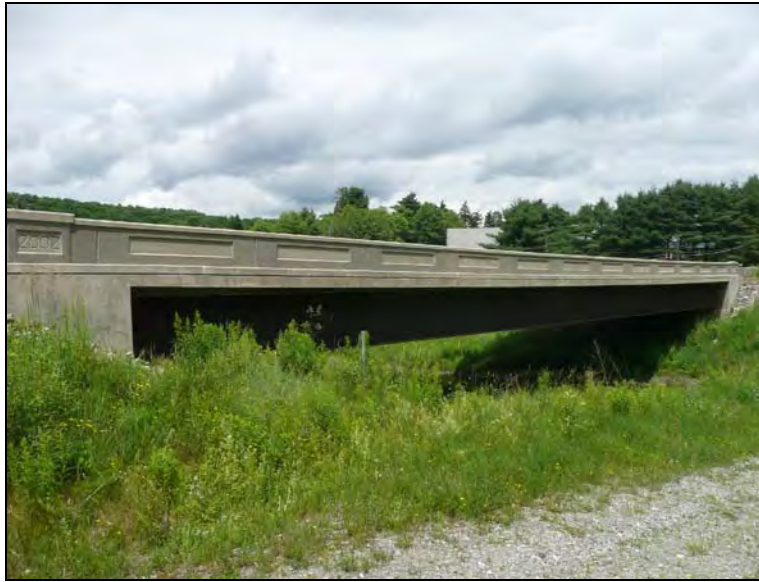
Figure 6. Overview of the Morrystown bridge.

Casting of these bridge rails took place beginning on June 27, 2002 and continued through July 19, for a total of eight pour dates. No dates or comments were found referencing form removal or finishing of the rails. Rail design for this bridge consisted of solid sections with different surface finishing on the inner rectangular panels than was present on the outer areas, for aesthetic purposes.

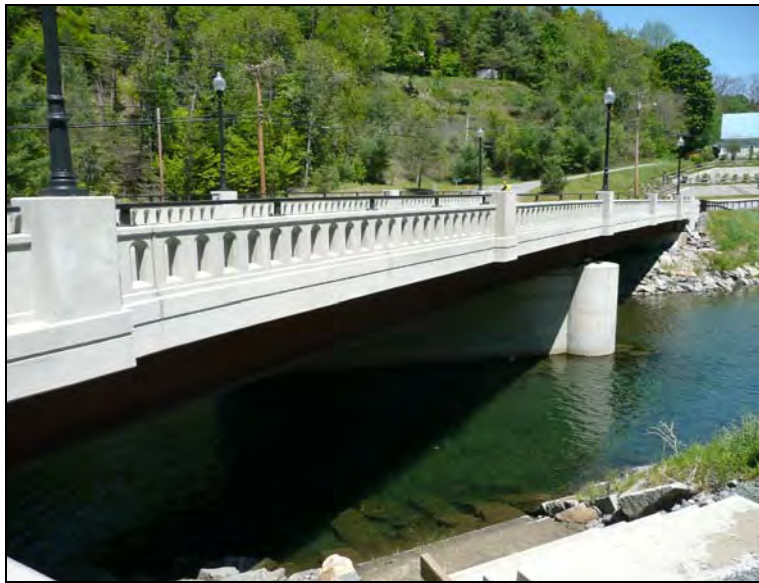
Figure 7. Overview of the Tunbridge bridge.

Rail pouring commenced on November 17, 2006 and finished on January 8, 2007. There were a total of 10 pour dates spread fairly evenly across this timeframe. Rail sections were cast in a leapfrog pattern, i.e. alternating sections and then filled in between afterwards. Forms remained on the concrete anywhere from 2 to 12 days depending on the conditions and were rubbed soon thereafter. Silane was applied within one month of casting in all cases. Rails for this bridge include gothic style windows with a top-mounted steel rail and lamp posts anchored to alternating pilasters.

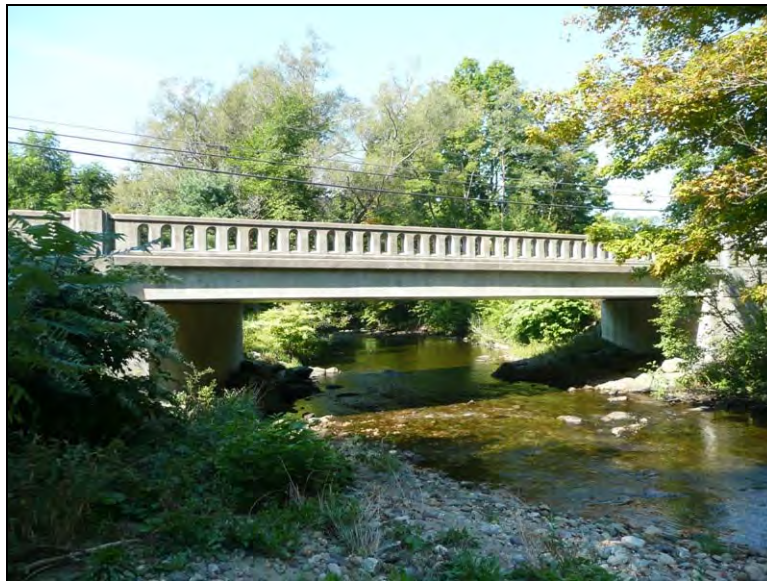
Figure 8. Overview of the Underhill bridge.

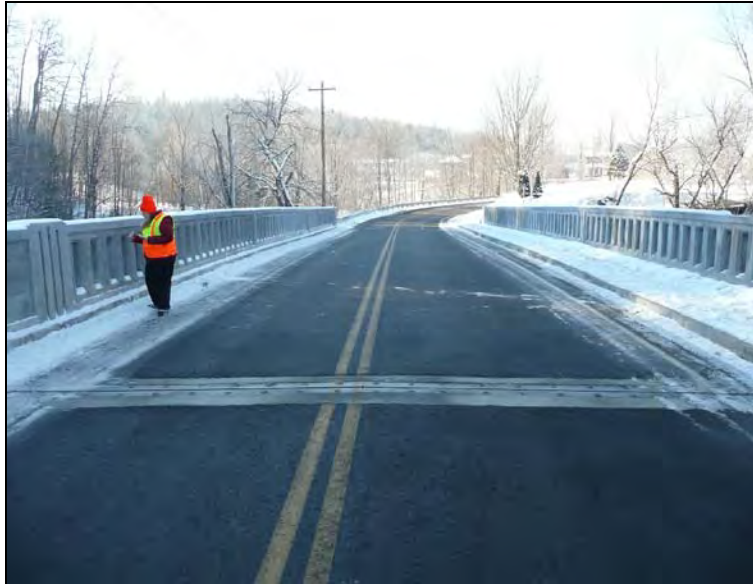
Figure 9. Overview of the Barton bridge.

Rails for the Barton bridge were poured on two days. The downstream (northbound) side was cast on November 1, 2007, while the upstream (southbound) was cast on November 5. In both instances forms were removed 11 days after pouring, at which time rubbing of

the rails commenced. Silane was applied to both rails on November 26. Rail design for this bridge consisted of Texas style rails with windows.

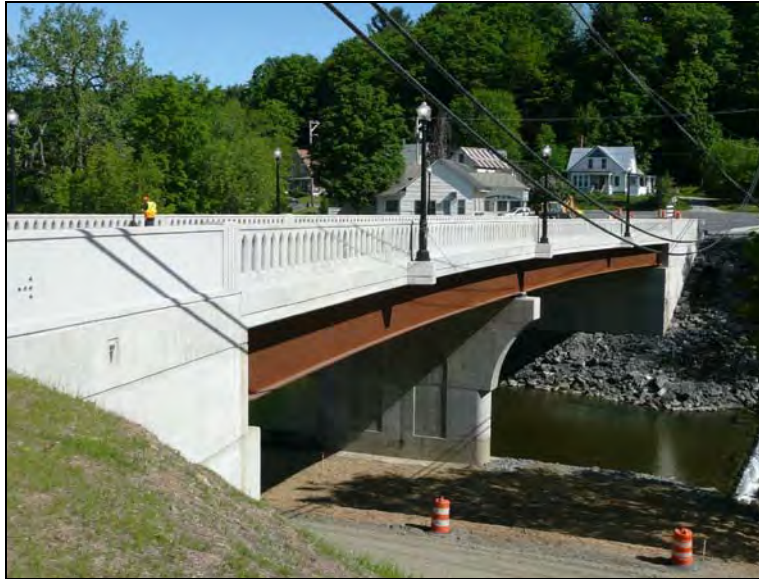
Figure 10. Overview of the Randolph bridge.

Downstream portions of the rail were poured during six days, from October 3 to 10, 2007 and the upstream were completed during an eight day period, from October 11 to 22. It was noted by the resident engineer that air contents of the concrete deliveries decreased steadily during the pours for the downstream rail on a daily basis, but were still within specification. For one section, “Section 7,” of the upstream rail, on the other hand, the air content was below specification. Section 7, from station 17+04 to 17+38 Lt, was poured on October 18. Forms were removed in all cases after only one day so that rubbing could begin in order to fill in any existing voids and smooth the finish of the rails. The rails were then kept wet by a hose and burlap for 10 days.

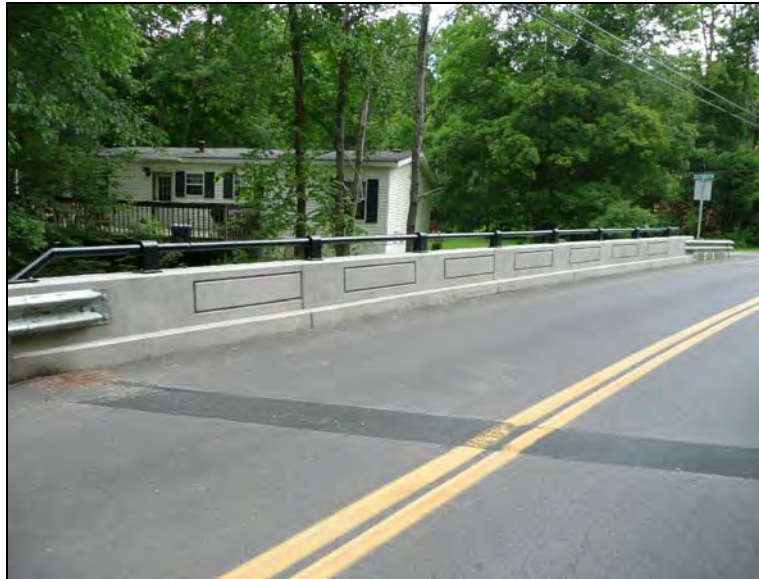
Figure 11. Overview of the Warren bridge.

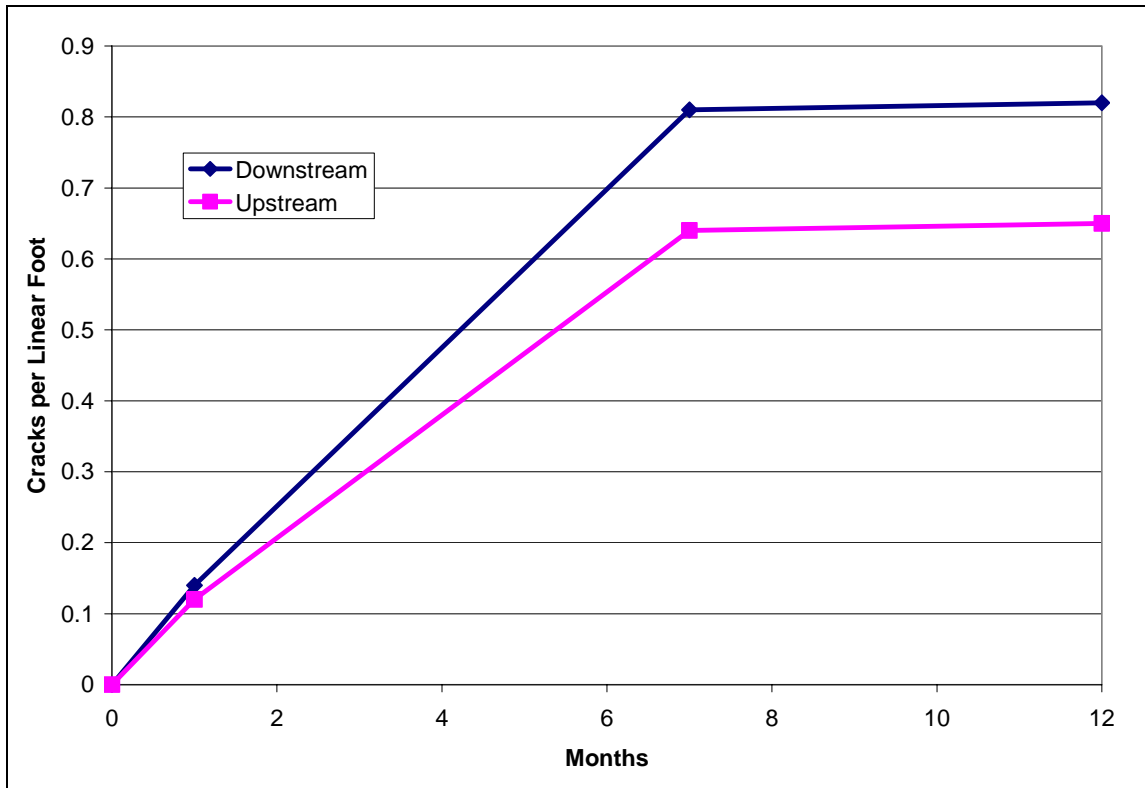
Figure 16. Plot of cracking over time for the Randolph bridge rails.

The Randolph bridge rails show a distinctly different trend than did the Barton rails, as displayed in Figure 16. The amount of cracking quickly increased to very similar levels as Barton, sometime within the first seven months to a similar average of 0.73 cracks per foot. In the subsequent five months, however, the total cracking barely increased, with only a total of only 2 more cracks reported along each rail. This would seem to indicate that maximum crack propagation occurred by the 7th month. However, it is important to note that there was a significant increase in crack width between the second and third site visit.

The widest cracks present at seven months following construction were on the order of 20 to 30 mils (as opposed to similar widths along the Barton structure one year following construction) and there were very few of these largest cracks (5.7% had a width of 20 mils plus). Once the rails reached one year of age the largest cracks were up to about 50 mils, with these being numerous and cracks in the aforementioned 20 to 30 mil range commonplace (13% of cracks were greater than 20 mils, while 2.7% of cracks were greater than 35 mils). It stands to reason that wider cracks allow for the penetration of contaminants and as well as water reducing the overall service life of the rails. It is also important to note that crack surveys were done during different seasons and varying

weather conditions. Seasonal conditions may influenced the width of the cracks as the rails would likely contract during winter months and expand during summer months. A longer evaluation period, over several years, would be needed to determine if seasonal conditions influenced our findings. However, the most likely explanation for this phenomenon is that the cracks originated as small shrinkage, loading, or miscellaneous cracks. Then, over time, dynamic loading on the bridge in conjunction with the rigid concrete design, generated a cyclic loading pattern along the bridge rails, stressing and relaxing them, causing the cracks to increase in width over time.

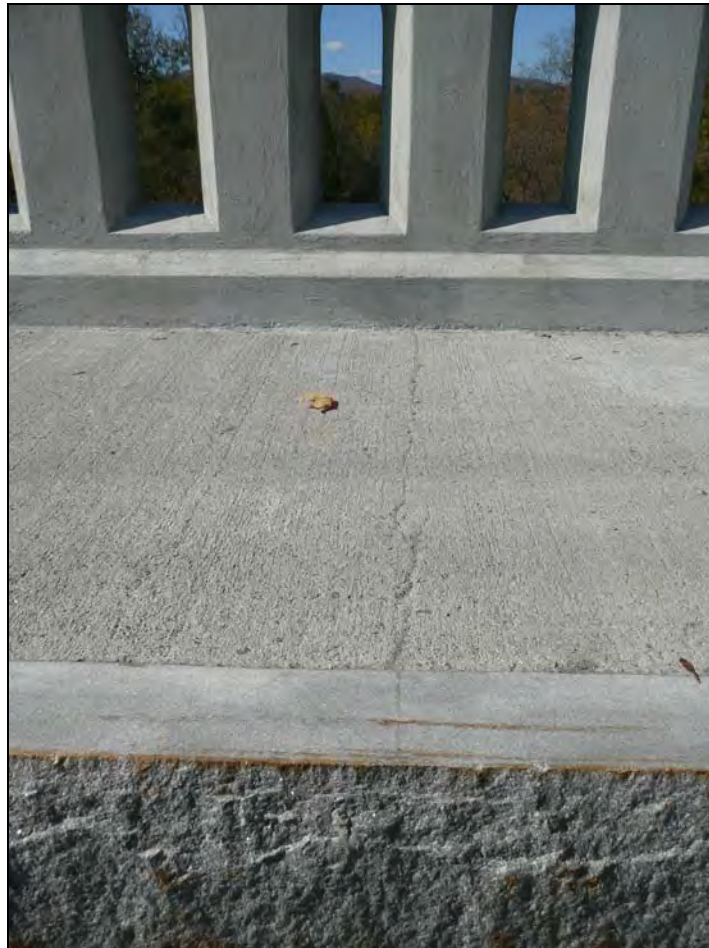
Figure 17. Cracking in Randolph rail, sidewalk, and curb.

Evidence that many cracks may be due to loading, and not simple shrinkage, is shown in Figure 17. This photograph depicts a crack beginning (or ending) at the bottom right corner of the center window in the rail and migrating downward to the concrete and continuing across the width of the sidewalk and finally across the top face of the granite curb. It is most likely due to stresses generated by periodic loading, as a shrinkage crack would be material dependent and therefore would not propagate into other structures cast at differing times and different materials. Several of these cracks are present on both the upstream and downstream sidewalks, all propagating through the rail as well and some through the curb. Since there is an asphalt overlay present on the bridge, it is impossible

to determine if the cracks continue into the bridge deck. Given the transverse locations of cracks on either bridge rail, it is plausible that some of these cracks may continue from one side of the bridge to the other. Out of all the bridges in the study, the Randolph structure has the highest AADT (16680) and truck traffic (1001), so it is subjected to large and repetitive loadings.

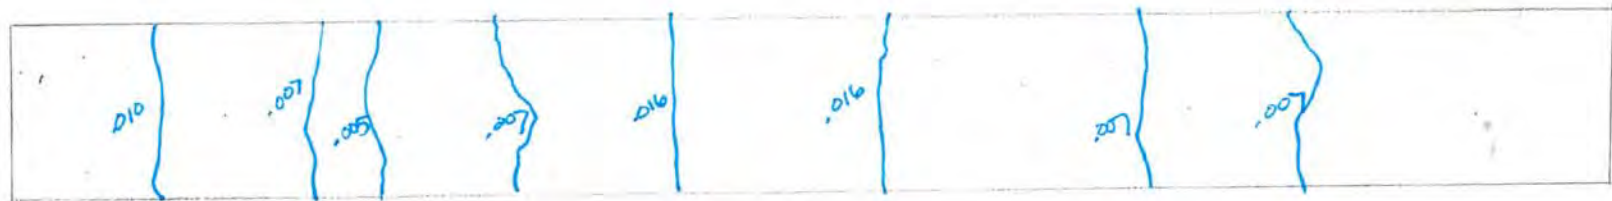
Figure A2. Completed crack mapping diagram of a Texas bridge rail.

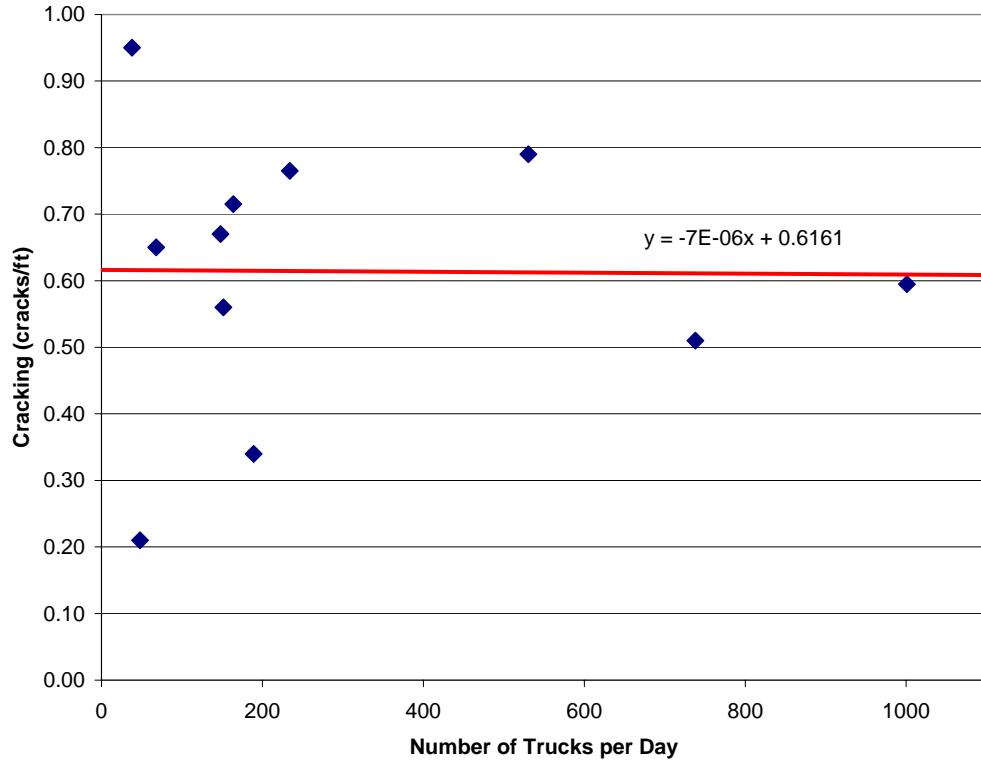
Figure B4. Plot of truck traffic versus crack density.
