Evaluation of Hybrid Rockfall Barrier/Drape System Initial Report

Experimental Features

Project No. 2011- 1

State of Vermont
Agency of Transportation
Materials and Research Section

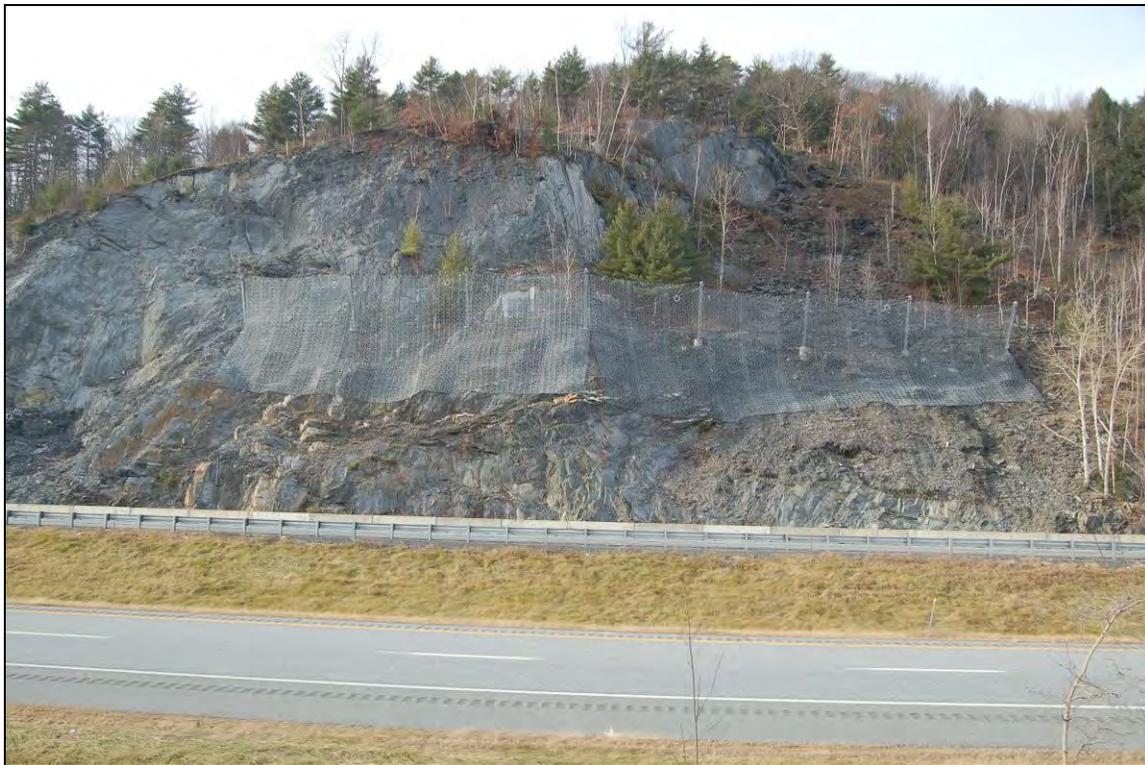
Figure 1 Photograph of Hybrid Barrier/Drape Installation, I-91, Fairlee, Vermont.

This experimental features report presents an evaluation of the construction and performance of a hybrid rockfall barrier/drape fence which was installed in the fall of 2009 on a rock slope at I-91 southbound, mile marker 89.50 in Fairlee, Vermont (VTrans Hartford/Newbury IM 091-2(72) project). Rockfall fences have been in use since the 1980s in the United States. VTrans had installed a medium duty rockfall fence in 1996 alongside US-5 in the town of Fairlee, Vermont. Advancements in fence design have led to a “hybrid” design that can be used in applications where falling rock is allowed to impact a fence and attenuate rockfall forces. This is accomplished by attaching a “tail” to a traditional rockfall fence that allows rock to exit the system at low velocities and ideally finish its trajectory in the catchment ditch at the base of a slope. Figure 1 shows the hybrid system as installed.

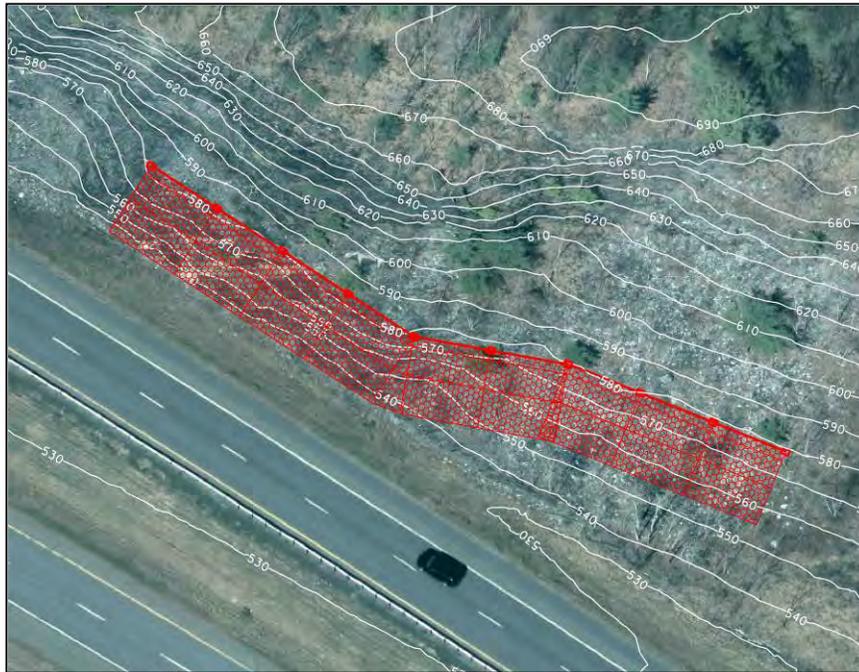
Figure 2 Location of Hybrid System Superimposed on Slope.

It was determined to place the system approximately 50 to 100 feet up-slope from the roadway. An aerial photograph showing an outline of the system on the slope and elevation contours is presented as Figure 2. Figures 3 and 4 shows the layout of the hybrid system and details of the system components.

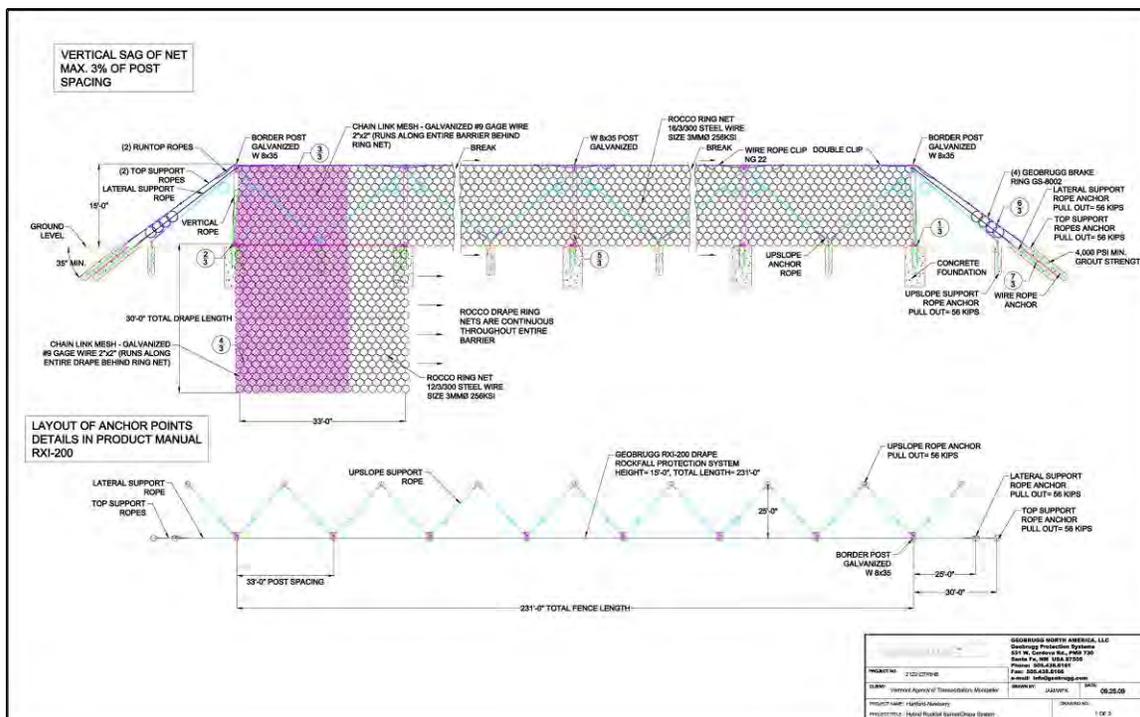
Figure 3 Plan Layout of Hybrid System.

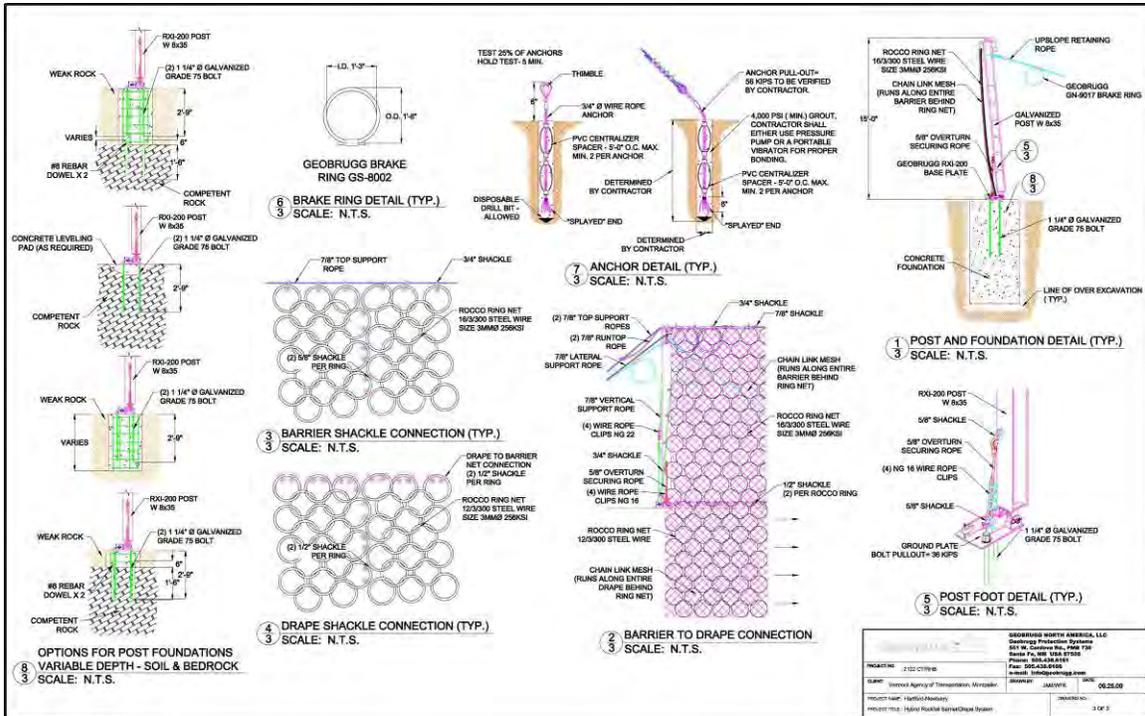
Figure 4 Detail Sheet showing Hybrid System Components.

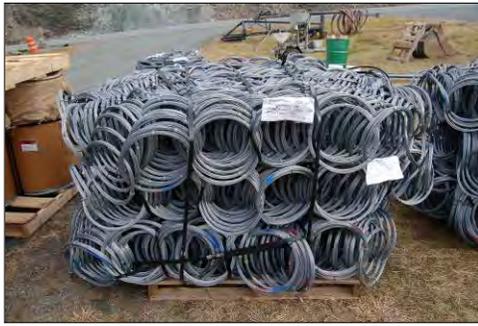
Figure 6 Ring Net Panels.

Hybrid rockfall systems are designed to catch falling rock while letting large rocks pass through (at reduced velocities) and accumulate at the toe of the slope. The steel posts and base plates provide a skeletal structure for the draping of netting. The steel ropes provide a means of attaching the netting and the breaking elements allow energy to dissipate without shocking the system. As an added support, steel ropes from the top of the posts are anchored into the slope uphill of the framework. The series of photos shows the fence components as delivered to the project site.

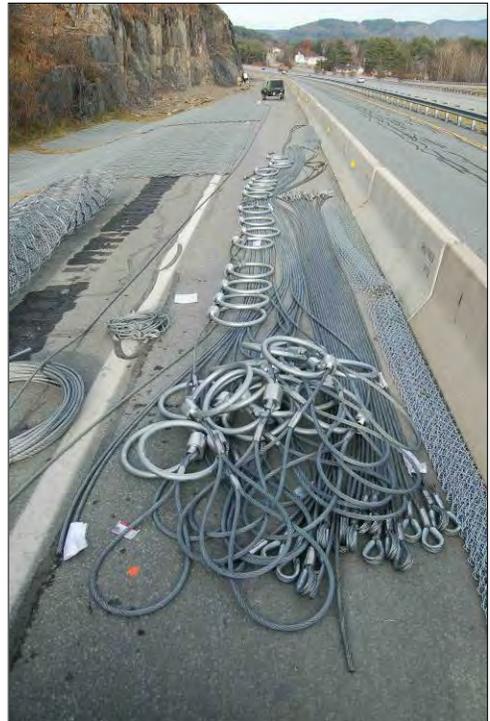
Figure 5 Support Cables, Breaking Elements and Rope Anchor Cables.

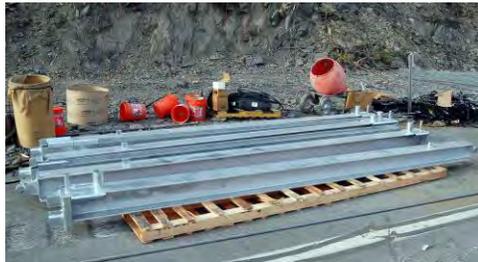
Figure 7 Steel Posts.

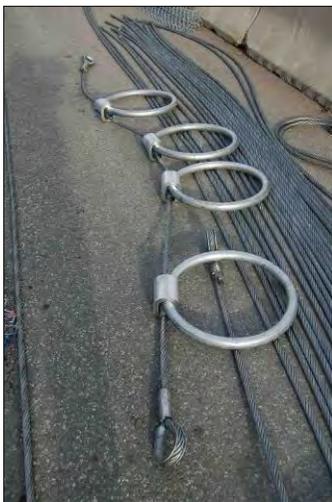
Figure 9 Close-up of Breaking Element.

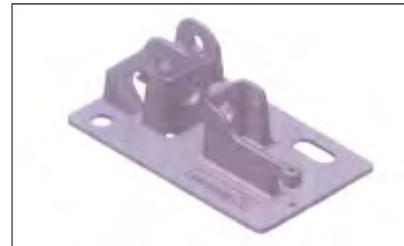
Figure 8 Steel Post Base Bracket.

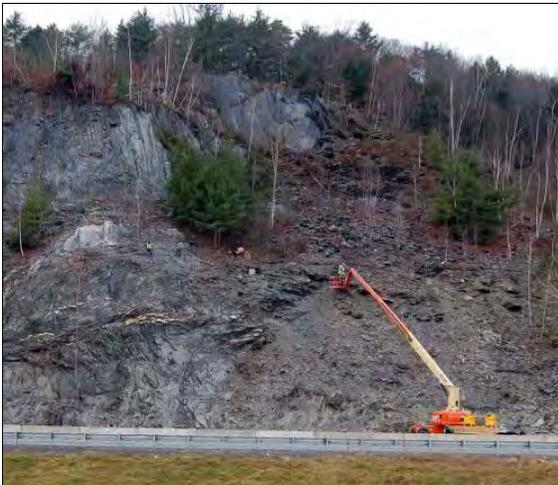
Figure 11 Preparing Slope for Hybrid System Footprint and Excavation for Steel Post Foundation Pads.

Construction was accomplished using a crane and rock slope mitigation technicians using rope access techniques. Work was initiated by first clearing a level area for the footprint of the fence portion of the system. Next, hand excavations through the overlying soil down to bedrock were conducted and galvanized steel rock anchors were drilled into the bedrock. Three foot diameter concrete foundations were poured over the protruding rock anchors. On top of these foundations, steel plates were installed that would accept the base of the steel HEB posts. After installing the posts, steel support ropes were threaded through the top of the posts and extended both laterally and horizontally to spiral rope anchors embedded into bedrock. A diagram showing the system is presented as Figure 9. Figure 10 shows details of the components of the hybrid system.

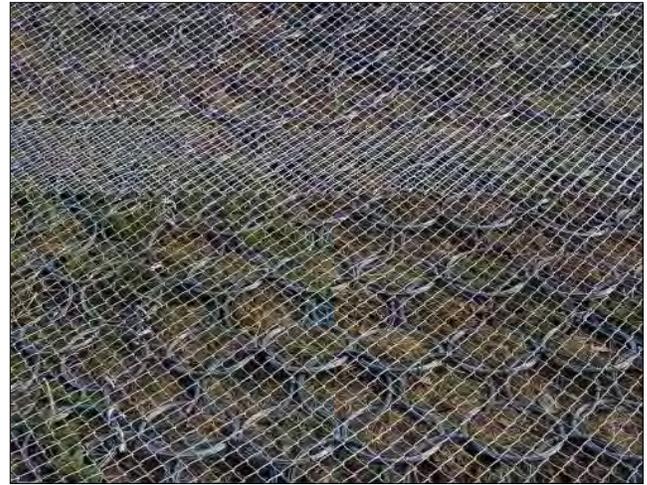
Figure 12 Connecting Chain-Link Mesh to Ring Nets.

Chain link netting was attached to each ring panel on the ground and panels were lifted into place by the crane. Panels were secured to the support ropes and each 20-foot section was shackled together. After all of the panels were put into place, the system was tightened. The following series of photos shows the construction sequence.

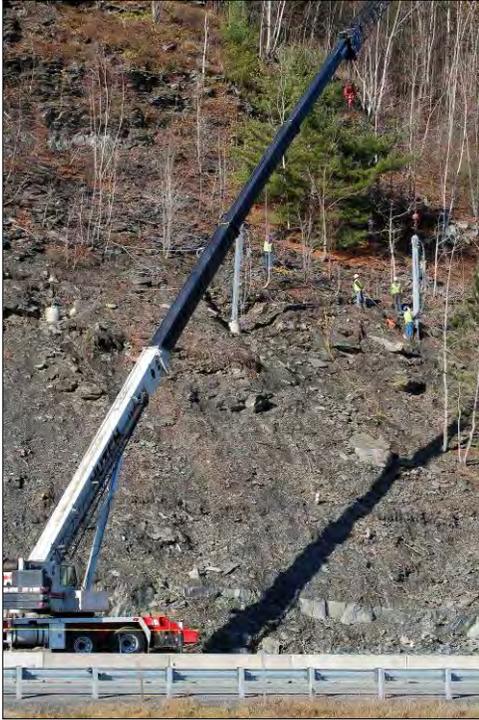
Figure 14 Placing Steel Posts.

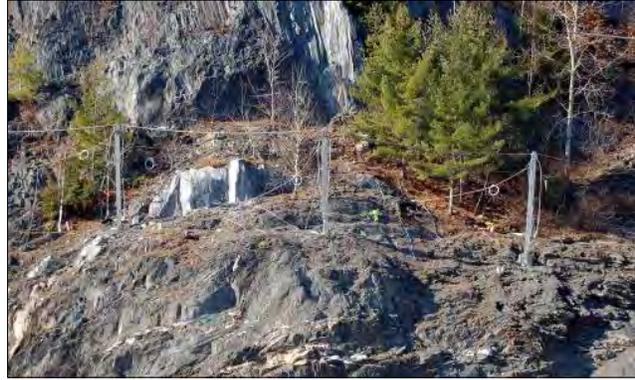
Figure 13 Lacing Support Wire Ropes.

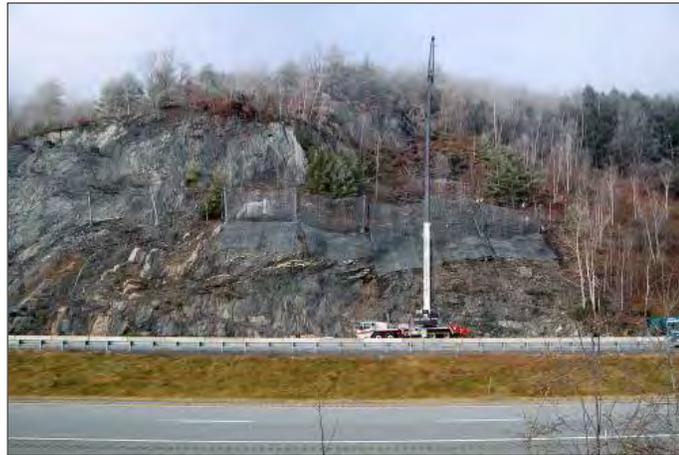
Figure 15 Hoisting Panels onto Steel Posts and Steel Support Ropes.

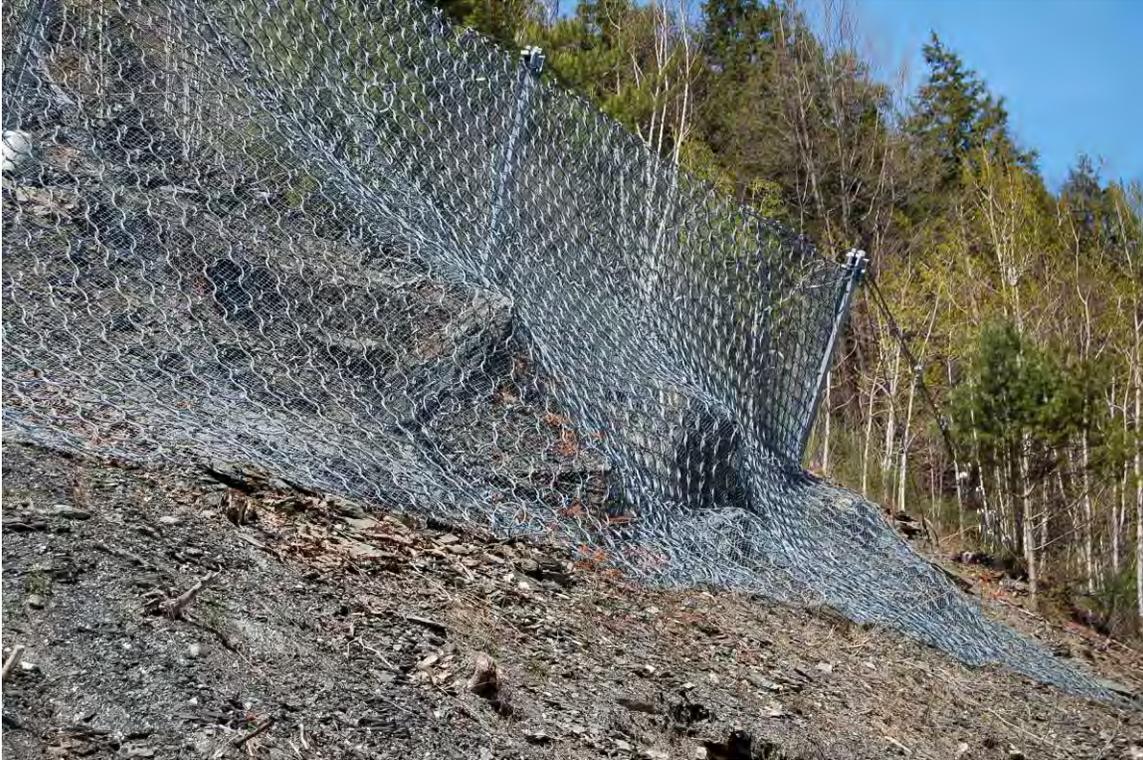
Figure 16 Rock Accumulated in the “Tail” Portion of Hybrid System.

The fence/netting remained intact with no distortions to the ring nets or distortions or tears to the chain link netting. A few small rocks impacted the posts and support ropes however this resulted in no damage to either element.

Testing of the hybrid system was performed in the spring of 2010. The contractor scaled the high portions (120-feet in height) of the slope while VTrans monitored any rock hits to the fence/netting. A number of large rocks impacted the fence/drape. Some of these rocks measured approximately 4-feet in length by about 2-feet in thickness and width. All of these rocks were retained underneath the drape portion of the system. Ideally, the rocks should tumble out from beneath the drape and fall uneventfully in the catchment ditch. The contractor was able to remove these accumulated rocks by reaching up with an excavator and lifting the lower end of the drape while scooping out the rocks. Figure 16 shows the accumulation of these rocks. Video recordings (though of poor quality) were taken during some of these rockfall events. Interestingly, one of the video shows a tractor trailer traveling down the Interstate at the same moment a large rock block was scaled. This large rock block was contained by the drape portion of the system and it became apparent that had
