**Reclaimed Stabilized Base with Cement
Duxbury-Moretown, VT
Interim Report**

**Report 2009-10
Reporting on Work Plan
2007-R-1**

State of Vermont
Agency of Transportation
Materials and Research Section

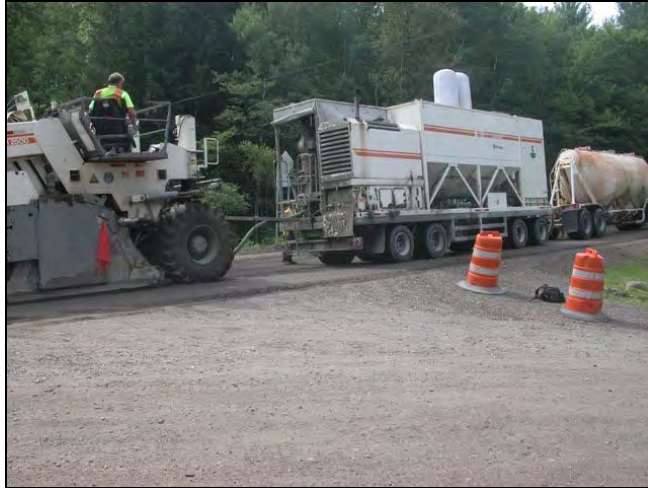
Figure 4 – Recycling Train

On July 16th Research personnel were onsite to observe the reclamation of an 800 LF beginning at MM 5.40 in the town of Duxbury. Reclaiming was conducted in 4 passes. The two outer passes were 7' wide and the two inner passes were 8' wide. The first two passes were in the southbound lane, and the latter two were in the northbound lane. Each pass consisted of a similar pattern. First the subbase was reclaimed to a depth of 8" while injecting cement slurry through the recycling train shown in Figure 4. The train proceeded at a rate between 4-6 meters/min. After, a vibratory sheep's foot roller made 5-7 passes over the reclaimed material. This was followed by an additional 5-7 passes with a vibratory roller depicted in Figure 5. Once two passes were completed along one side of the road, a grader and vibratory roller shaped and compacted the base to specification. Light traffic was released onto the stabilized base within 30 minutes of final compaction.

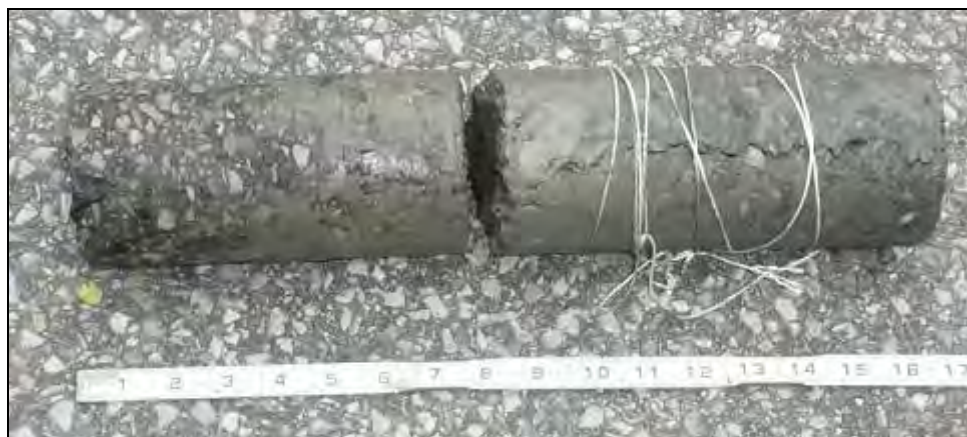
Figure 6 Core Extracted Over Crack

Of the three cores removed over observed surface cracks within the pavement, two were found to contain cracking that extended down to the base of the reclaimed layer. The width and appearance of the cracks were also found to be greater and more distinct within the reclaimed layer indicating that the cracks are bottom-up cracks, or cracks that propagated from the reclaimed layer into the bituminous concrete pavement. In addition, the majority of the cracks observed along the experimental section are transverse indicating that the cracks may be due to shrinkage or some form of thermal crack. A photograph of a core extracted over a crack is shown in Figure 6. The estimated width of this crack is 0.030 inches. The photograph shows roughly 8 inches of pavement (on the lefthand side) and 8 inches of reclaimed base (on the right).
