## GUARDRAIL APPROACH SECTION, GALVANIZED 3 RAIL BOX BEAM

STANDARD  
S - 364D

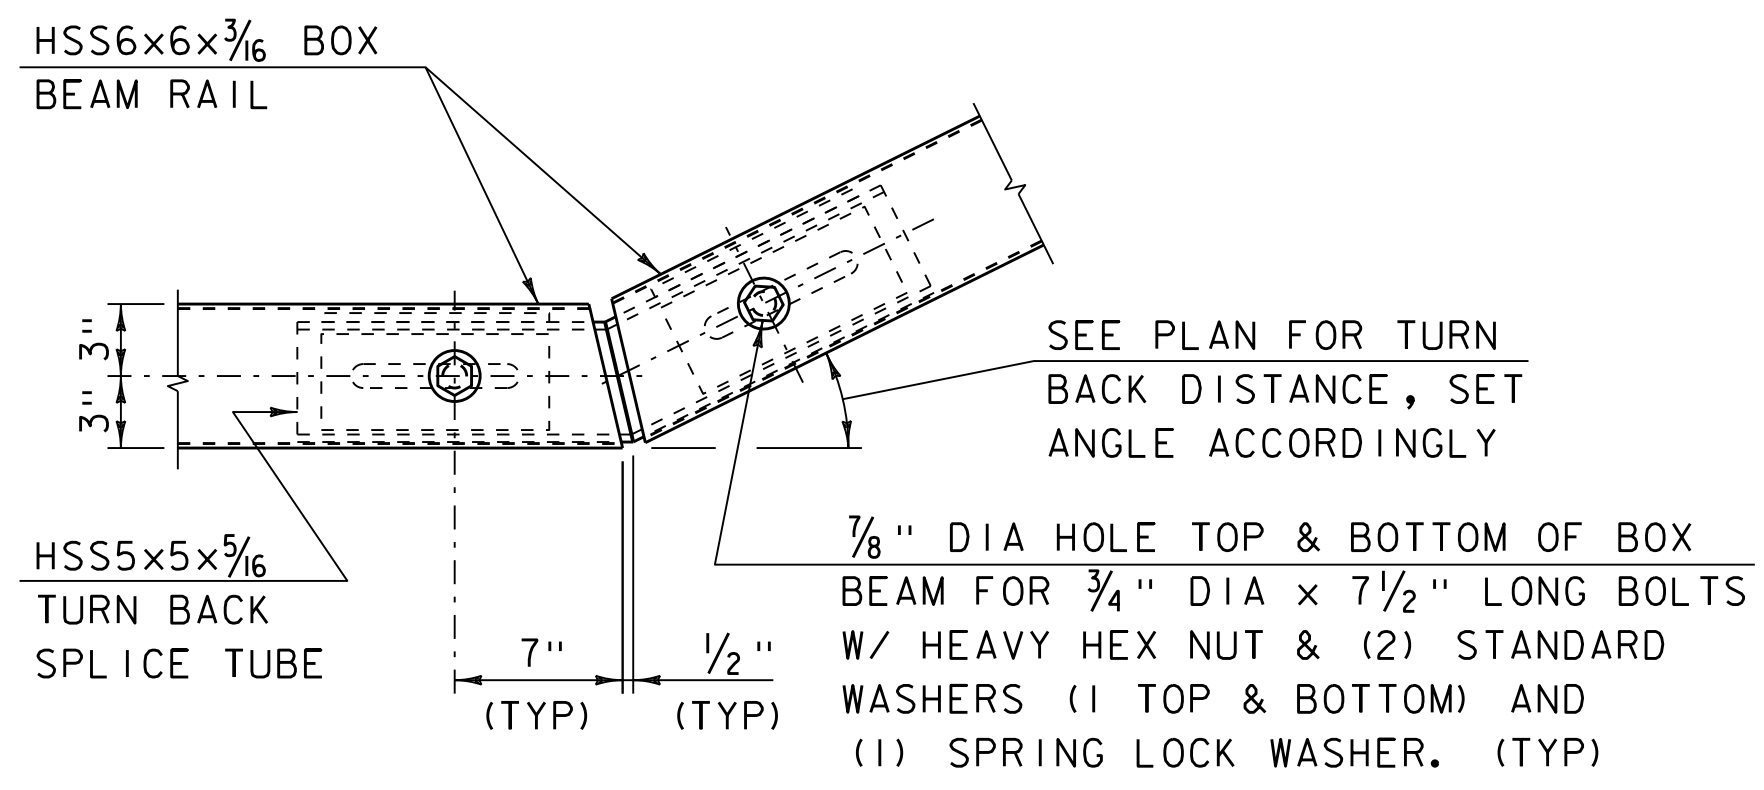
TOP VIEW  
TURN BACK SPLICE TUBE ASSEMBLY

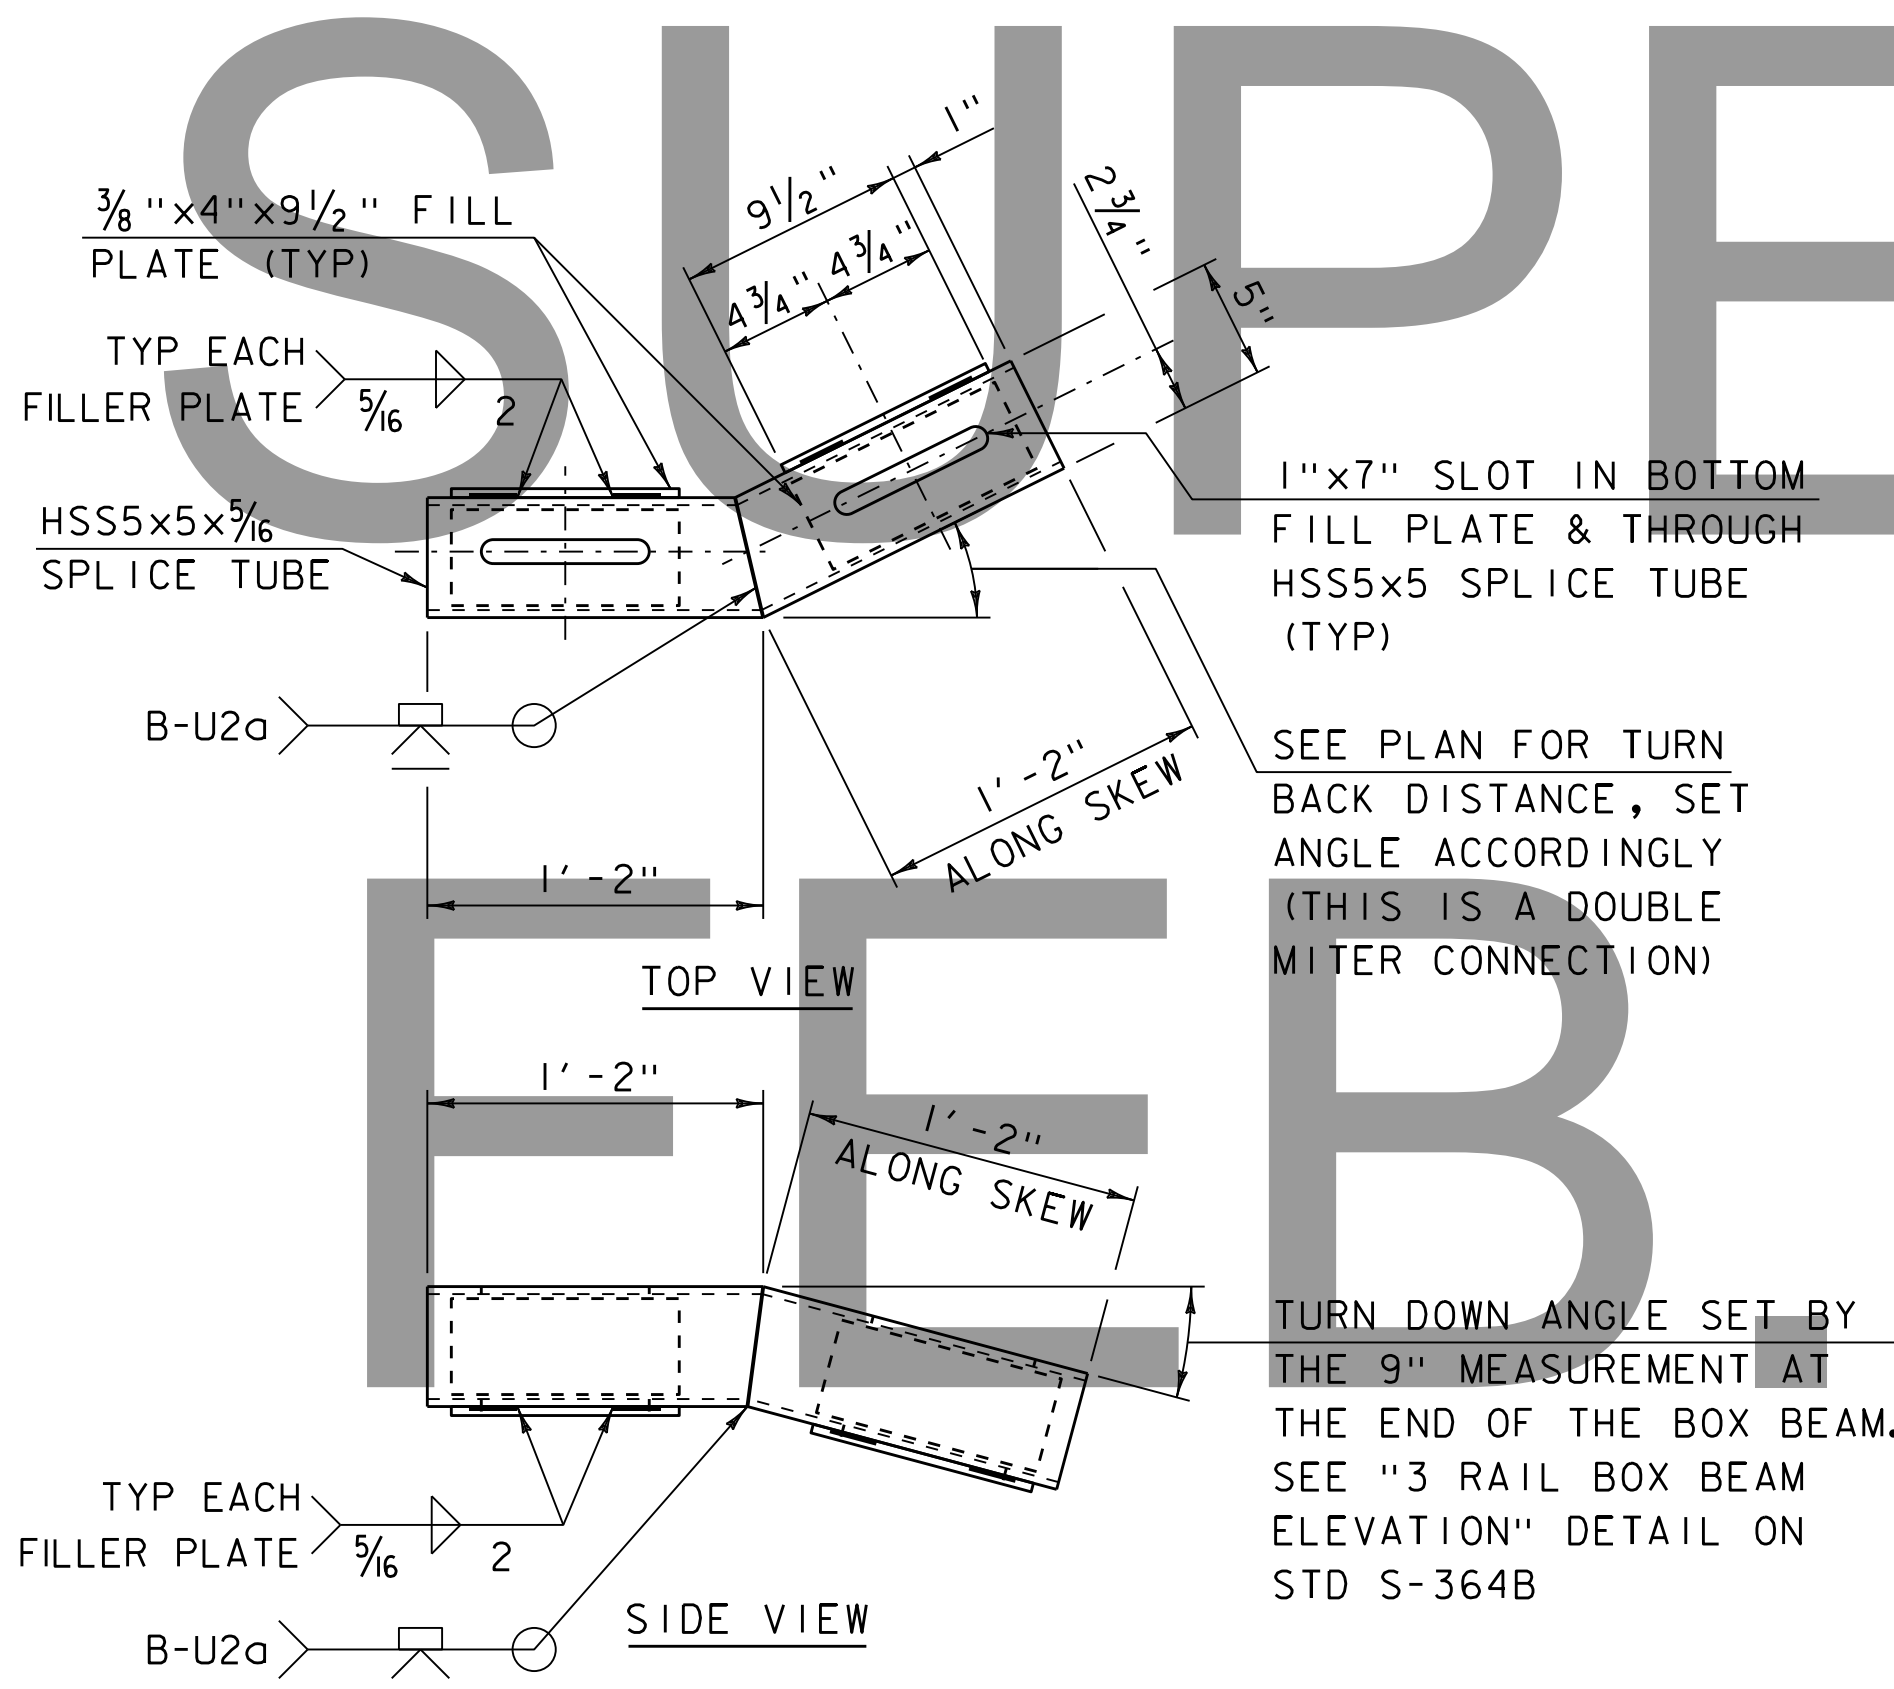
TURN BACK SPLICE TUBE DETAIL  
TURN BACK & TURN DOWN TUBE JOINT

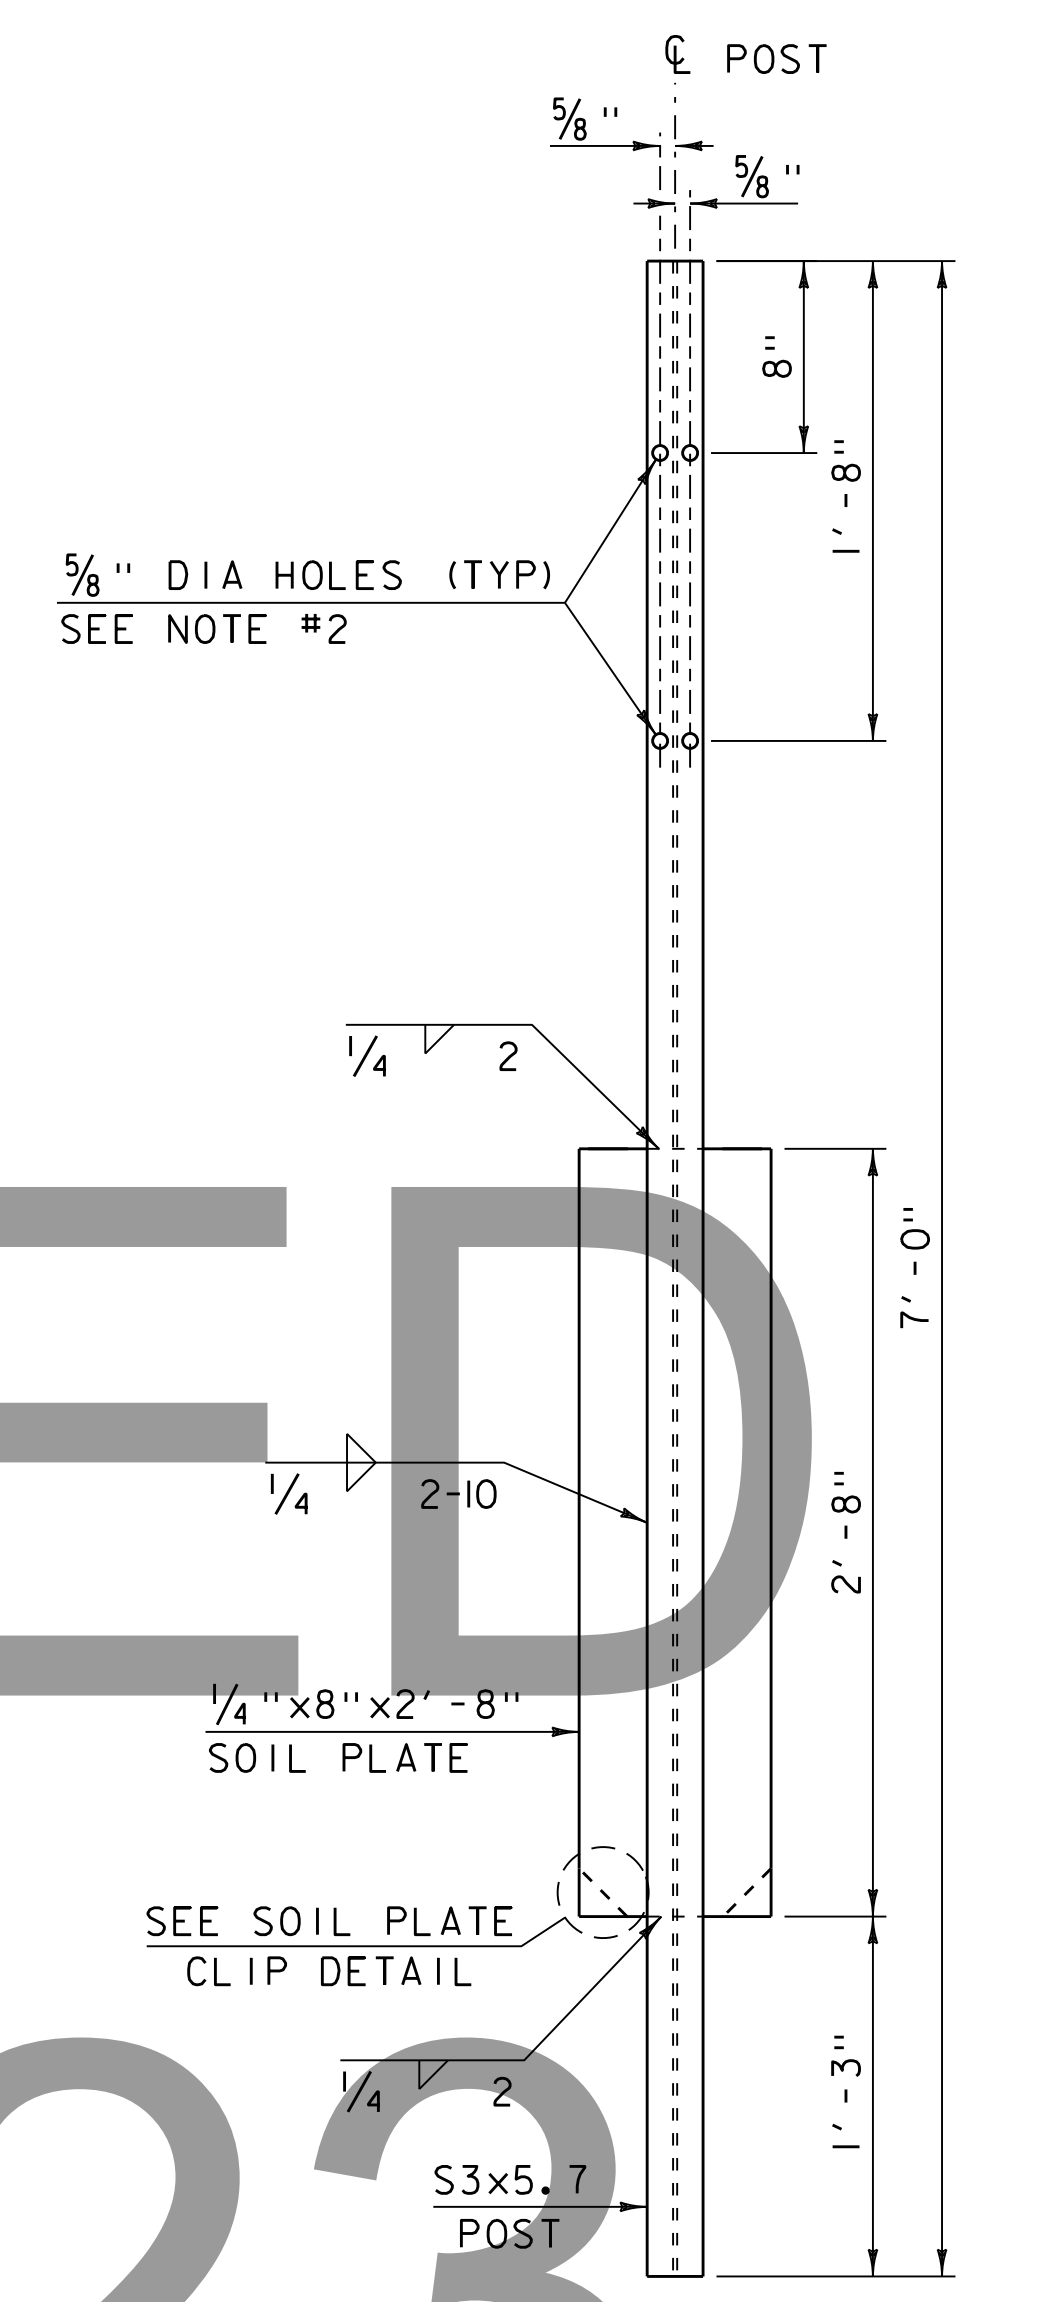
TRANSITION POST DETAIL
