**VERMONT AGENCY OF TRANSPORTATION**

**Research and Development Section  
Research Report**

**EVALUATION OF THE EFFECTIVENESS OF CENTERLINE  
RUMBLE STRIPES ON RURAL ROADS**

**Report 2015 – 07**

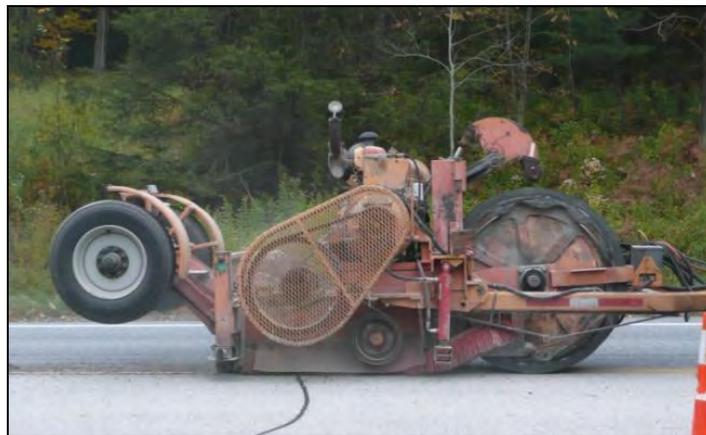
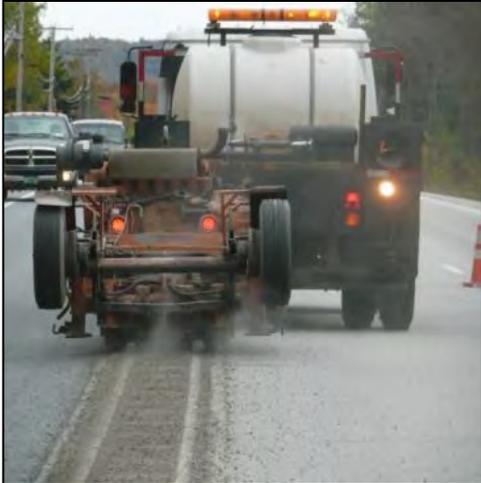
The entire length of the rumble stripes was completed by Thomas Grinding on Friday, October 9th, 2009, with the milling machine shown in Figure 5 and Figure 6. Weather conditions were overcast and the air temperature was 50°F. After the milling machine ground the stripes, the stripes were swept by BD Sweeping. All sweeping operations were conducted directly after milling, shown in Figure 7. Figure 8 shows the rumble stripes after milling and sweeping processes finished.

**Figure 5: Milling machine.**

**Figure 6: Milling machine**

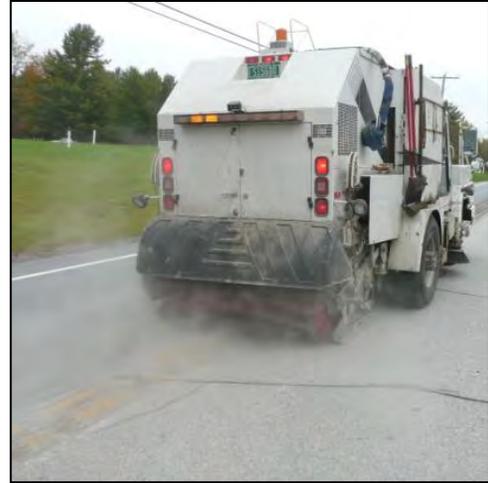
**Figure 7: Street sweeper**

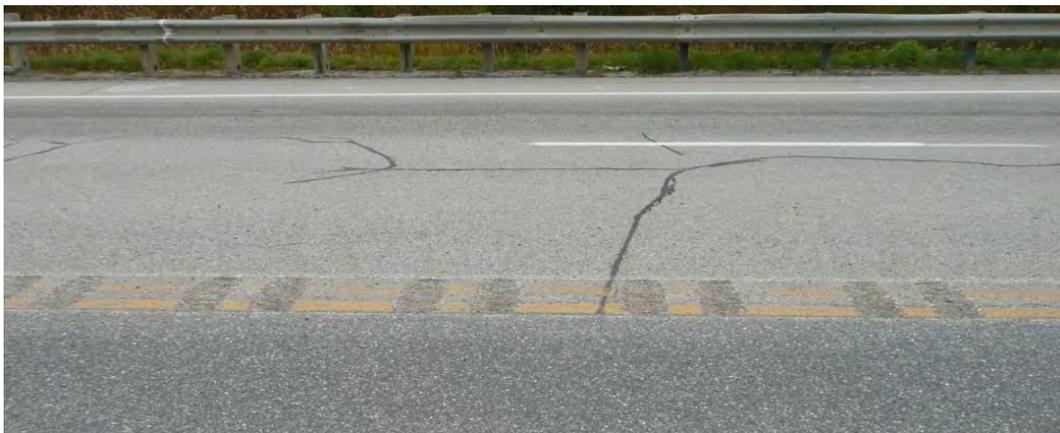
**Figure 8: Rumble stripes after milling and sweeping.**

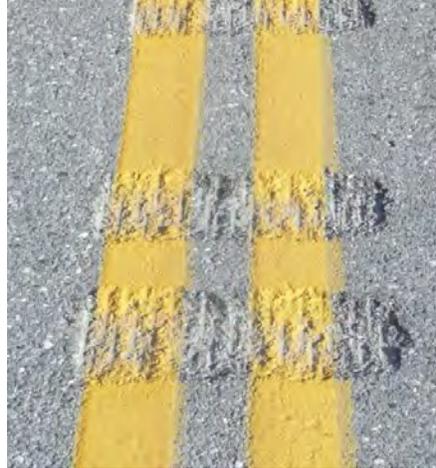
L&D Safety Markings Corporation completed all pavement marking striping operations on Monday, October 12. According to [www.wunderground.com](http://www.wunderground.com), weather conditions were recorded as clear with a mean temperature of 38°F; the temperature was approximately 45°F at noon (11). Research personnel were unable to be onsite for striping operations therefore no photographs were taken, however photos were taken at the first site visit following installation (See Figure 9).

**Figure 9: Centerline rumble stripes approximately one month after installation in Mendon, VT.**

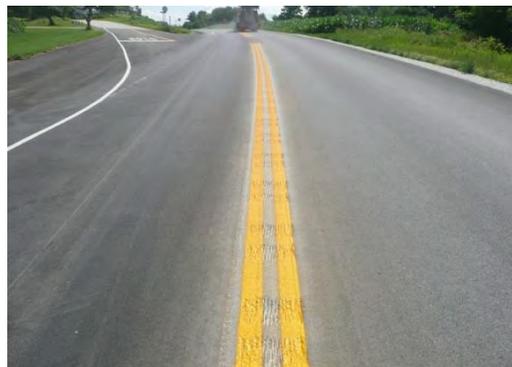
In an attempt to extend the duration for retroreflectivity of the polyurea durable pavement markings, L&D Safety Markings Corporation recessed along the centerline for the pavement markings on Monday, July 12, 2010 and Tuesday, July 13, 2010. The subcontractor then milled the rumbles on Monday, July 19, 2010 from MM 5.200 to 11.015. The rumble stripes were then swept and the subcontractor applied polyurea along the centerline on Wednesday, July 21, 2010. According to [www.wunderground.com](http://www.wunderground.com), weather conditions were recorded as clear with a mean temperature of 70°F; the temperature was approximately 81°F at noon (11). The centerline rumble stripes are shown in Figure 10.

**Figure 10: Centerline rumble stripes immediately after painting in Sheldon, VT.**
