**VERMONT AGENCY OF TRANSPORTATION'S TECHNICAL TRANSFER
ADAPTATION OF MNDOT'S HYDRAULIC INSPECTION VEHICLE EXPLORER
(HIVE)**

Jonathan Griffin

Submission Date: August 1, 2018

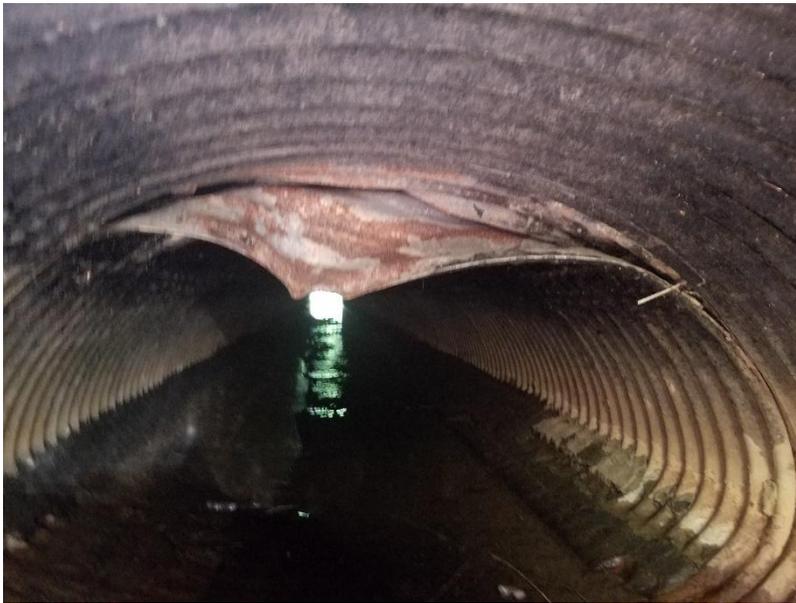
Figure 1 shows a Vermont culvert in need of repair. This image was captured while performing video inspections in May 2018 using the HIVE and shows how video is needed to fully understand culvert condition.

Figure 1 Photo Showing Vermont Culvert in Need of Repair (Initially Captured by Vermont's HIVE in May 2018)

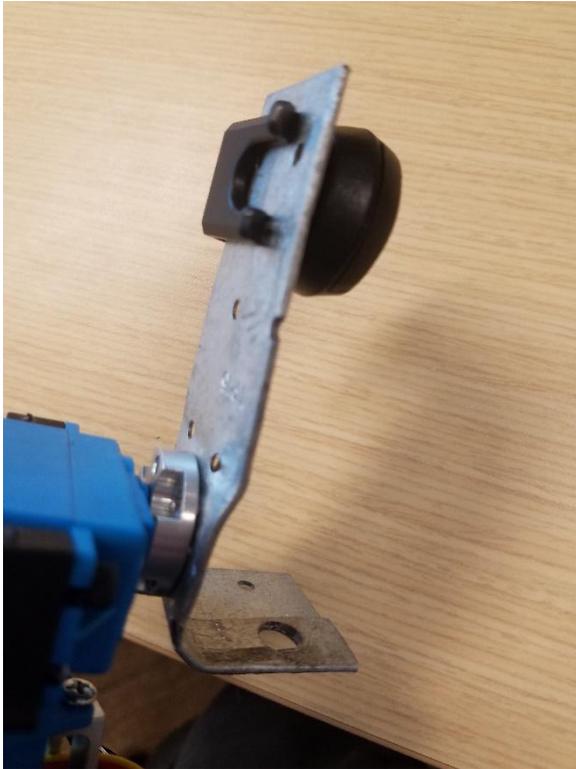
Prior to full time field work, the HIVE went through several mini trials to demonstrate its capabilities. After the first day of testing it was decided that the HIVE-provided lighting was not adequate inside of the culvert. VTrans developed a new mounting bracket for the camera which included space for mounting a pen light directly above the camera lens vastly improving the visibility during barrel inspections. The new bracket is shown in Figure 7.

Figure 7 Showing New Mounting Bracket Developed by VTrans for Additional Lighting
