ACOUSTIC EMISSION MONITORING OF PREFABRICATED AND PRESTRESSED REINFORCED CONCRETE BRIDGE ELEMENTS AND STRUCTURES

Dryver R. Huston, Principal Investigator The University of Vermont College of Engineering and Mathematical Sciences

Research Project Reporting on VTRC 16-3

Final Report 2018-02

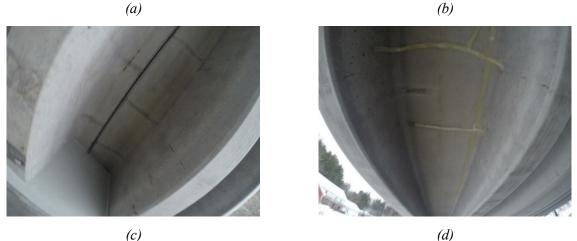
Figure 1.1: VT 100 Gold Creek Bridge near Moscow and Stowe with girder and deck cracks (a) bridge side view, (b) deck with multiple cracks, (c) girder with cracks in the flanges near to the end, and (d) some of the cracks repaired

An example of notable concrete cracking in a PBES bridge has been recently observed in Vermont. The bridge crossing Gold Creek on VT 100 near Moscow and Stowe has extensive cracking in the girders and cast-in-place integral deck. The source of these cracks has not been firmly established. It is also not certain if the cracks are stable or are still growing. While these cracks may not pose a serious structural threat to the bridge, they do present aesthetic, serviceability and long-term maintenance concerns.

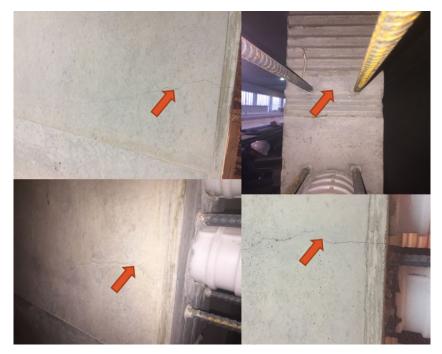
Figure 1.3: Recorded end zone cracking of bulb tee

The three major types of characteristic end zone cracking appearing in NEXT beams and NEBT girders include; horizontal web cracking, inclined web cracking, and Y cracking. Eccentric loading is a common source of horizontal web cracking. Pre-tensioning strand distributions are typical sources of inclined web cracking and Y cracking. Both horizontal and inclined web cracking are typically small enough that they close under service loading. Y cracking does not normally close under service loading and therefore has the greatest potential for durability issues (Okumus and Olivia, 2013). Figure 1.3 shows examples of horizontal web cracks observed during this study.

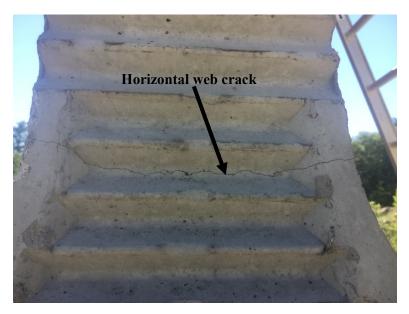
Figure 2.3: Horizontal end-zone web cracking of a Northeast Bulb Tee (NEBT) girder

Current end zone cracking control methods for reinforcement bar pattern designs were developed with respect to vertical flange cracking and have been largely effective as vertical flange cracking is now a rare occurrence (*Okumus and Olivia, 2013*). These same reinforcement bar patterns, however, have not been as effective in the reduction of horizontal web cracking, inclined web cracking, and Y cracking, supported by observations made during this study. The only cracks observed during this study were horizontal web cracks, Figure 2.3.

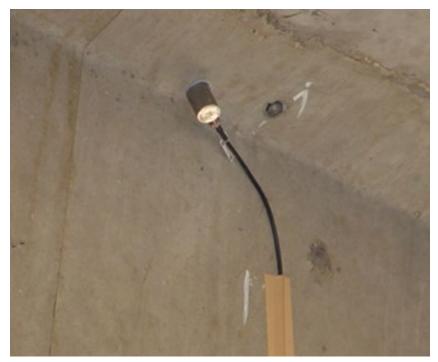
Figure 3.1: Acoustic emission sensor attached to a concrete girder (Figure courtesy Mistras Group)

The goal is to select an instrumentation package to measure the occurrence and location of cracking in prefabricated and pre-stressed bridge girders during fabrication and during transport to bridges sites. AE testing is the primary measurement technique. The method attaches sensors onto the surface of the girder with adhesives, connects the sensors to the data acquisition unit with coaxial cables and collects data continuously throughout the cycle. Figure 3.1 show a typical sensor installation.

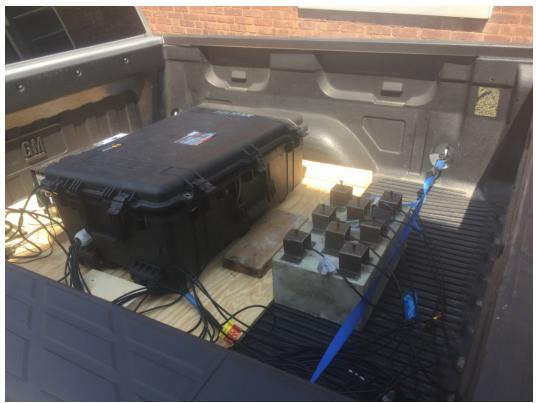
Figure 7.1 Pilot transport test AE equipment set-up

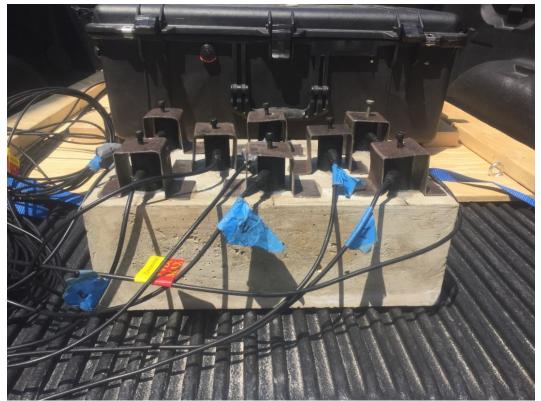
Figure 7.2 AE sensor connection to concrete block with U-shape brackets

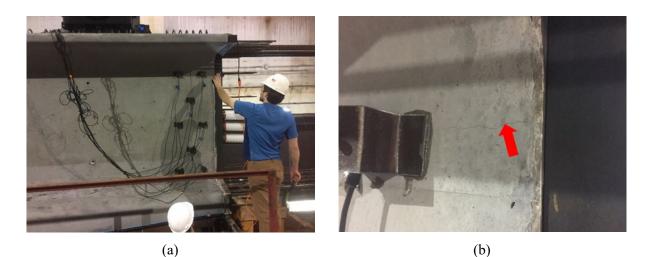
Figure 9.9: Northeast Bulb Tee girder field testing of detensioning (a) AE equipment/sensor setup, (b) observed horizontal web crack

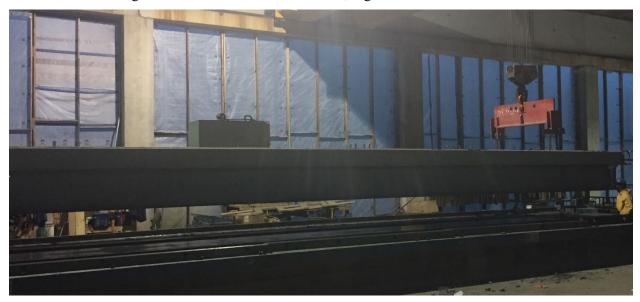
Figure 9.10: NEXT beam field testing of craned form removal
