PAVEMENT MARKING COMPARISON STUDY – I-89 LIQUID MARKINGS

Ian Anderson, Research Engineer
Vermont Agency of Transportation
Research Section

Experimental Feature
Reporting on Work Plan 2013-R-03

Final Report 2018-05

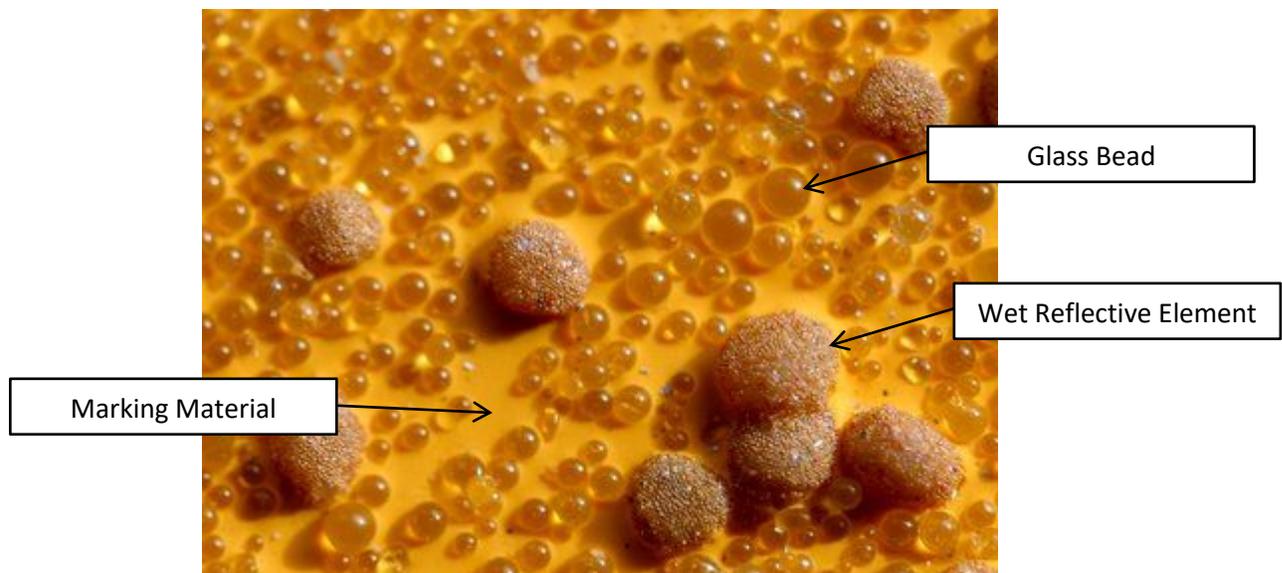
Figure 2: 3M Optics, Glass Bead and Wet Reflective elements

The Utah Blend is a specified gradation of glass beads, and thus considered a Premium Optic. Utah Blend optics were used on all pavement marking materials in this project as a control to test the Wet Reflective elements against. The Utah Blend has a larger maximum bead size, and variable gradation from typical AASHTO Type 1 beads, increasing the chance the light will be reflected. Wet Reflective elements differ from the glass beads in their composition, being smaller ceramic beads clustered around a central core, rather than a singular sphere. The ceramic beads reflect light from their surface, and are colored in conjunction with the desired pavement marking. The clustered structure aids in the ability to reflect light in a wet condition, as they have lower surface tension and shed water faster than conventional glass beads. Wet Reflective elements are used in conjunction with glass beads, providing both dry and wet retroreflectivity. In this study, all Wet Reflective elements were combined with the Utah Blend in a double drop, in which the Utah Blend is applied first, followed by Wet Reflective elements. An image showing both glass beads and Wet Reflective elements can be seen in Figure 2.

A proper application of beads results in the top layer of optic beads embedded to about 60% of the diameter of the bead. There should be consistent quality of both optic beads and paint so that the dry-film paint thickness and bead coverage promotes even retroreflectivity across both directions of road travel in two lane highways. Inadequate paint thickness results in under-embedded beads. This will result in improperly anchored beads that will fall out prematurely. In addition to bead pop-out, under-embedded beads cause a large percentage of the light that enters them to exit out the back. Too much paint results in over-embedded beads. While over-embedded beads may remain in the binder, reduced exposure limits light entrance and resultant retroreflectivity [6]. The retroreflectivity values in markings with over embedded beads increase over time with wear of the marking material by tires. Plowing does lead to retroreflectivity recovery because the

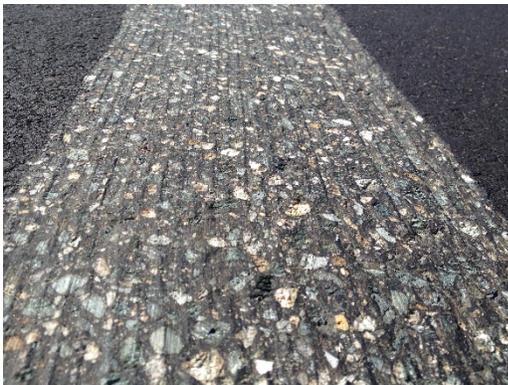
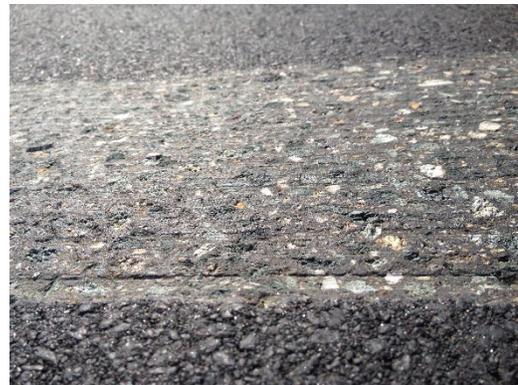
Figure 3: Recessed pavement section for marking application

The project was awarded to Pike Industries, Inc. headquartered in Belmont, NH. All markings were applied by L&D Inc from Barre, VT from August 11th, 2014 to August 20, 2014. At the time of application, temperature, relative humidity, precipitation/cloud cover, wind condition, ambient air, and pavement temperatures were recorded. All environmental requirements for the marking installations were met at the time of placement. The project plan called for the comparison of four different durable liquid pavement markings. The research section added in the Waterborne paint marking as a constant for the test. Along with the different liquids being tested, there were also two optics categories tested on each binder type (Utah Blend and Utah Blend with wet reflective elements). Each paint deck was half surface-applied and half recess-applied. The recessed sections were measured and their depths recorded to ensure compliance with required marking thickness. Examples of recesses for lane markings can be seen in Figure 3.

Both white and yellow waterborne markings were applied on August 11, 2014 from mile marker 52.495 to mile marker 49.0 with a truck. The average depth for the recessed white lines was 62.1 mils and the yellow lines were 60.07 mils. On the day of the application, the average temperature was 68°F and there was no precipitation. Below in Figures 4-6 are pictures of the waterborne application process.

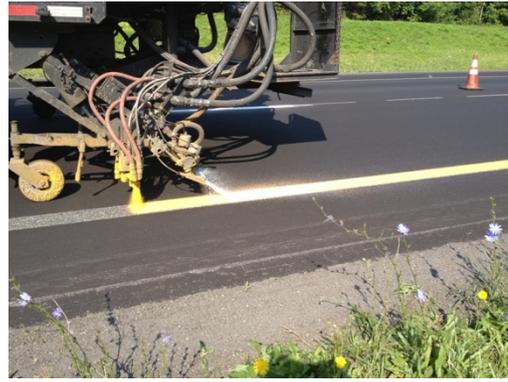
Figure 5: Waterborne binder and optic package being applied.

Only Utah Blend beads were used, in a single drop. The liquid marking application and surface applied optic beads are distinctly visible in two separate process streams at the back of the truck in Figures 5 and 6. During the application, observers noticed that excess beads bounced or rolled off the marking because of insufficient material to capture them.

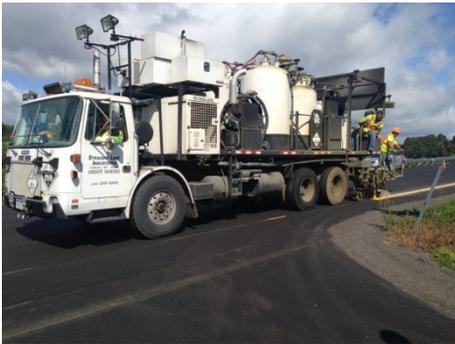
Figure 11: Epoxy markings being applied by the truck.

On August 18, all of the Epoxy markings were completed from mile marker 40.0 to the end of the project at mile marker 36.93. Markings were spray applied by a truck with double drop system. Recess depth readings were only taken on the yellow (passing lane) side and averaged 81.29 mils. The average temperature for the day of the Epoxy markings was 56°F with only traces of precipitation. Figures 11 and 12 shows the application process of the Epoxy paint.

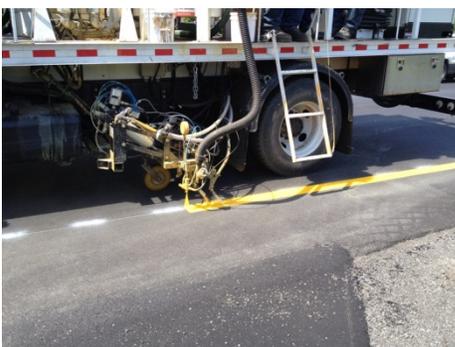
Figure 13: MMA markings being applied by the truck with double drops.

The final markings of the project (MMA) were applied on August 20 with a temperature of 63°F. Methyl Methacrylate markings were spray applied from mile markers 49.0 to 47.5 with a truck. Again, only the yellow recessed lines were measured and averaged 72 mils. Figures 13 and 14 shows the application process of the Methyl Methacrylate.

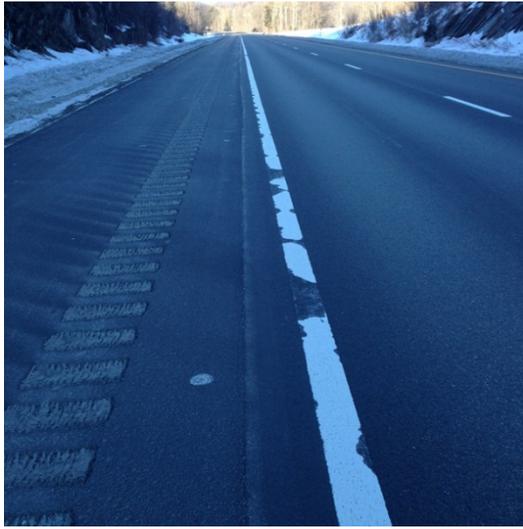
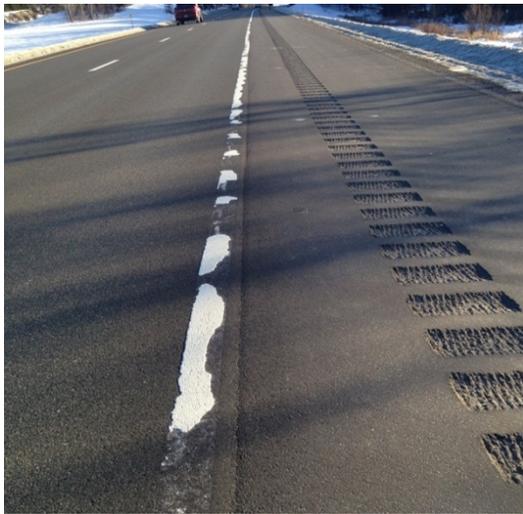
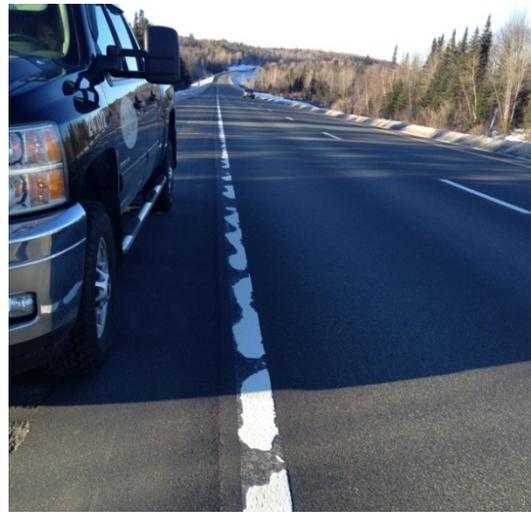
Figure 23: TS 25 Damage Overview

Figure 24: TS 25 Line Damage Close-up

Figure 25: TS 28 Damage Overview

Figure 26: TS 28 Damage Overview

In the December 2014, the district staff notified research personnel that sections of the thermoplastic markings were missing or severely damaged. Research personnel then proceeded to go out to observe the markings. Below, Figures 23–26 shows the damaged and missing Thermoplastic markings. It appears that plowing caused major localized damage to the lines which had been applied only a couple months before the damage occurred. This may be due to the binder not being heated to the specified temperature. Field notes indicate the thermoplastic was brittle and could be lifted up with the edge of a key showing clear delamination. In other places thermoplastic was not visible at all from being scraped up by the plow. During the same site visit, waterborne was noted to be fading significantly where there is a sharp incline just before Berlin Exit 7 off-ramp (TS 1 and 2). The two failing test sites were both surface applied. Test sites 3 and 4 were both recessed and provided much better visual and retroreflective results.

In May 2015, the thermoplastic and waterborne were repainted due to wear (visual line loss) and loss of retroreflectivity. After the first plow and salt, waterborne markings had declined by as much as 96% for the white lines and 51% for the yellow lines and thermoplastic markings had declined retroreflectivity as much as 77% in the white lines and 80% for the yellow line.
