Shelburne St. Roundabout

Project Status

AUGUST 12, 2019

Michael LaCroix
Vermont Agency of Transportation
Project Manager

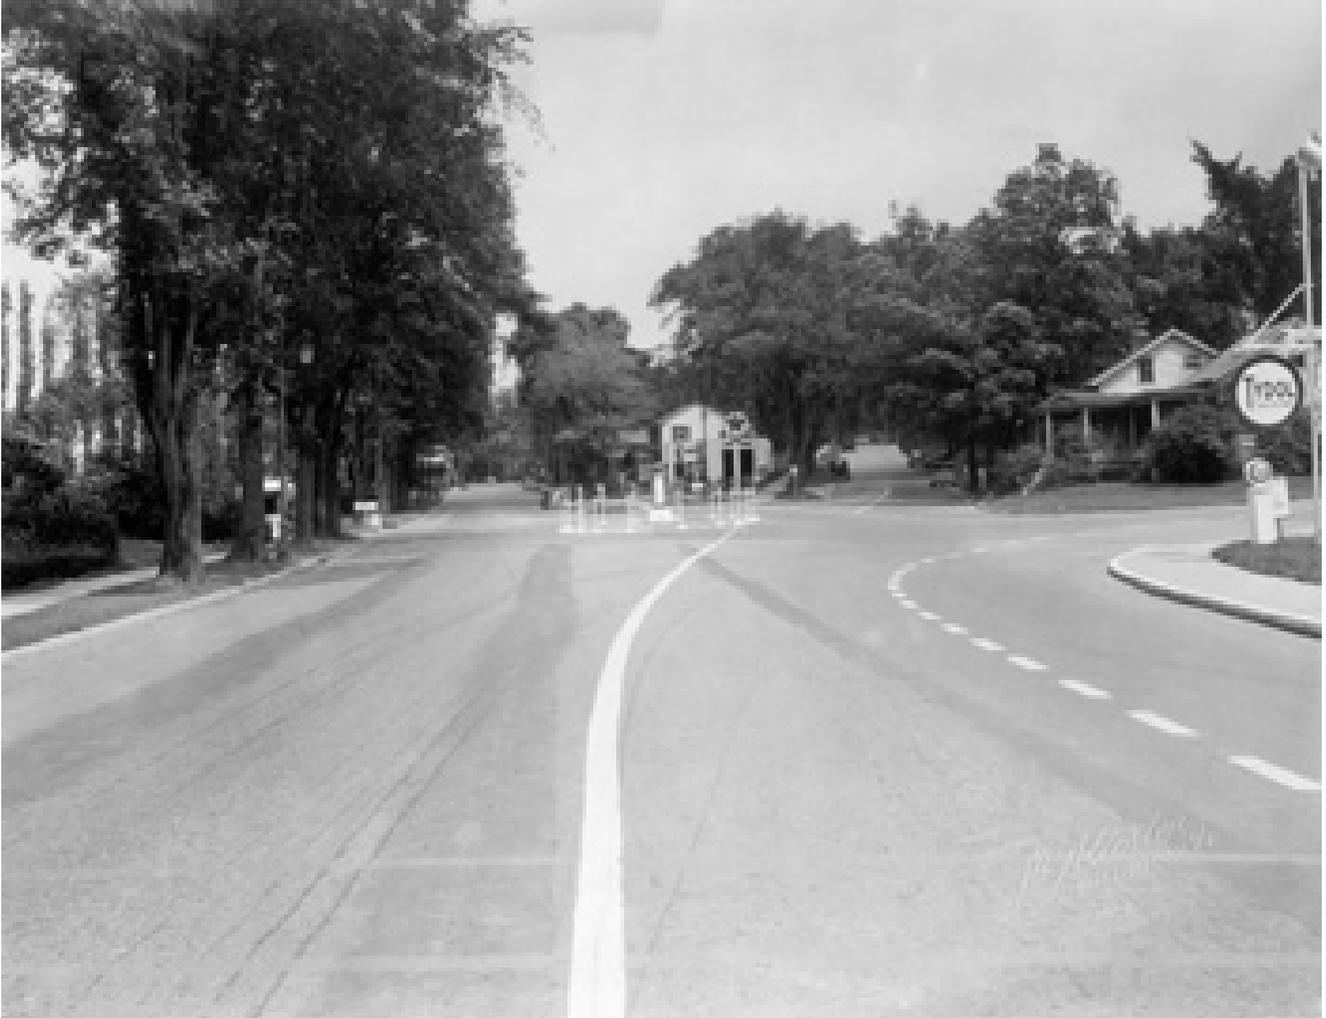
Figure 1: The "Rotary" in the 1940's

Not much has changed with the streets at the intersection in nearly 80 years. The “rotary” was enlarged and raised in that time, but most of the major changes occurred outside of the roadways, mainly with business/residence changes and landscaping reductions.

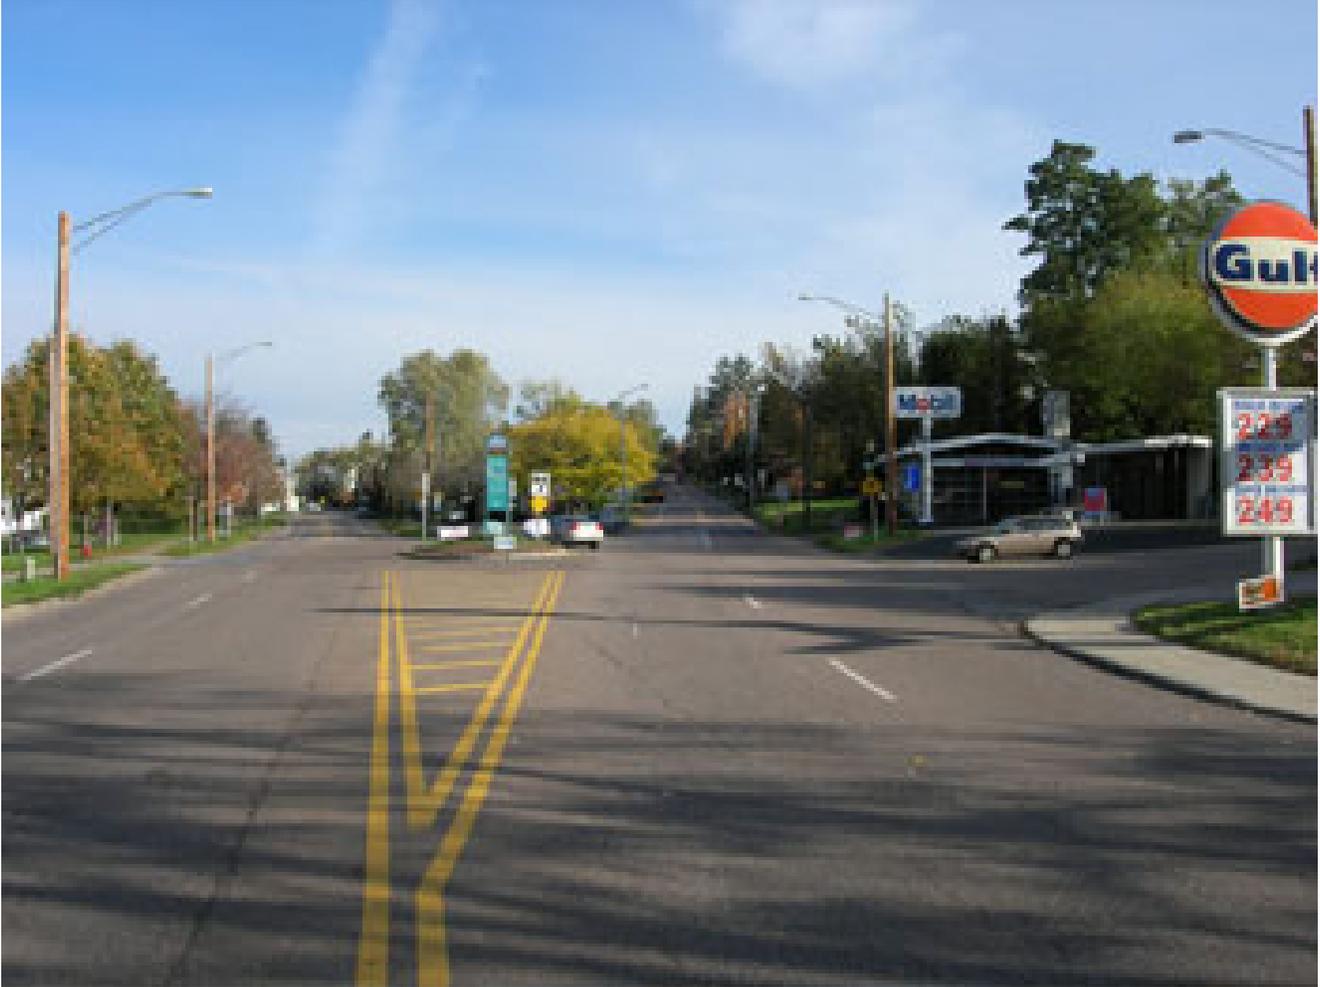
Figure 2: The "Rotary" in 2011

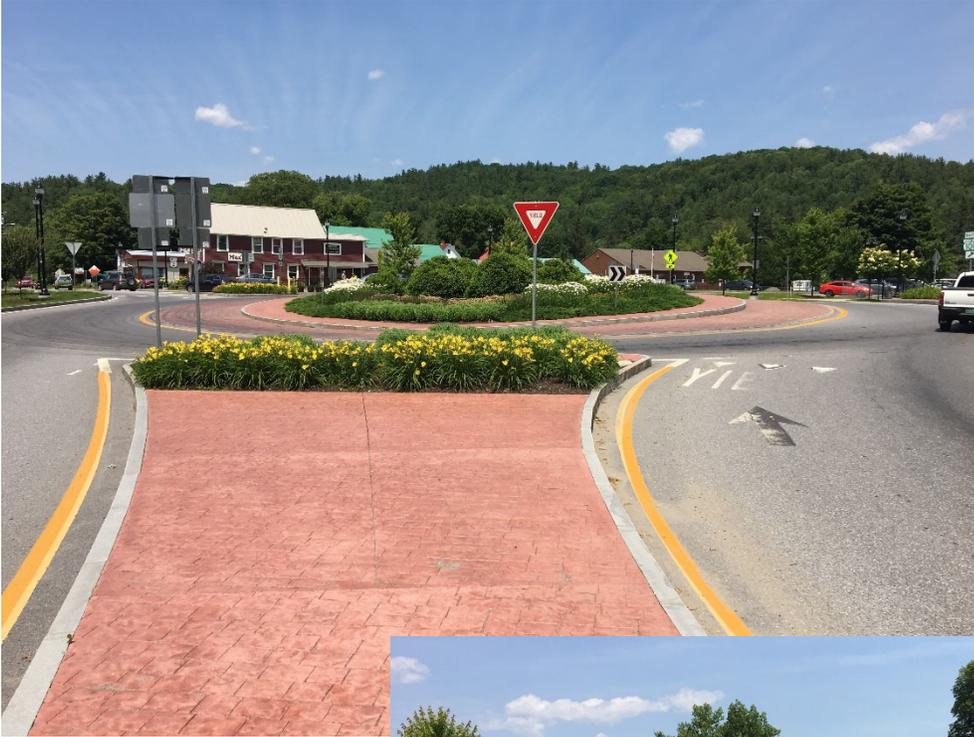
Modern
Roundabout
in Waterbury,
VT

- Can handle 19,200 vehicles per day without needing new lanes*
- Expected crash reduction of up to 72%.
- Geometry of the Roundabout focuses user’s sight distance by obscuring and reveal certain perspectives.
- Left turns become right turns and become more predictable to all users
- Adjacent drives will be controlled.
- Crosswalks will be shorter in length, only cross one lane of traffic at a time and are located at highly visible locations.
- The Roundabout’s central and splitter island create opportunity for aesthetic treatments.
- New trees and shrubs throughout the project.
- Buried utility infrastructure will be updated and consolidated in neatly assembled corridors and easily (and safely) accessible for maintenance personnel.
- New buried sand filters and detention vaults to treat stormwater without surcharging the existing downstream infrastructure.
