Alternatives Analysis Report

Town Highway Bridge Project

Main Street, Town Highway #2, Bridge #102 over Vermont Railway
Merchants Row, Town Highway #8, Bridge #2 over Vermont Railway

State Project Number: Middlebury WCRS(23)

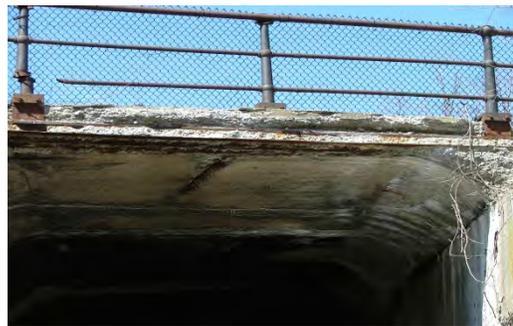
Figure 1: Deterioration of south fascia, Merchants Row Bridge (Photo by VHB, March 2008).

For over twenty-five years, bi-annual VTrans bridge inspection records have chronicled the ongoing deterioration of both bridges. Concrete cracking, delamination, and spalling have occurred on all bridge components with particular deterioration noted on the fascias (see Figure 1). Embedded steel reinforcement is exposed in a variety of locations, especially at the fascias, the ends of the pier caps, and in the flanges of the approach spans under the sidewalks. Heavy efflorescence is common on the soffits of both bridges, indicating leakage through the deck. In April 1997, a hole in the sidewalk of the Merchants Row Bridge was reported. Inspection reports from 1998 to the present have noted that full depth holes can occur at any location in the Merchants Row Bridge, and are most likely to occur under the sidewalks

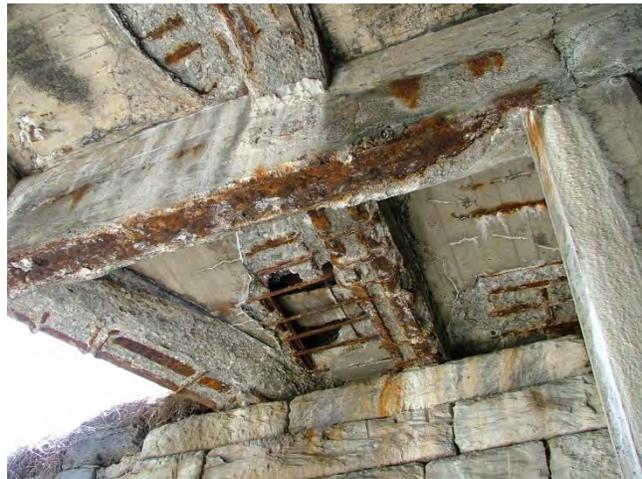
Figure 2: Exposed rebar in Merchants Row Bridge approach span (Photo by VHB, March 2008).

and parking areas. The 1986 bridge inspection report for this same bridge notes a hole in the soffit up to the steel mesh of the bridge decking. At present, the mesh is exposed in multiple locations on the Merchants Row Bridge (see Figure 2).

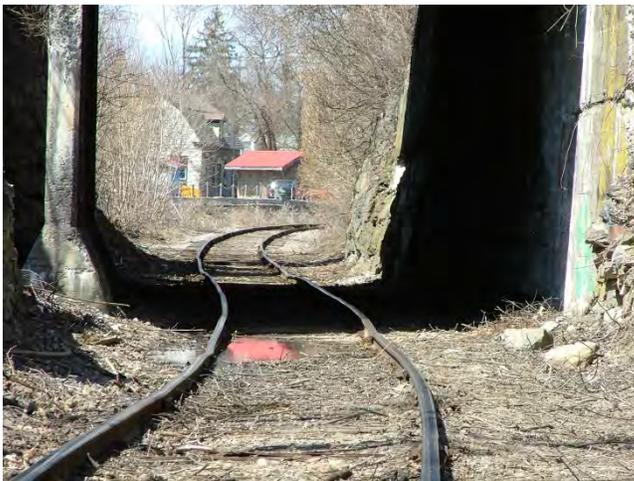
Figure 3: Curved alignment, Post Office wall on right beyond bridge shadow. Note ponding between tracks, indicating poor drainage (Photo by VHB, March 2008).

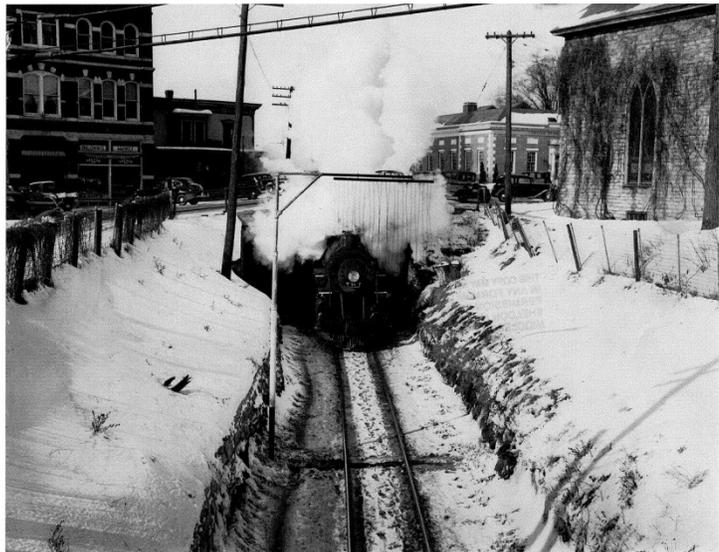
Figure 4. Photo from Merchants Row Bridge looking north at southbound train passing under the Main Street Bridge in 1939. St. Stephens Episcopal Church is visible at top right. The rubble retaining walls between the bridges are also visible.

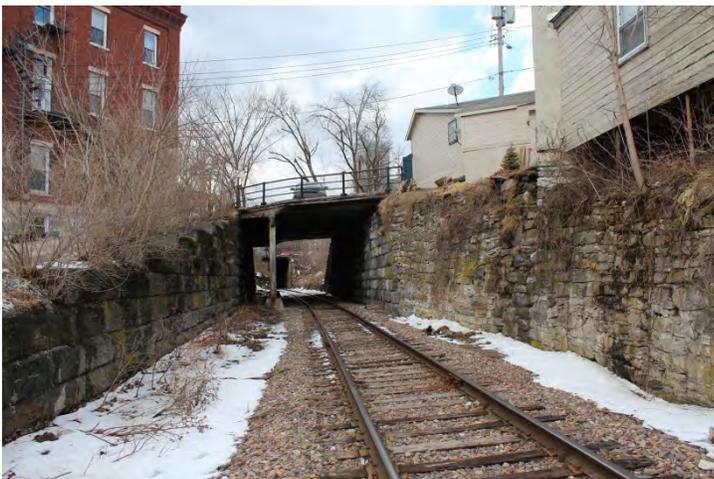
Figure 5. Looking north at Merchants Row Bridge, ashlar retaining wall at left, rubble wall retaining wall at right (VHB, February, 2013).

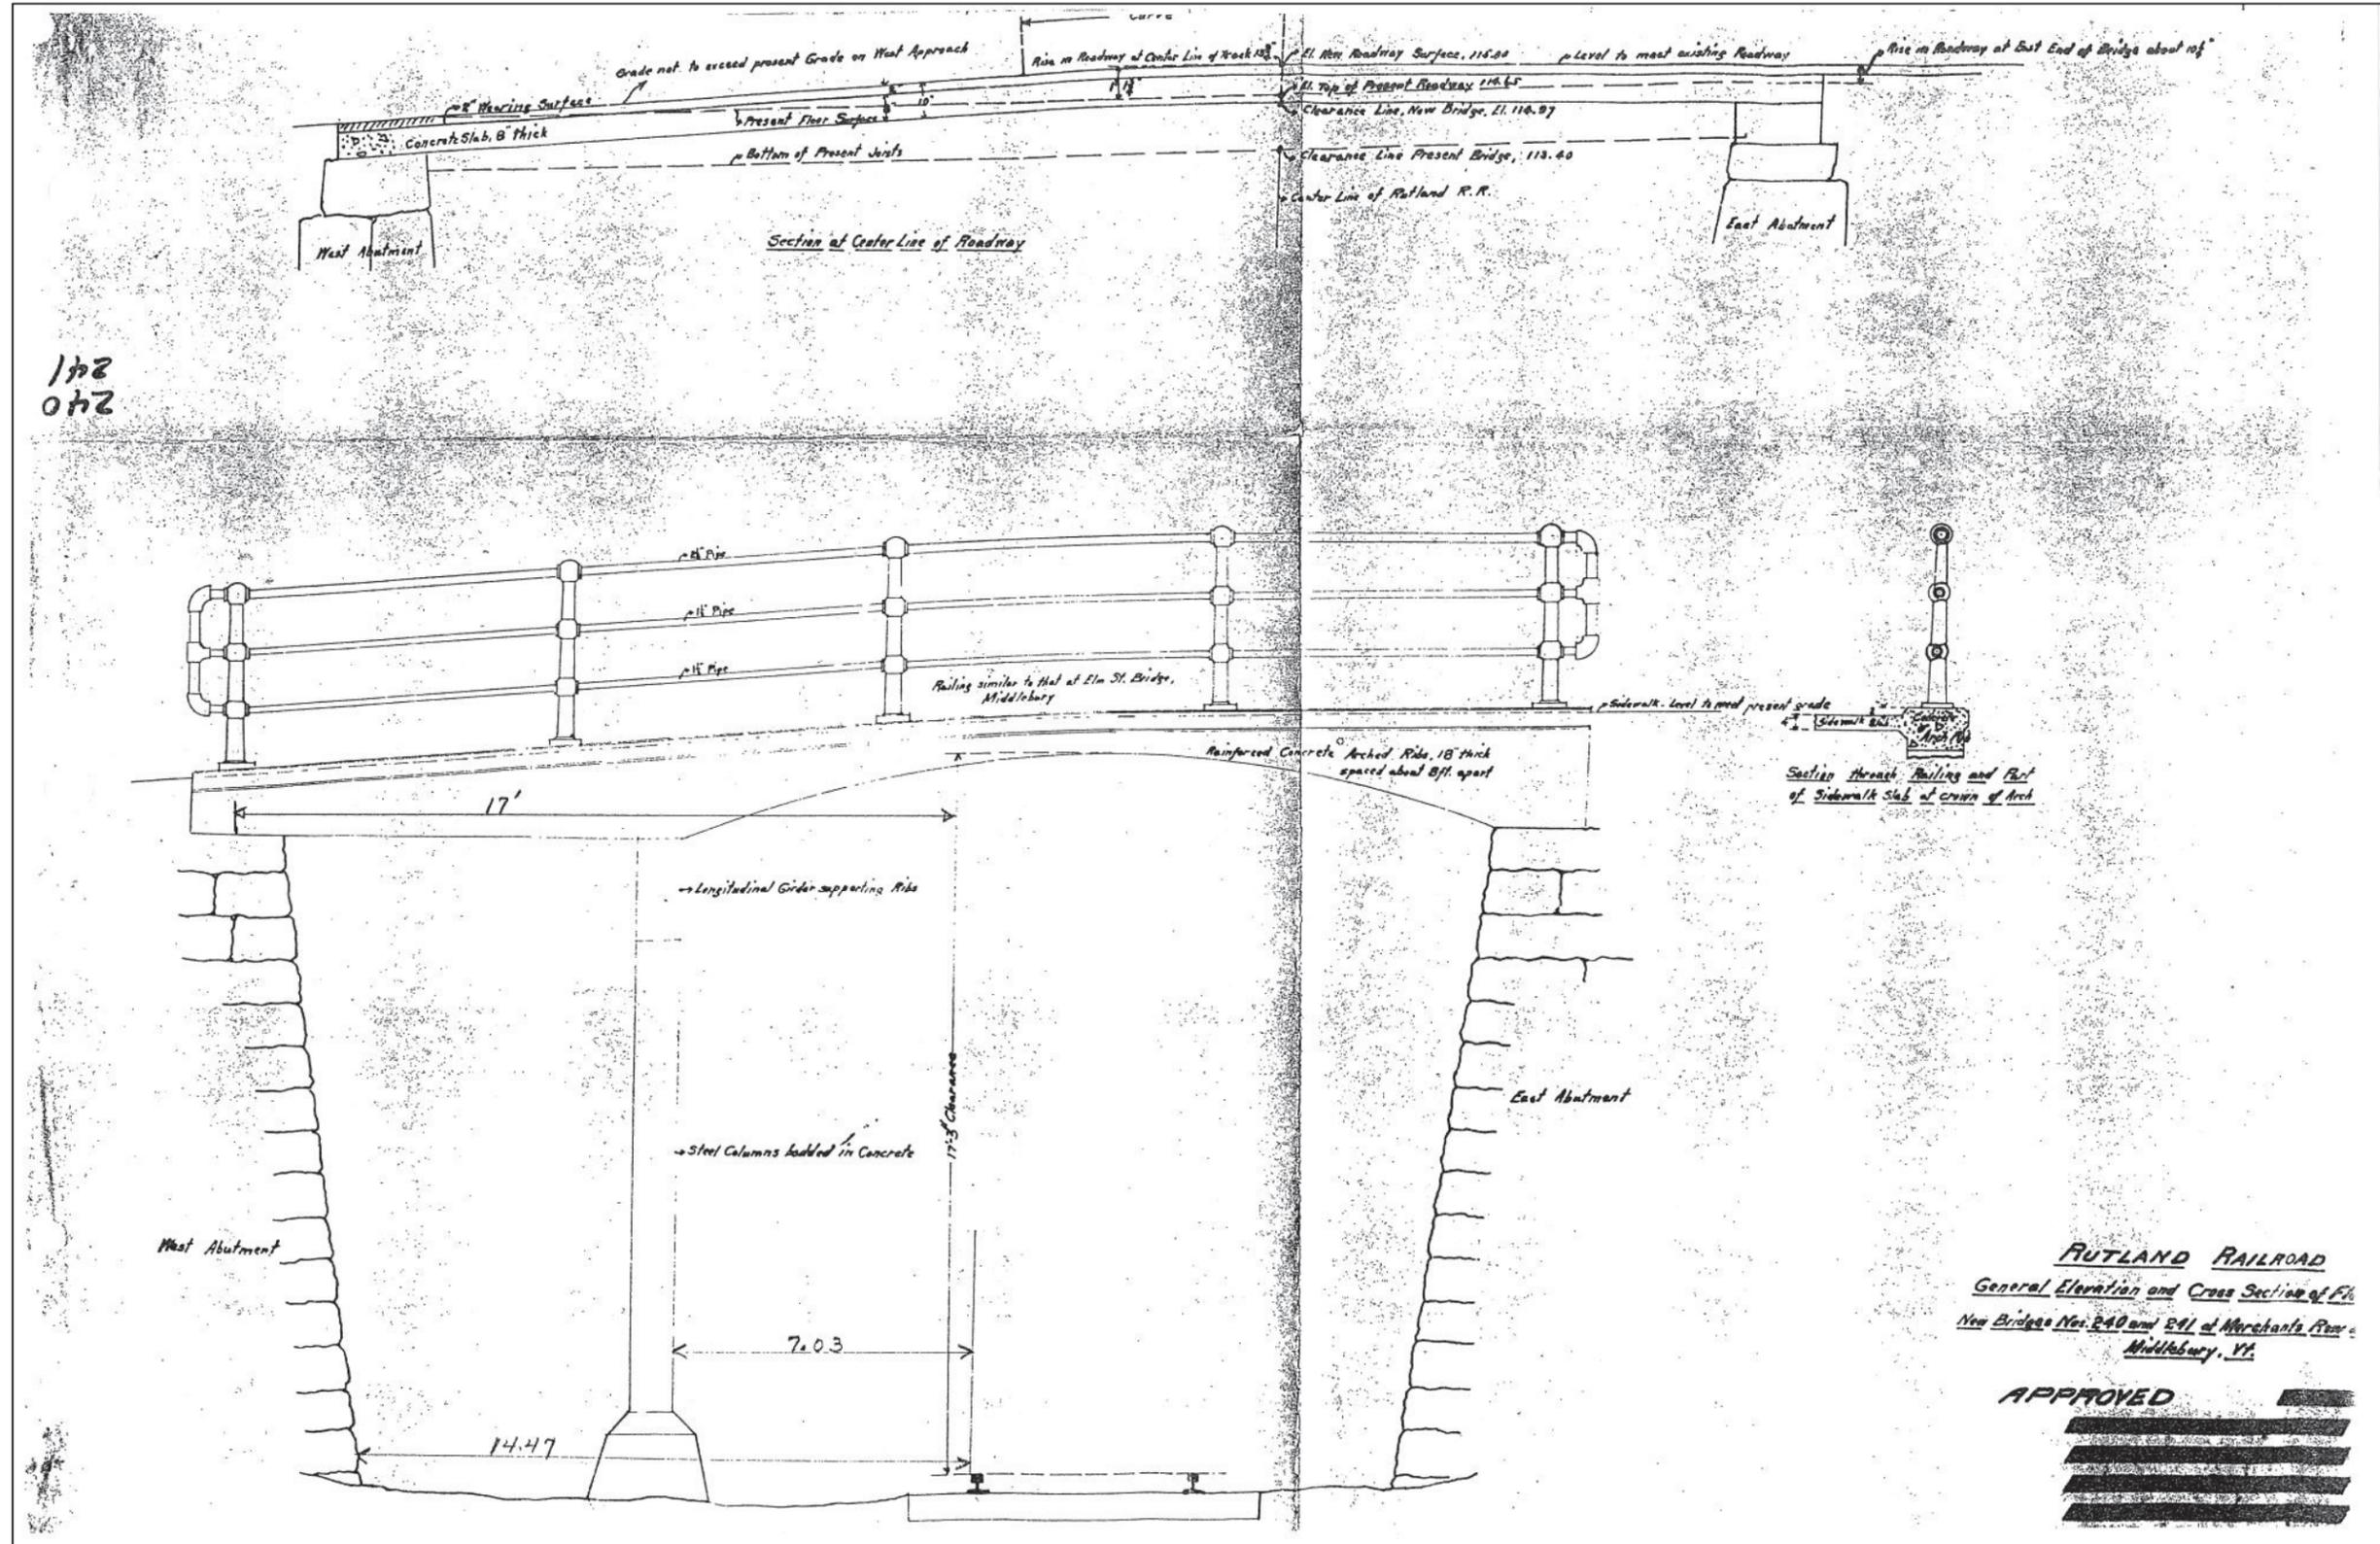
Figure 18. Plans for 1920-1921 construction of Main Street Bridge and Merchant's Row Bridge. VTrans archives, accessed March 2013.

Figure 24. View of Elm Street Bridge, 1963. Note similar railing to Merchant’s Row Bridge and Main Street Bridge, as noted on 1920-1921 plans for bridges (Figure 18). Poulin Collection of Rutland Railroad Photographs, accessed March 2013, http://middigital.middlebury.edu/rutland_railroad/RRAPoulinPhotos/.

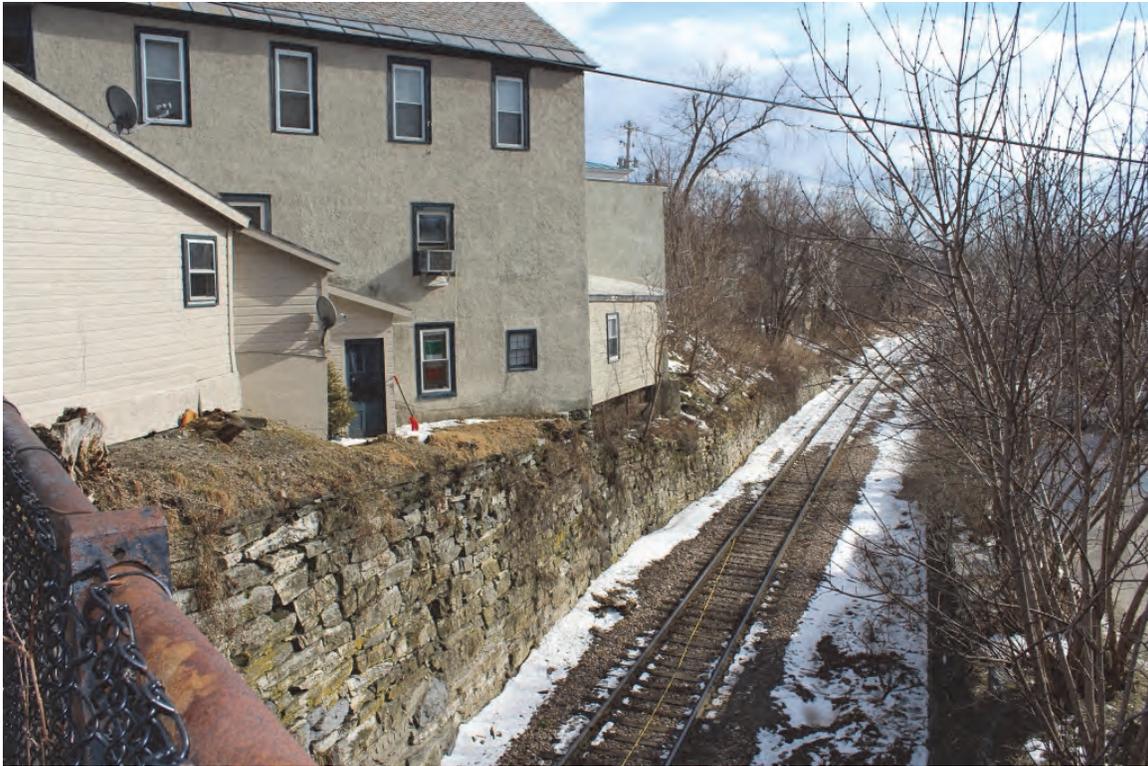
1. View of south approach and east wall from Merchants Row Bridge. Photographer facing SE, February 15, 2013.

Section 1A
Stone retaining wall
249 feet
Photos 1, 4, 6

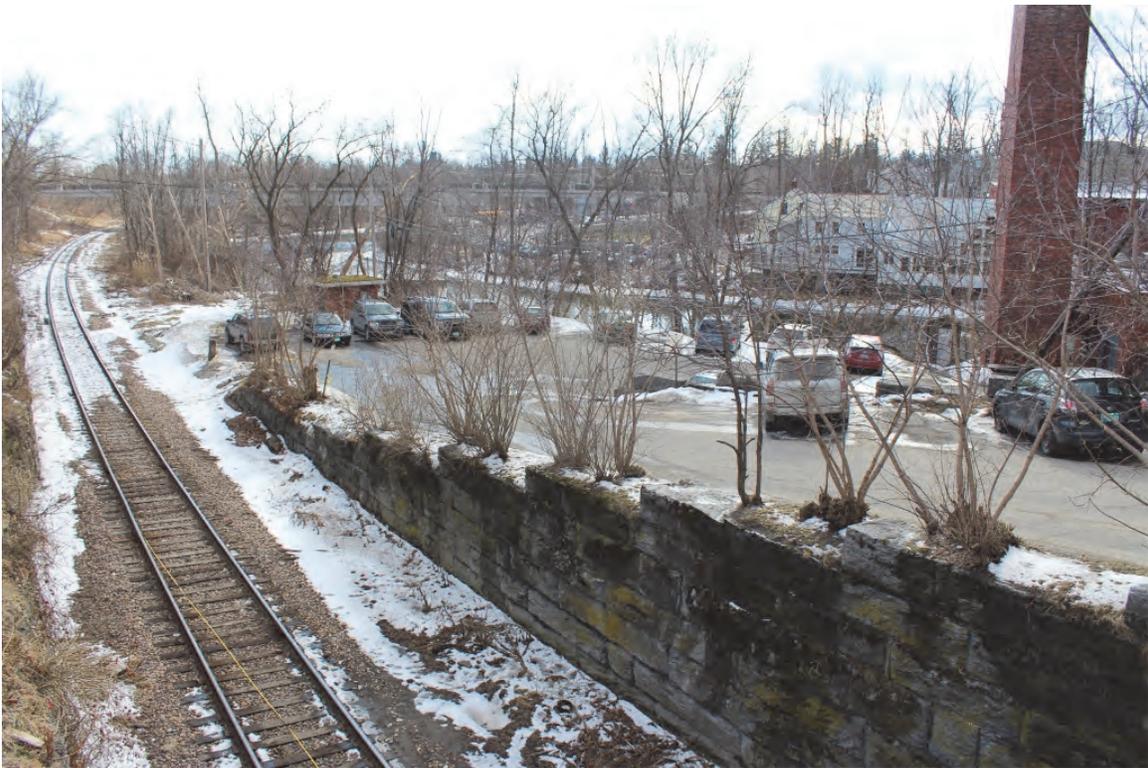
2. Main Street and Merchants Row Bridge Replacement, Middlebury, VT. View of Merchants Row Bridge, west wall at south approach. Photographer facing S, February 15, 2013.

Section 2A
Granite Ashlar retaining wall
169 feet
Photos 2, 5, 7

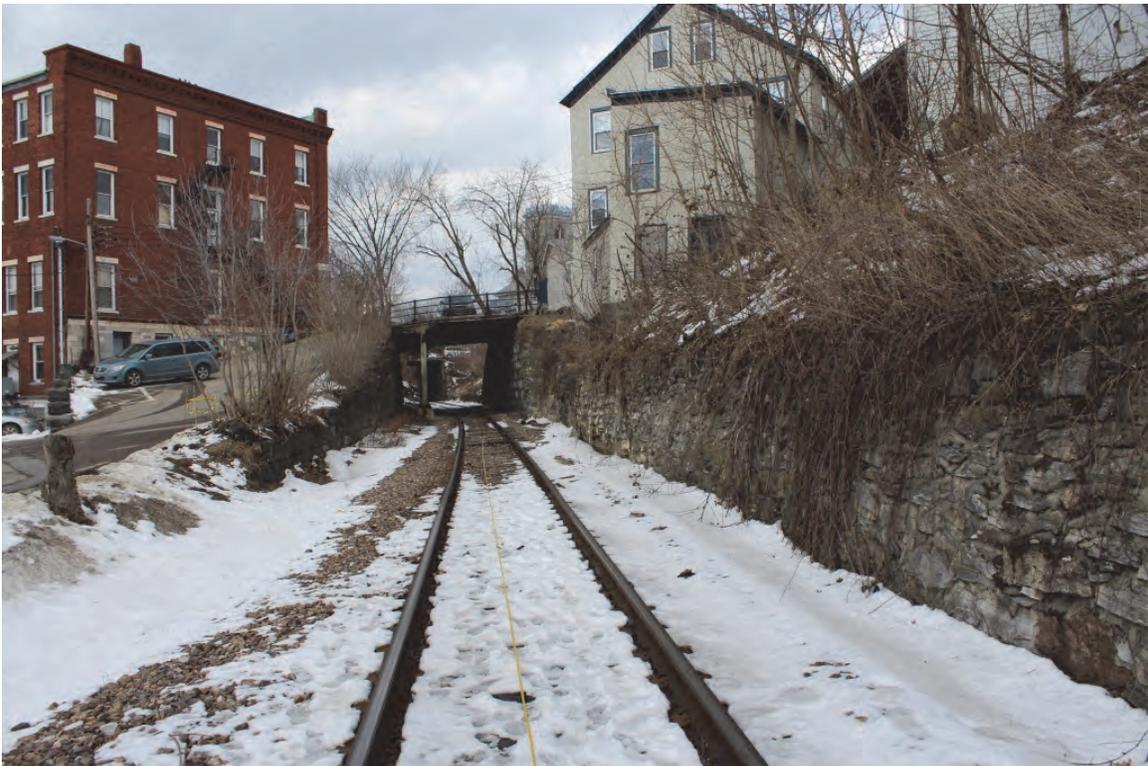
4. Main Street and Merchants Row Bridge Replacement, Middlebury, VT. View of Merchants Row Bridge, showing degree of vegetation growth on east wall. Photographer facing N, February 15, 2013.

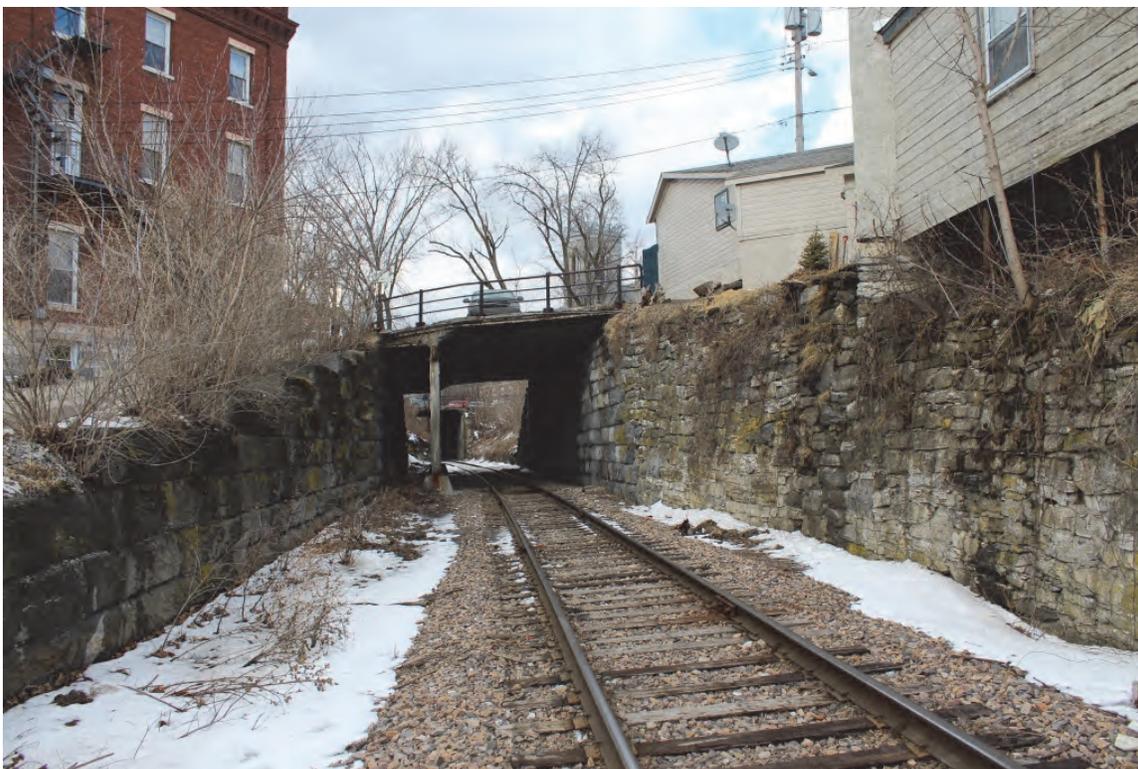
5. Main Street and Merchants Row Bridge Replacement, Middlebury, VT. View of Merchants Row Bridge, east abutment, south side. Photographer facing NW, February 15, 2013.

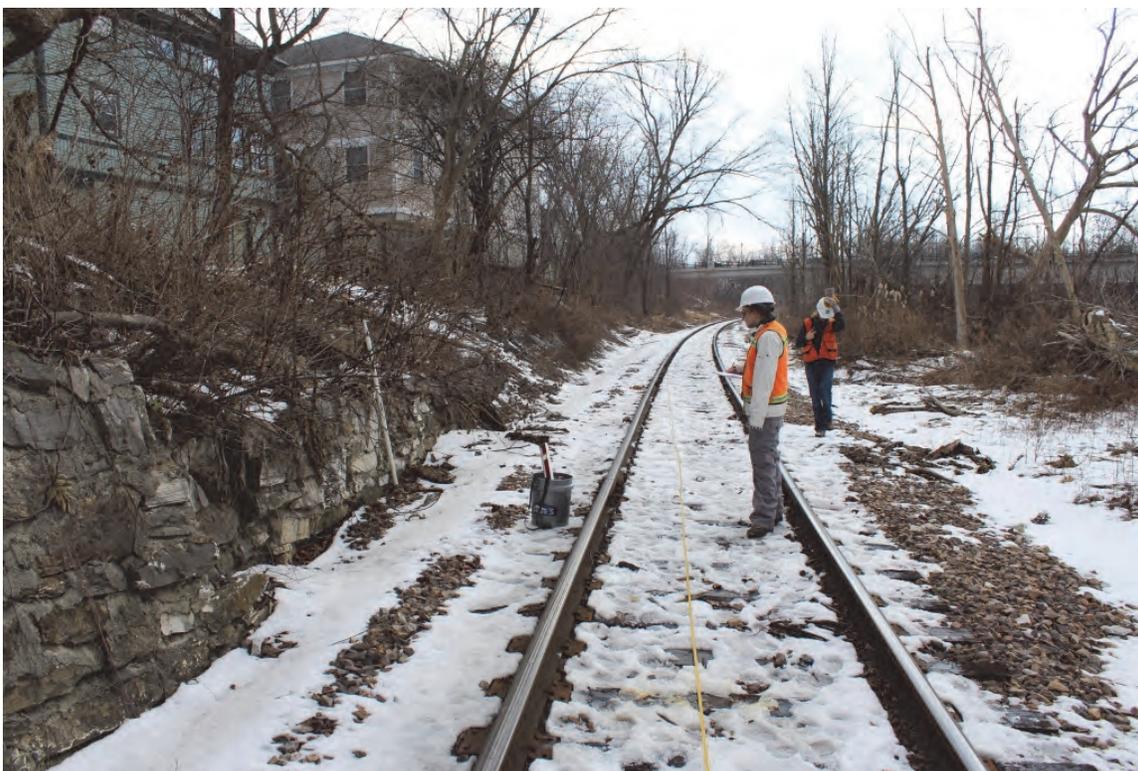
6. Main Street and Merchants Row Bridge Replacement, Middlebury, VT. View of south terminus of east retaining wall, south of Merchants Row Bridge. Photographer facing S, February 15, 2013.

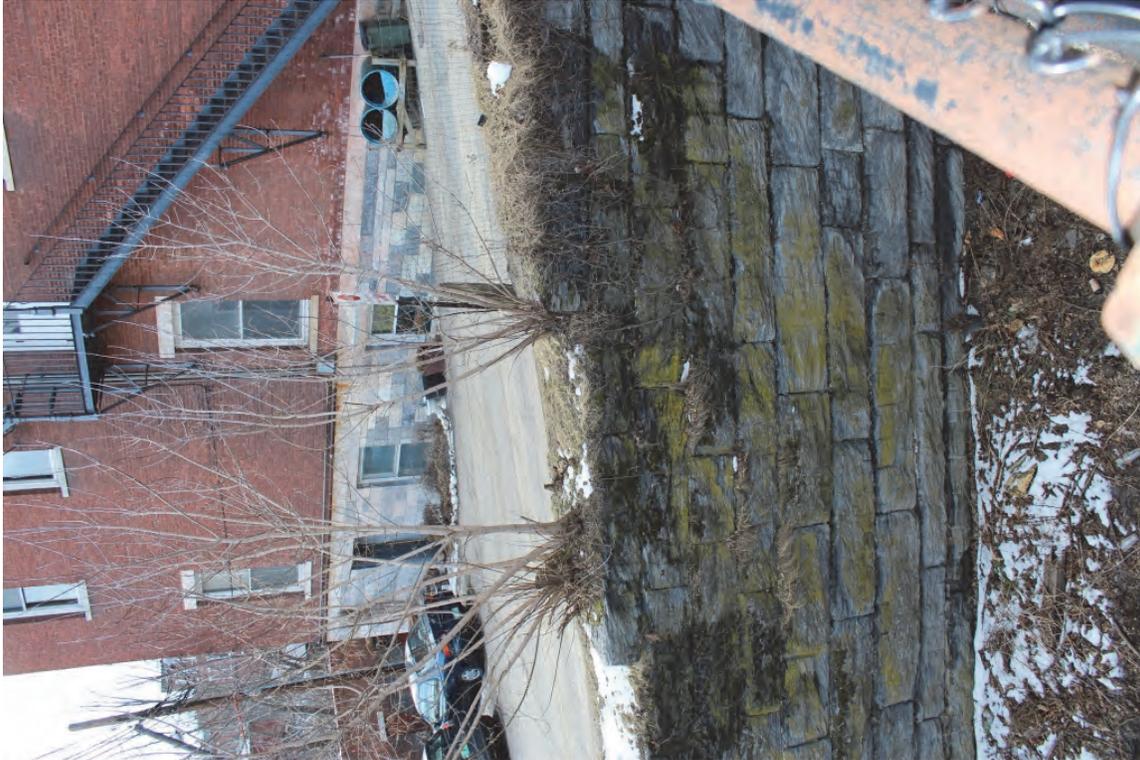
7. Main Street and Merchants Row Bridge Replacement, Middlebury, VT. View of Merchants Row Bridge, west wall and abutment, south side. Photographer facing W, February 15, 2013.

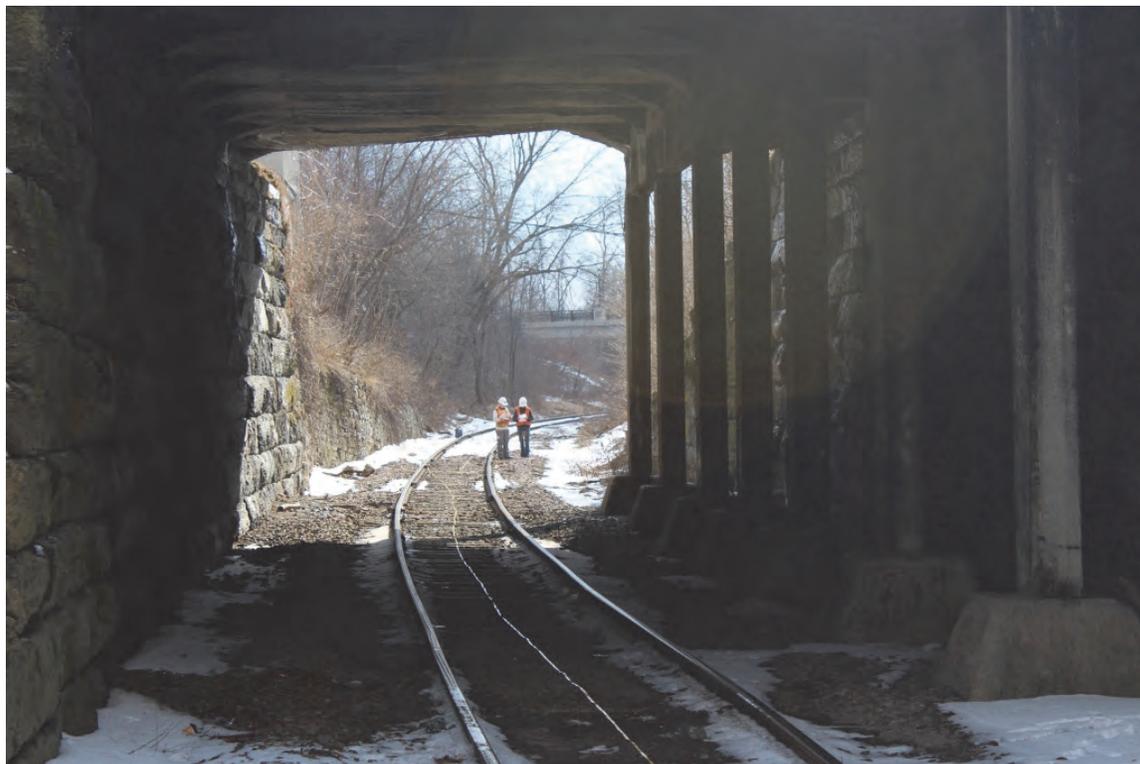
8. Main Street and Merchants Row Bridge Replacement, Middlebury, VT. View of Merchants Row Bridge, piers and abutments. Photographer facing S, February 15, 2013.

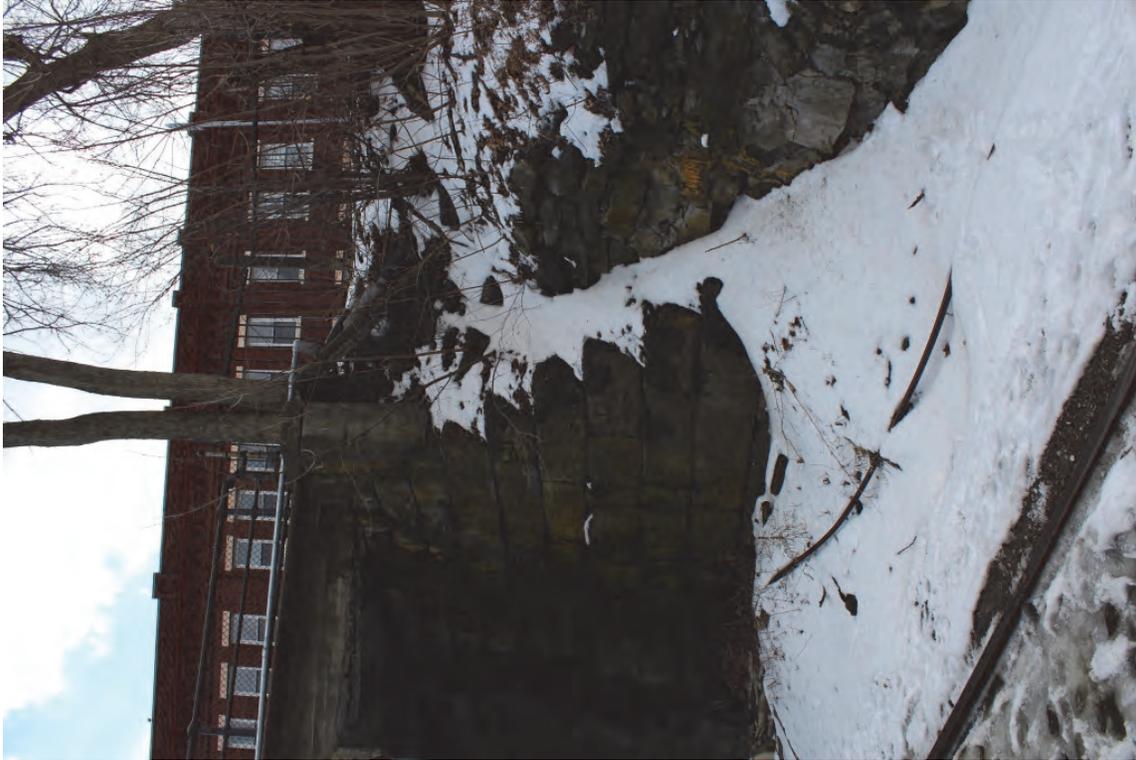
9. Main Street and Merchants Row Bridge Replacement, Middlebury, VT. View of Merchants Row Bridge, west wall and abutment, north side. Photographer facing SW, February 15, 2013.

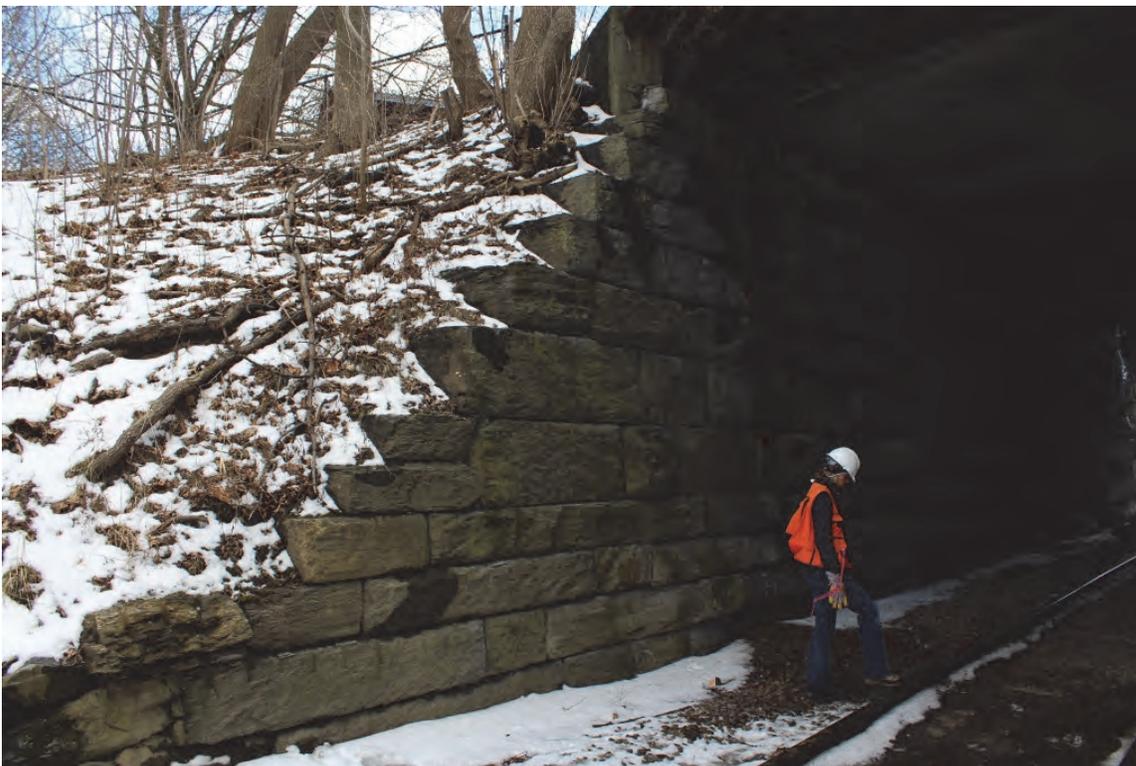
10. Main Street and Merchants Row Bridge Replacement, Middlebury, VT. View of Merchants Row Bridge, east abutment, north side. Photographer facing SE, February 15, 2013.

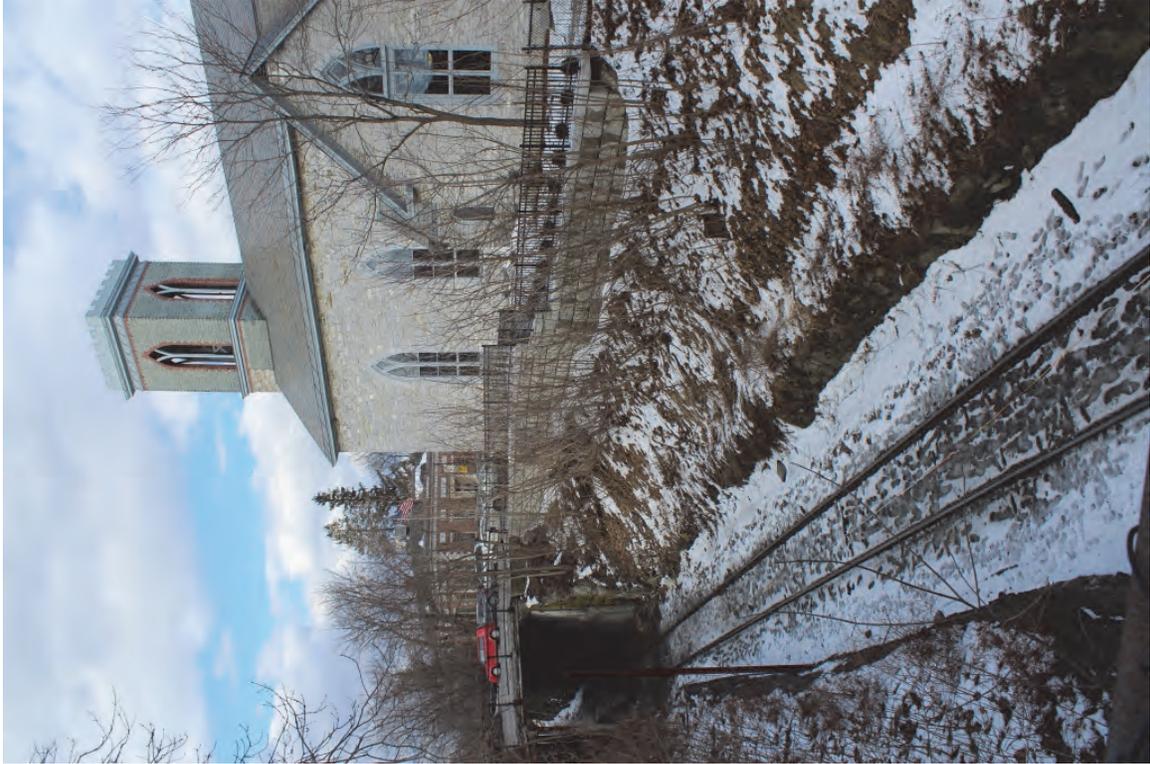
11. Main Street and Merchants Row Bridge Replacement, Middlebury, VT. View of east wall of railroad right-of-way and retaining wall southwest of St. Stephen's Episcopal Church, from Merchants Row Bridge. Photographer facing N, February 15, 2013.

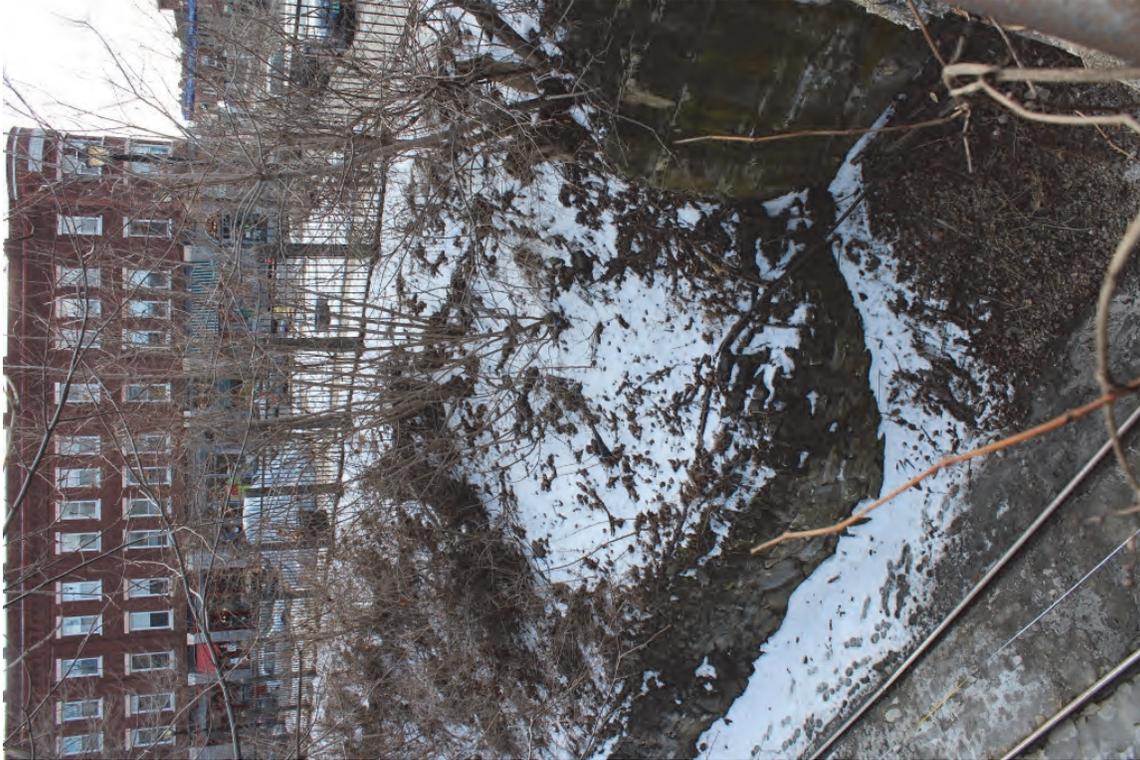
15. Main Street and Merchants Row Bridge Replacement, Middlebury, VT. View of Main Street Bridge, west wall and end of west abutment, south side. Photographer facing SW, February 15, 2013.

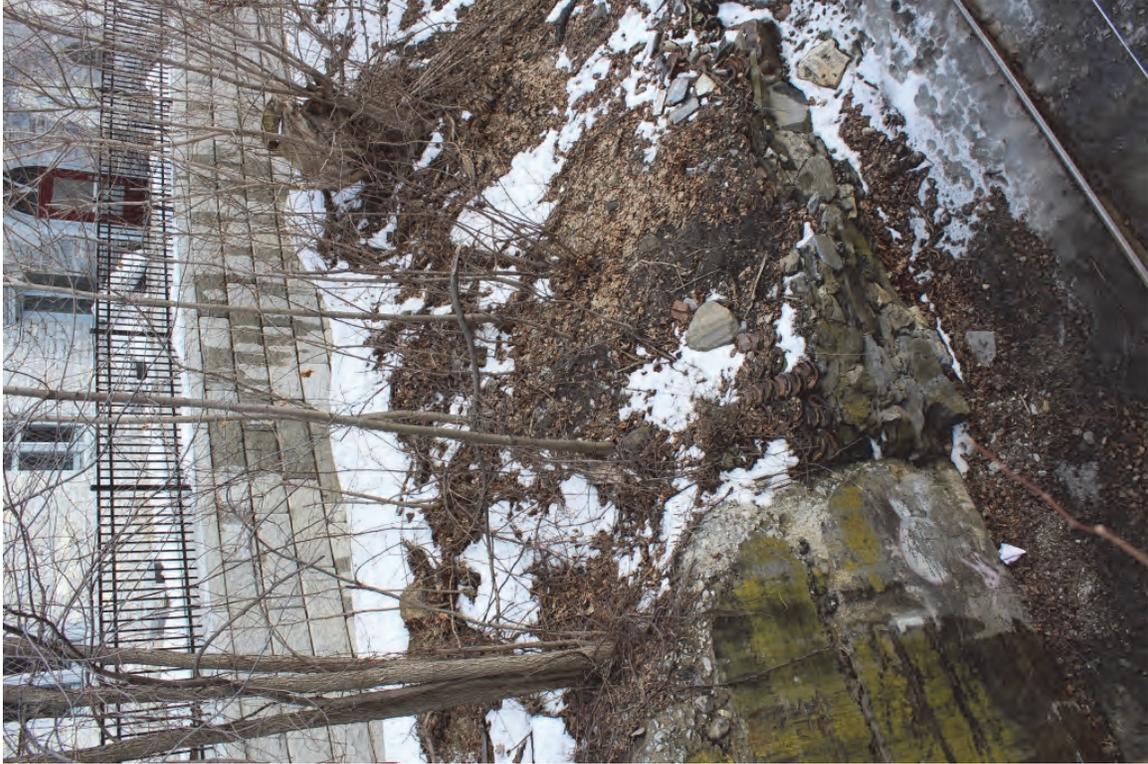
17. Main Street and Merchants Row Bridge Replacement, Middlebury, VT. View of retaining wall southwest of St. Stephen's Episcopal Church and east retaining wall from Main Street Bridge, south side. Photographer facing E, February 15, 2013.

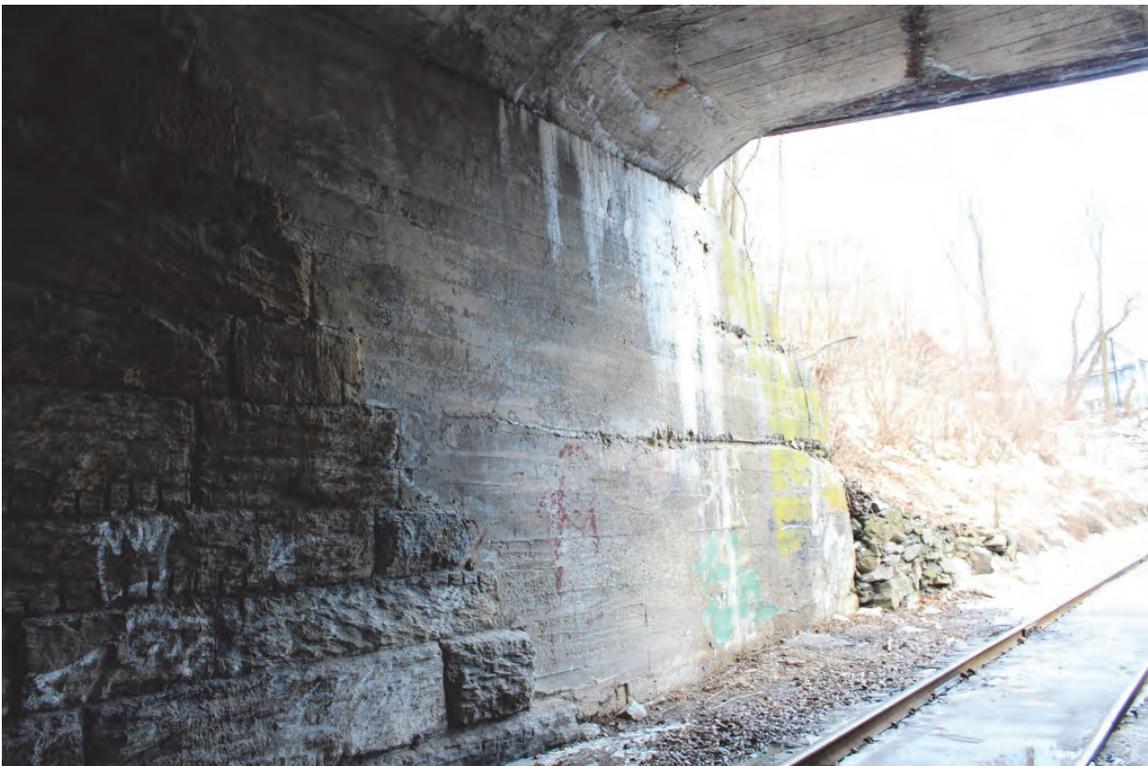
18. Main Street and Merchants Row Bridge Replacement, Middlebury, VT. View of Main Street Bridge, east wall and abutment, south side. Photographer facing SE, February 15, 2013.

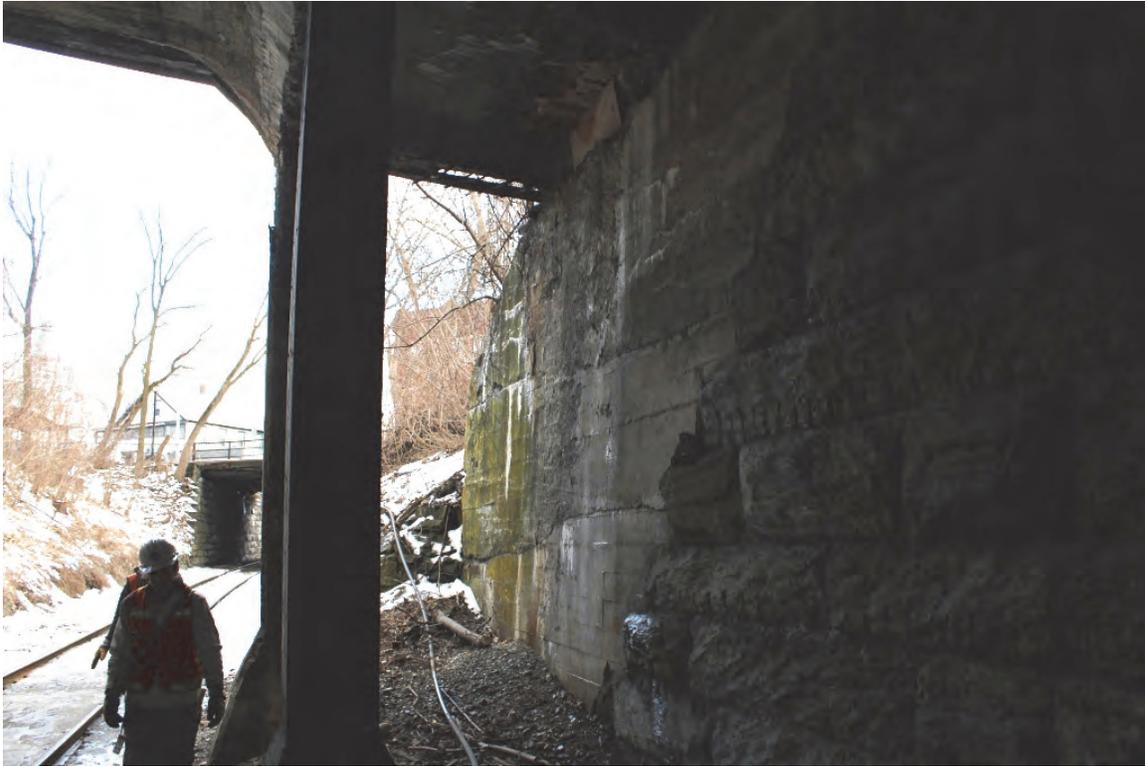
19. Main Street and Merchants Row Bridge Replacement, Middlebury, VT. View of Main Street Bridge, west wall and abutment, south side. Photographer facing SW, February 15, 2013.

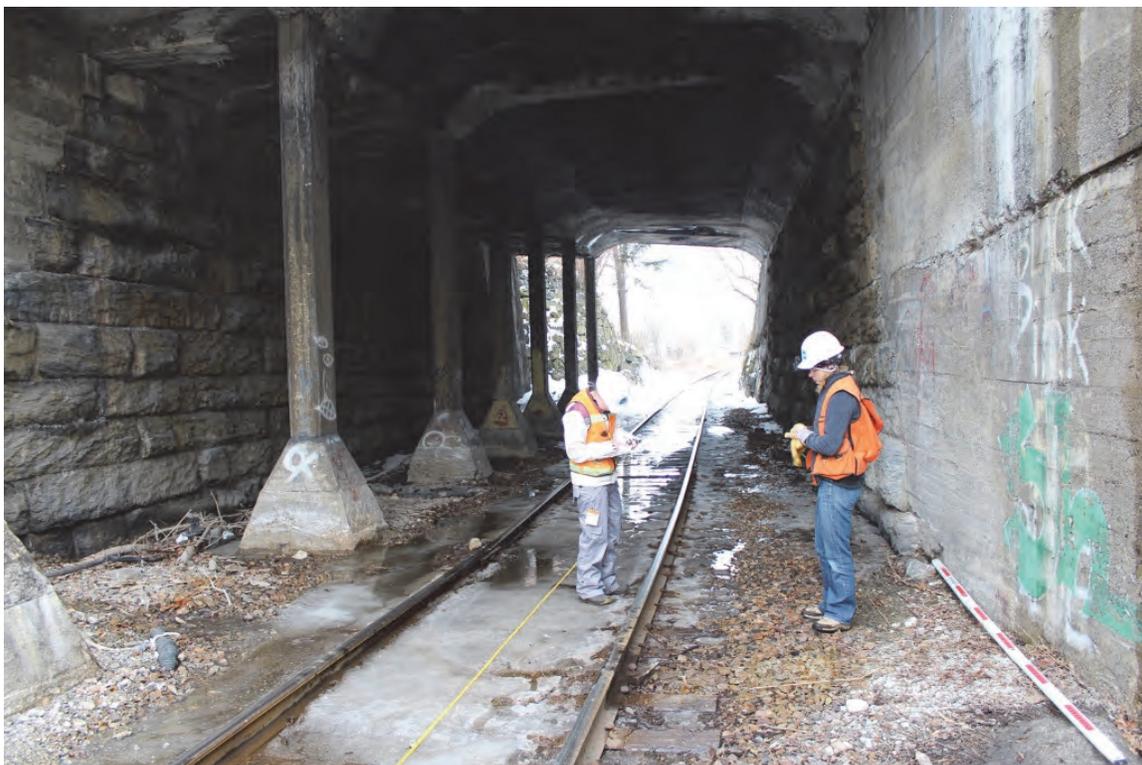
20. Main Street and Merchants Row Bridge Replacement, Middlebury, VT. View of Main Street Bridge, piers and abutments. Photographer facing N, February 15, 2013.

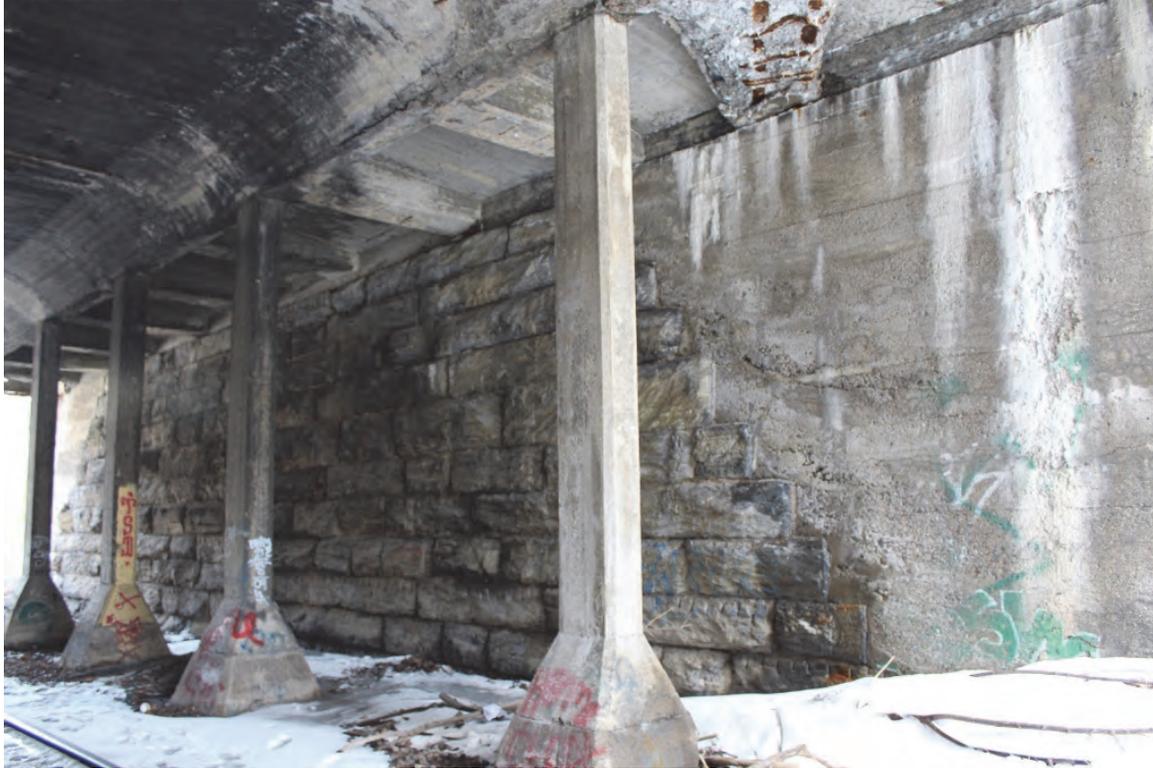
21. Main Street and Merchants Row Bridge Replacement, Middlebury, VT. View of Main Street Bridge, west abutment, north side. Photographer facing S, February 15, 2013.

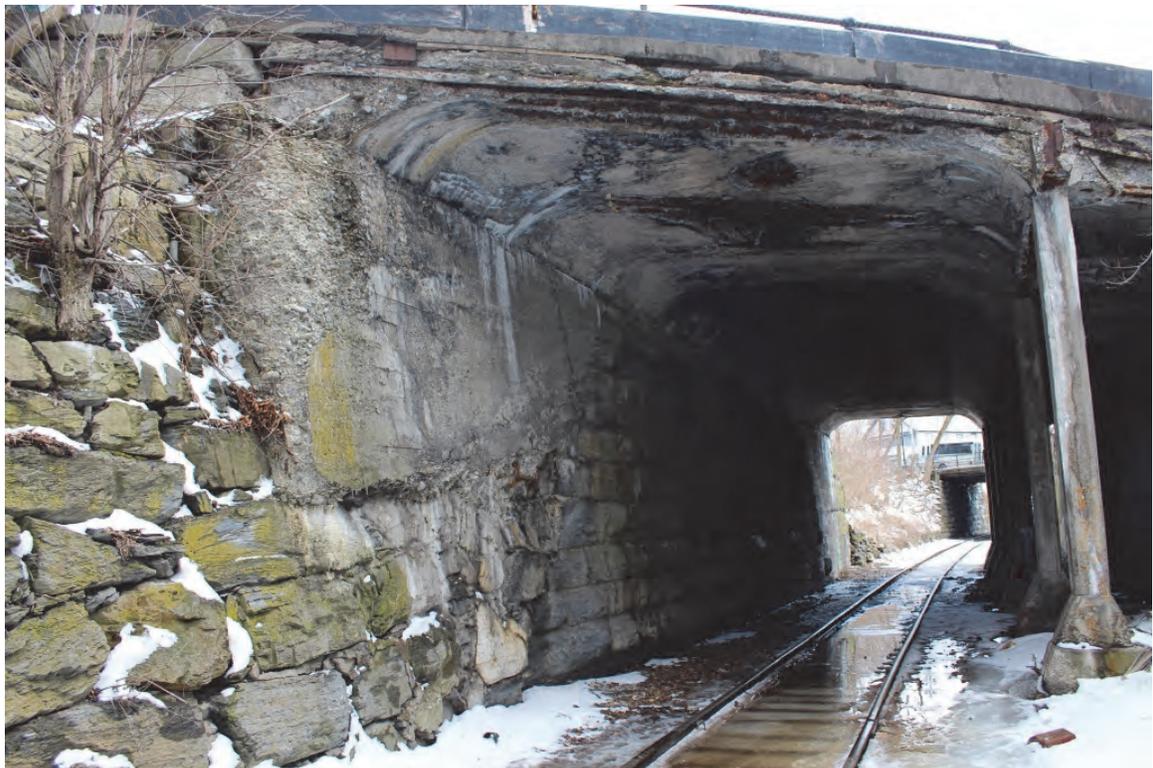
22. Main Street and Merchants Row Bridge Replacement, Middlebury, VT. View of Main Street Bridge, east abutment, north end. Photographer facing SE, February 15, 2013.

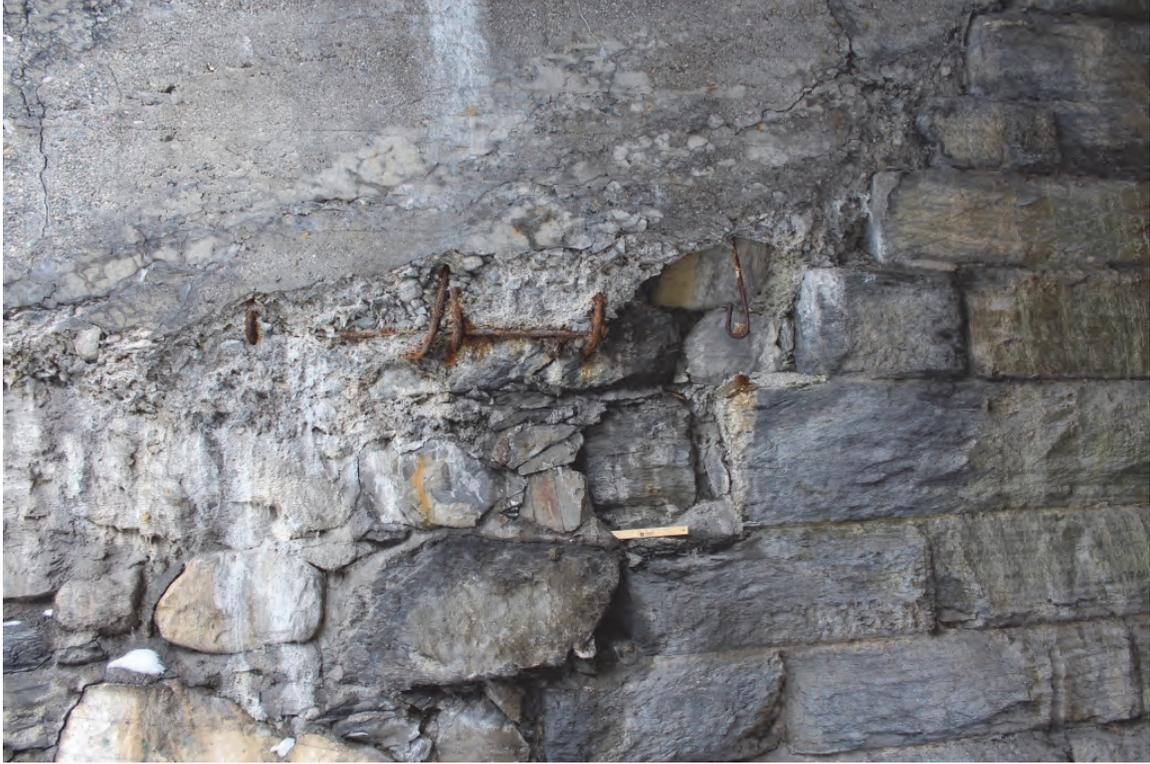
23. Main Street and Merchants Row Bridge Replacement, Middlebury, VT. Closeup of Main Street Bridge, east wall and abutment contact point, north end. Photographer facing E, February 15, 2013.
