Alternatives Analysis Report

Town Highway Bridge Project

Main Street, Town Highway #2, Bridge #102 over Vermont Railway
Merchants Row, Town Highway #8, Bridge #2 over Vermont Railway

State Project Number: Middlebury WCRS(23)

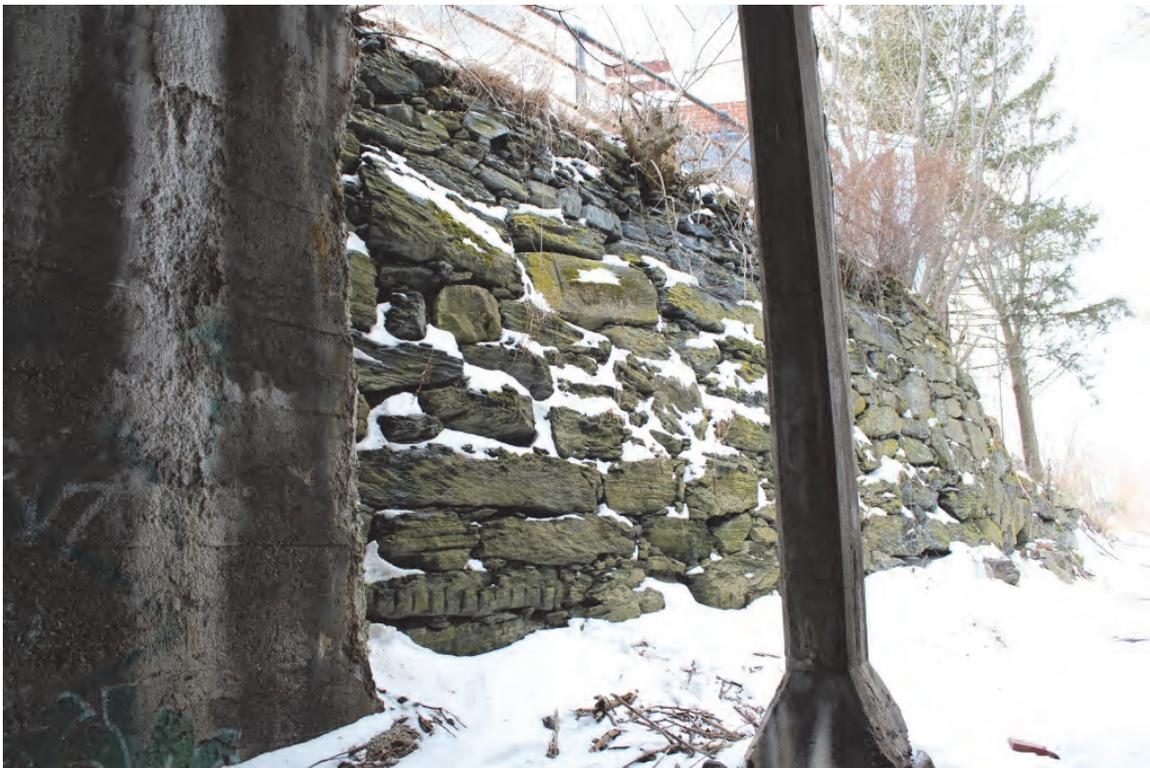
24. Main Street and Merchants Row Bridge Replacement, Middlebury, VT. View of west wall, Main Street Bridge, north side. Photographer facing NW, February 15, 2013.

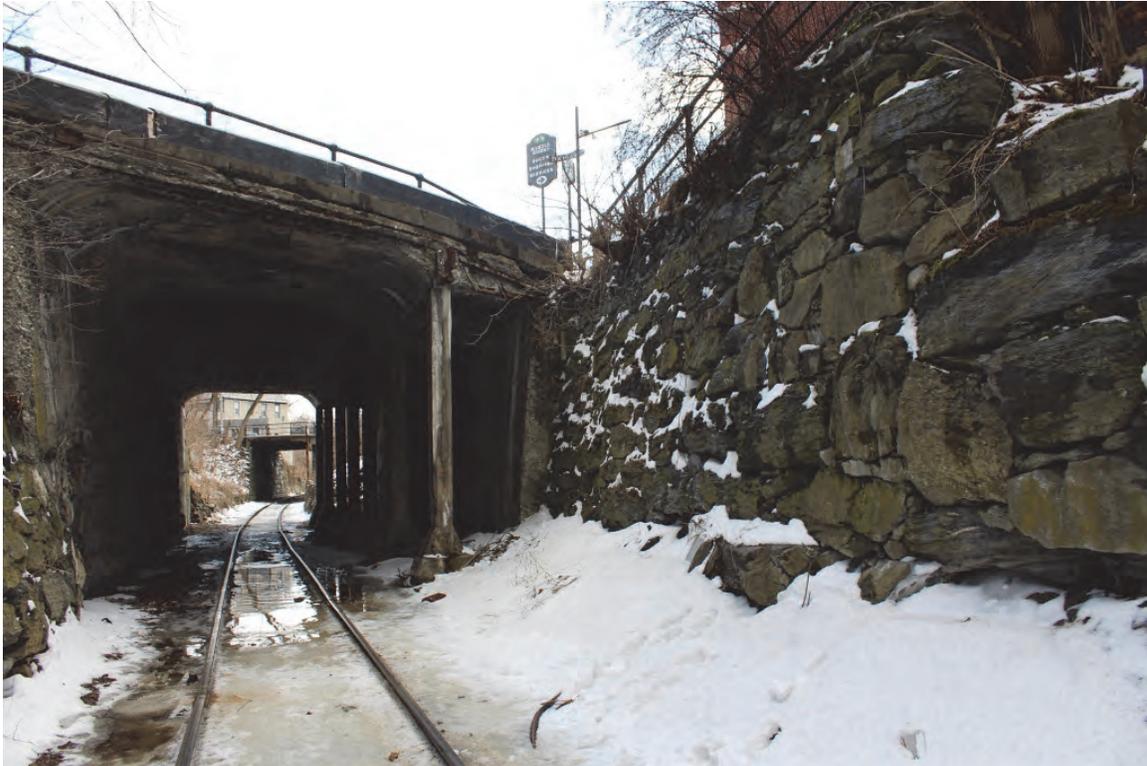
25. Main Street and Merchants Row Bridge Replacement, Middlebury, VT. View of Main Street Bridge, west wall at north approach. Photographer facing S, February 15, 2013.

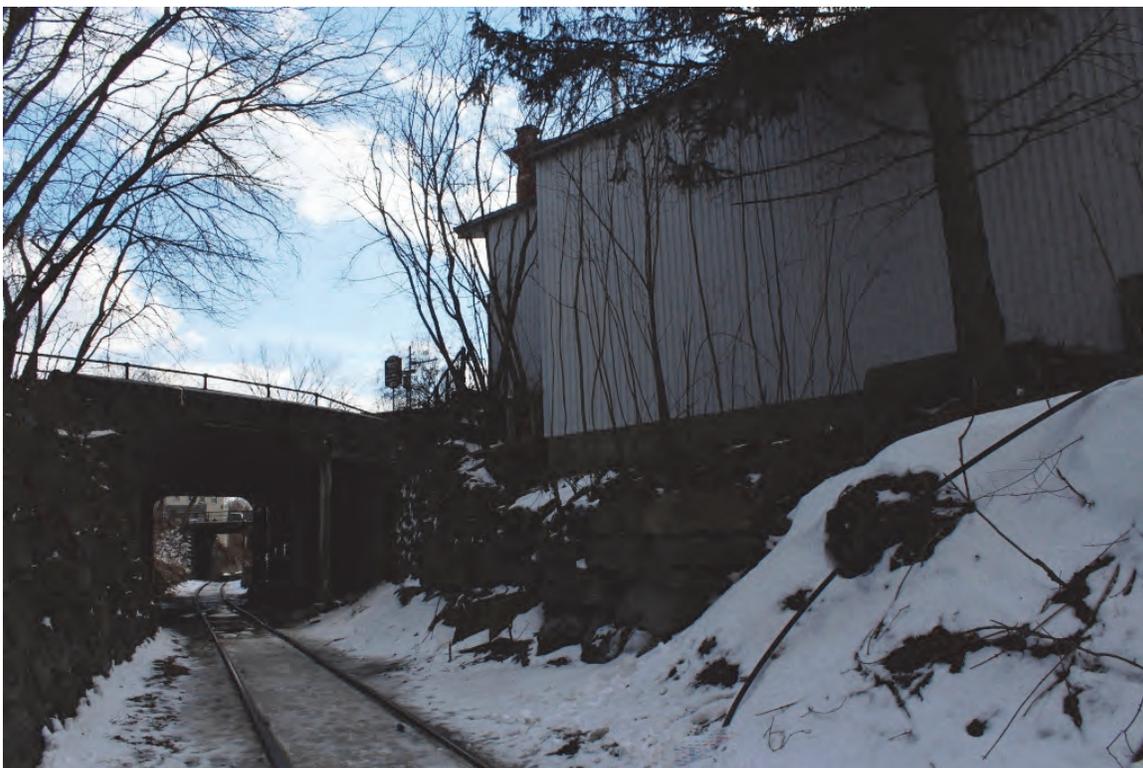
26. Main Street and Merchants Row Bridge Replacement, Middlebury, VT. View of Main Street Bridge, west wall below Lazarus Building. Photographer facing S, February 15, 2013.

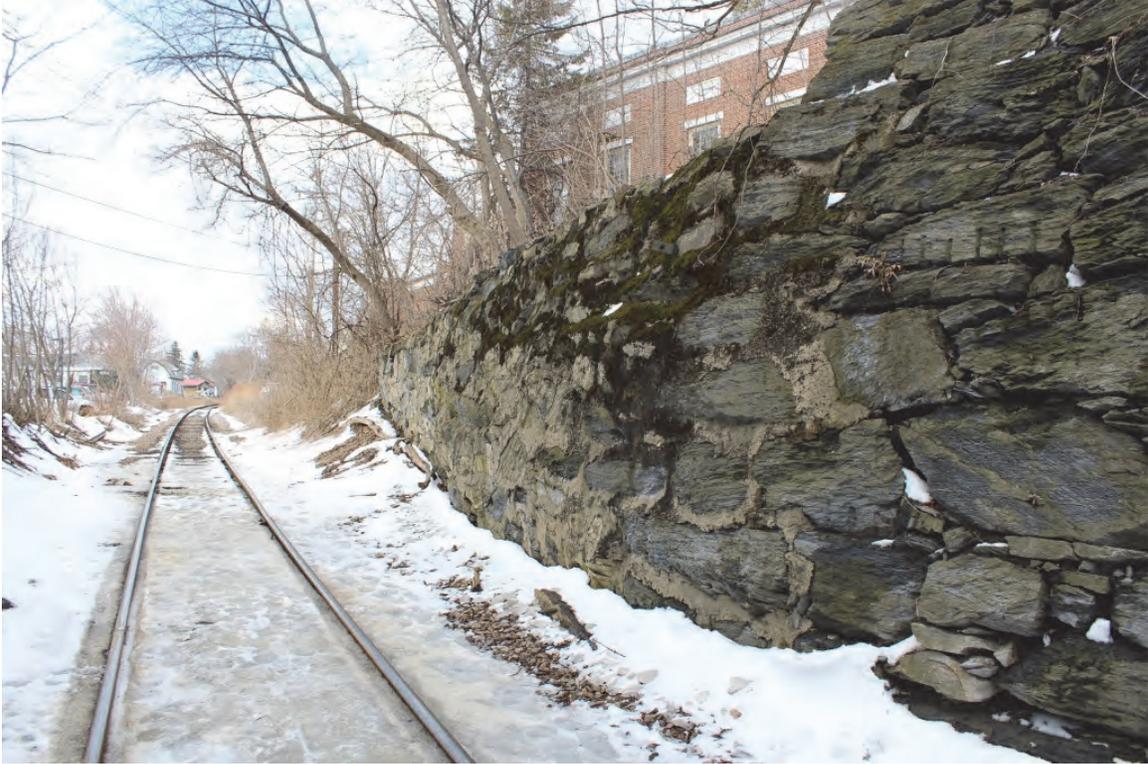
27. Main Street and Merchants Row Bridge Replacement, Middlebury, VT. View of north terminus of east wall, north of Main Street bridge. Photographer facing N, February 15, 2013.

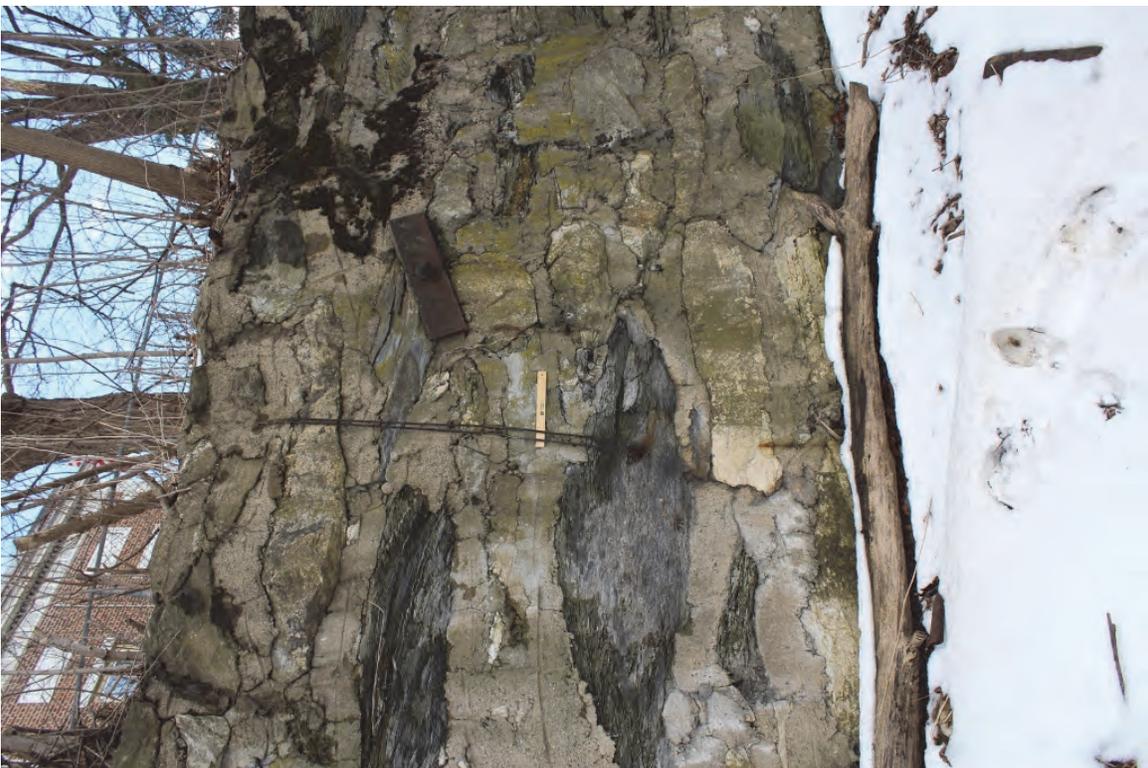
28. Main Street and Merchants Row Bridge Replacement, Middlebury, VT. Closeup of east retaining wall, north of Main Street bridge, showing tie back. Photographer facing E, February 15, 2013.

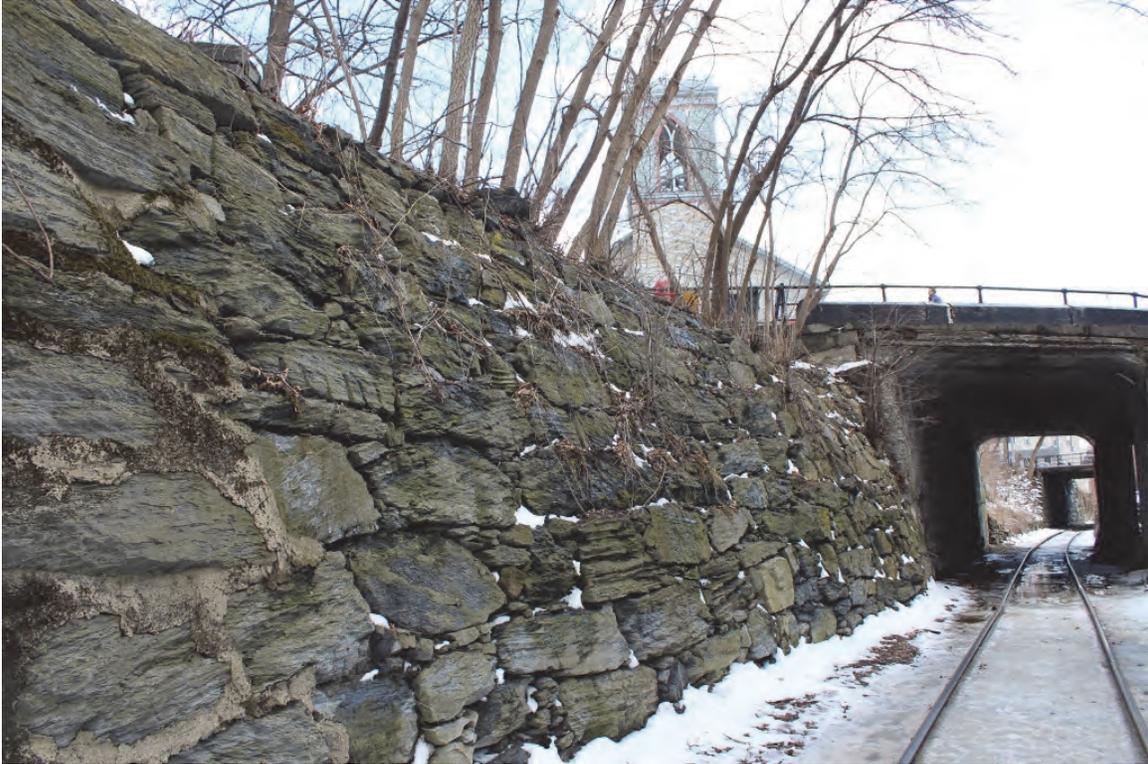
29. Main Street and Merchants Row Bridge Replacement, Middlebury, VT. View of Main Street Bridge and east wall at north approach. Photographer facing SE, February 15, 2013.

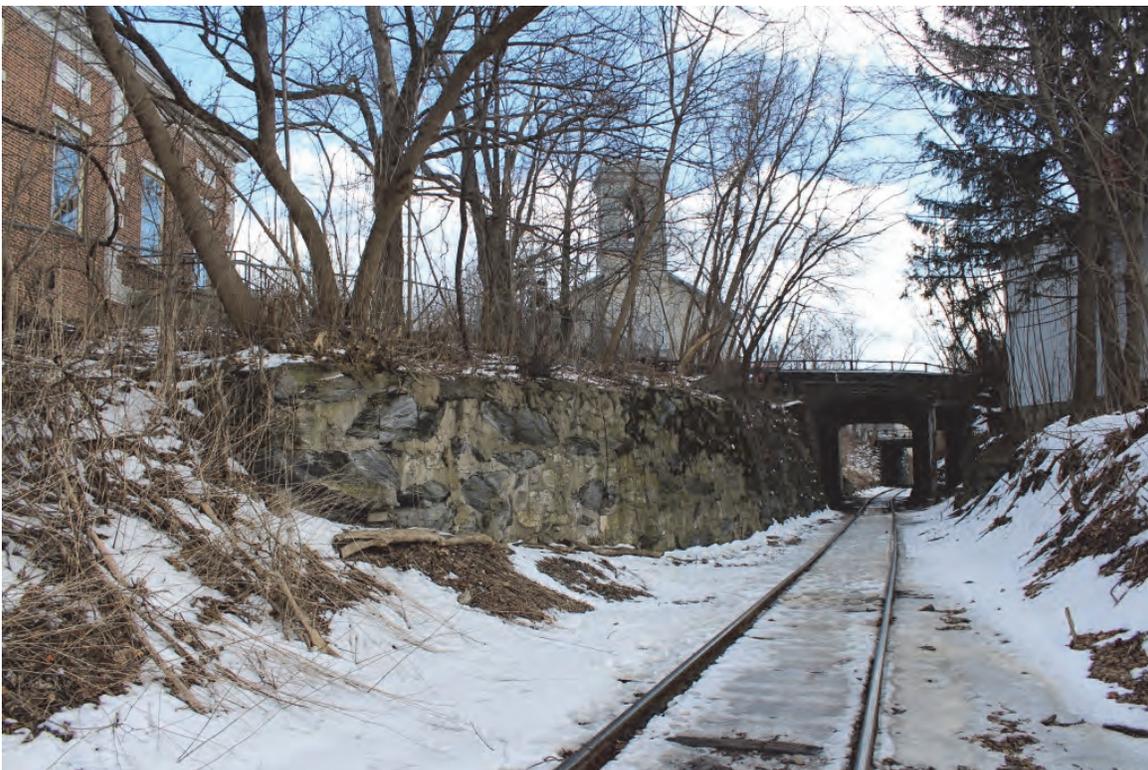
30. Main Street and Merchants Row Bridge Replacement, Middlebury, VT. View of Main Street Bridge, east wall, north side. Photographer facing SE, February 15, 2013.

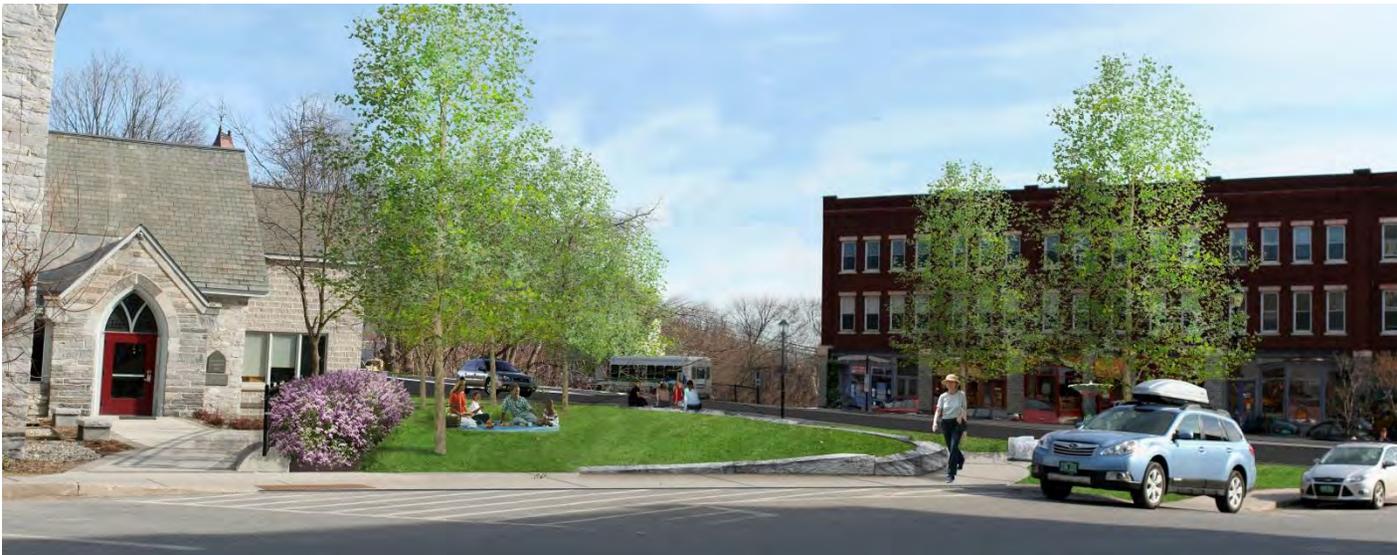
Before
(View from Main Street)

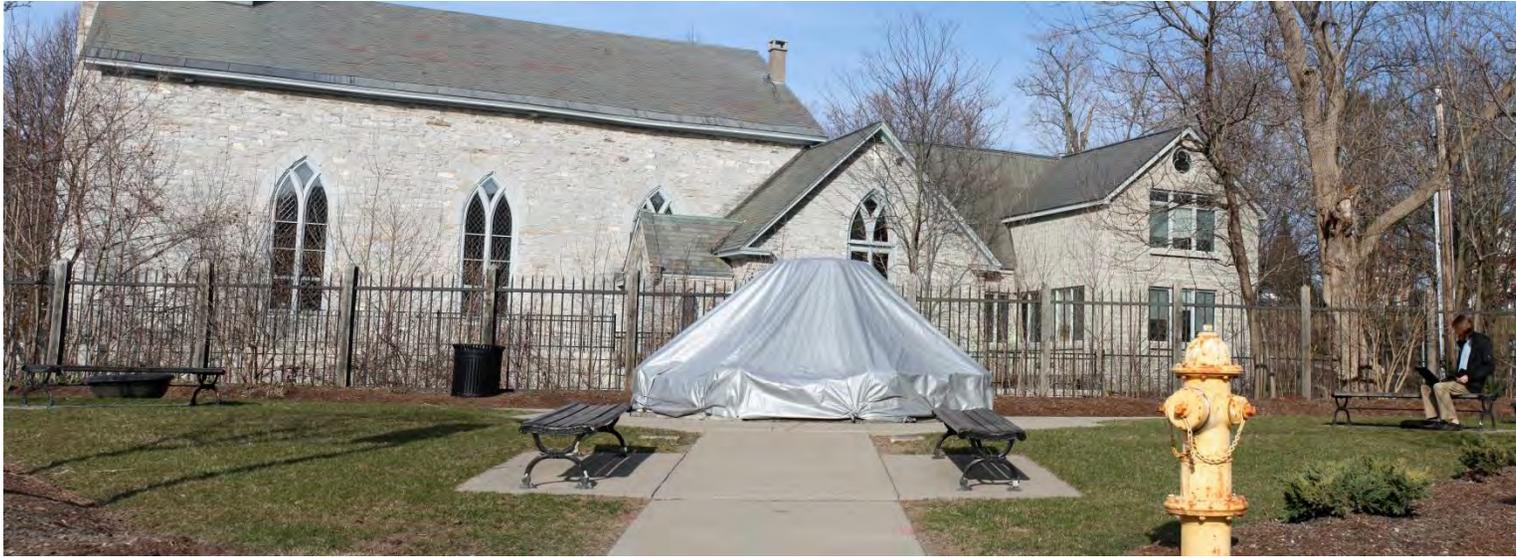
After

Main Street and Merchants Row Bridges
Middlebury WCRS(23)
Tunnel Simulations

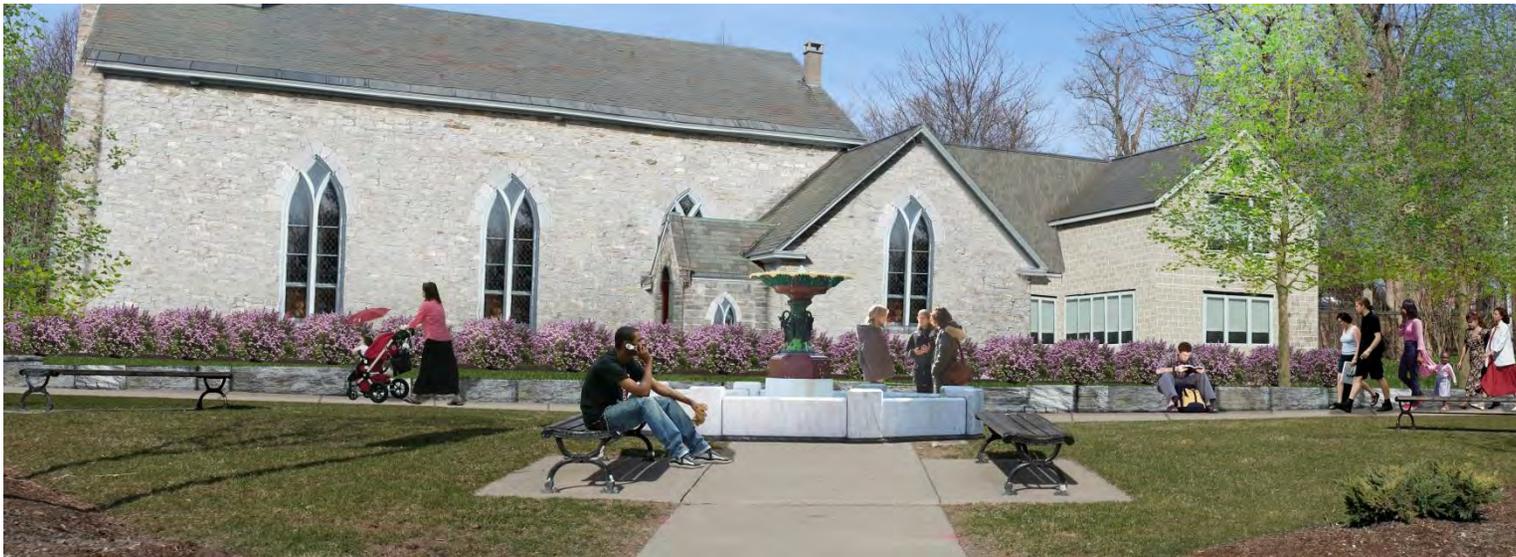
Before
(Fountain View from West)

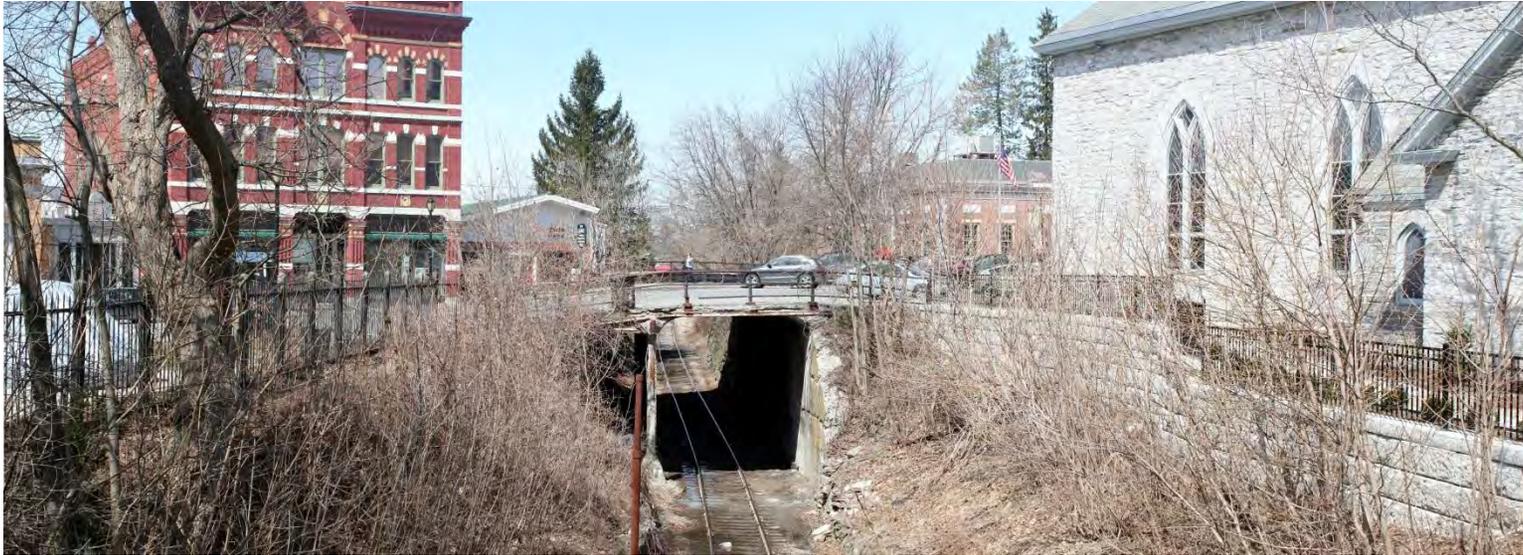
After

Main Street and Merchants Row Bridges
Middlebury WCRS(23)
Tunnel Simulations

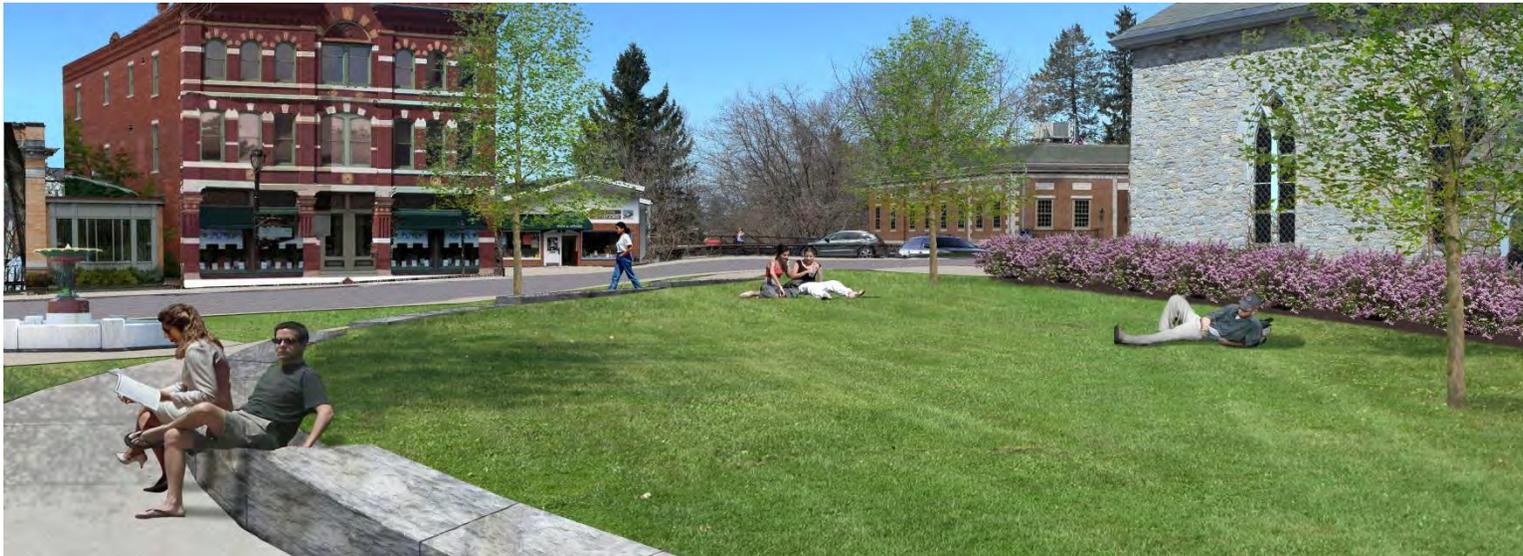
Before
(View from Merchants Row)
