Hartford (Quechee) NH 020-2(45)
Public Informational Meeting
US Route 4 – Bridge #61 over Ottauquechee River

June 21, 2018

Hartford (Quechee) US 4 (NHS) Br. 61

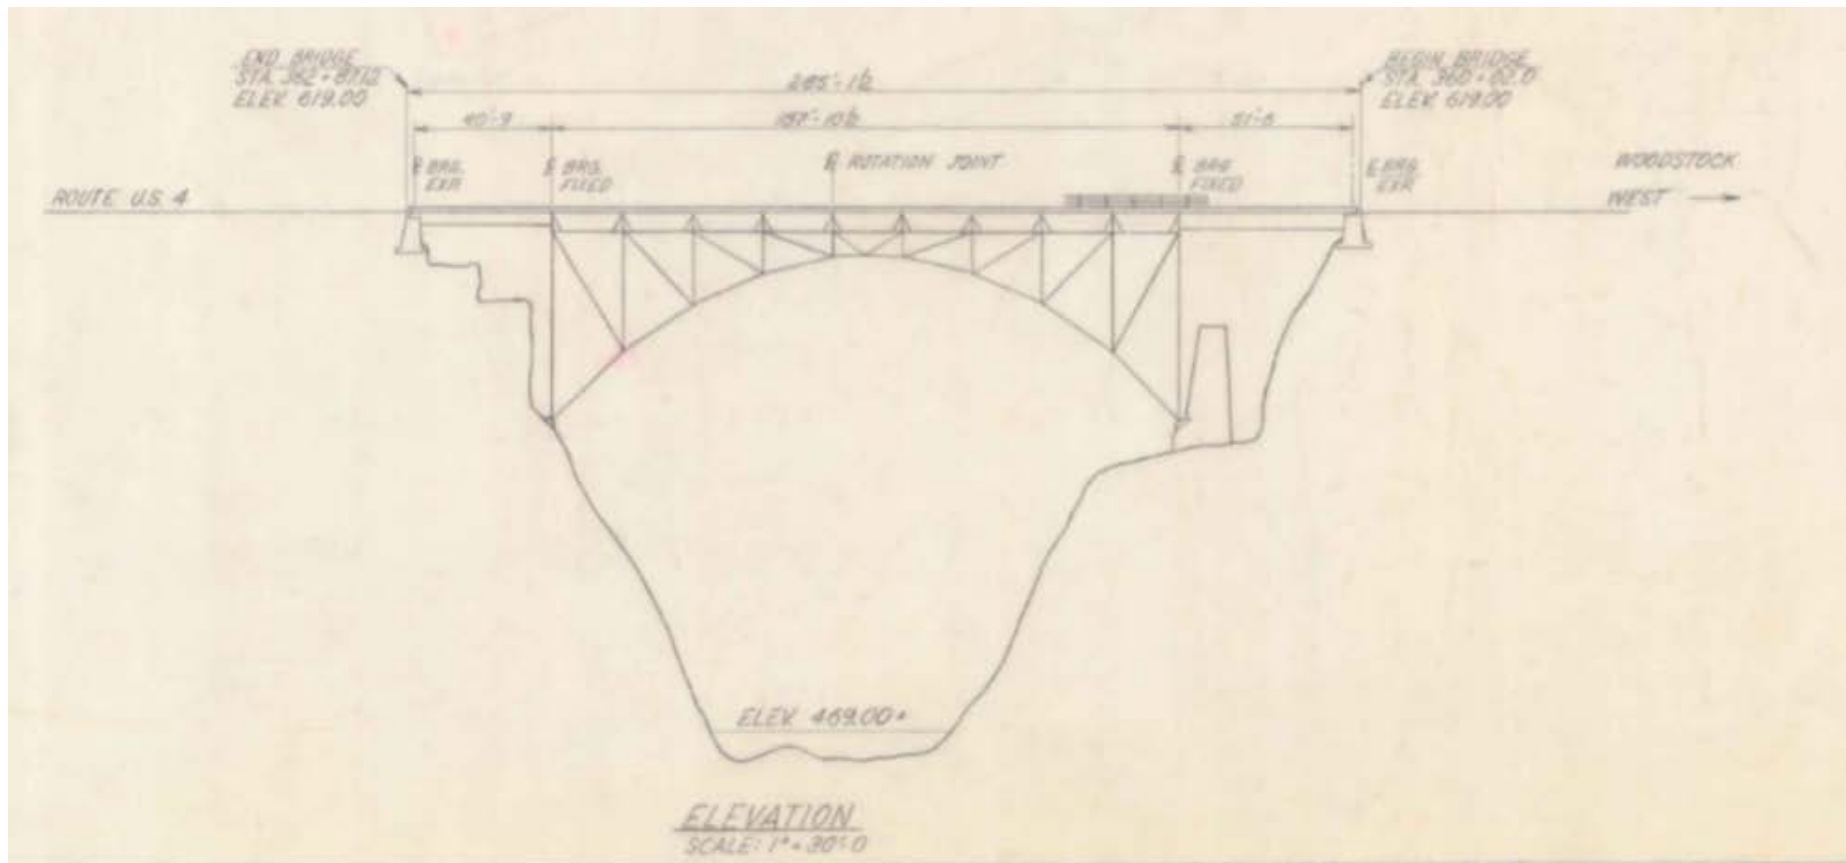
Hartford (Quechee) US 4 (NHS) Br. 61 3 Span Steel Deck Arch

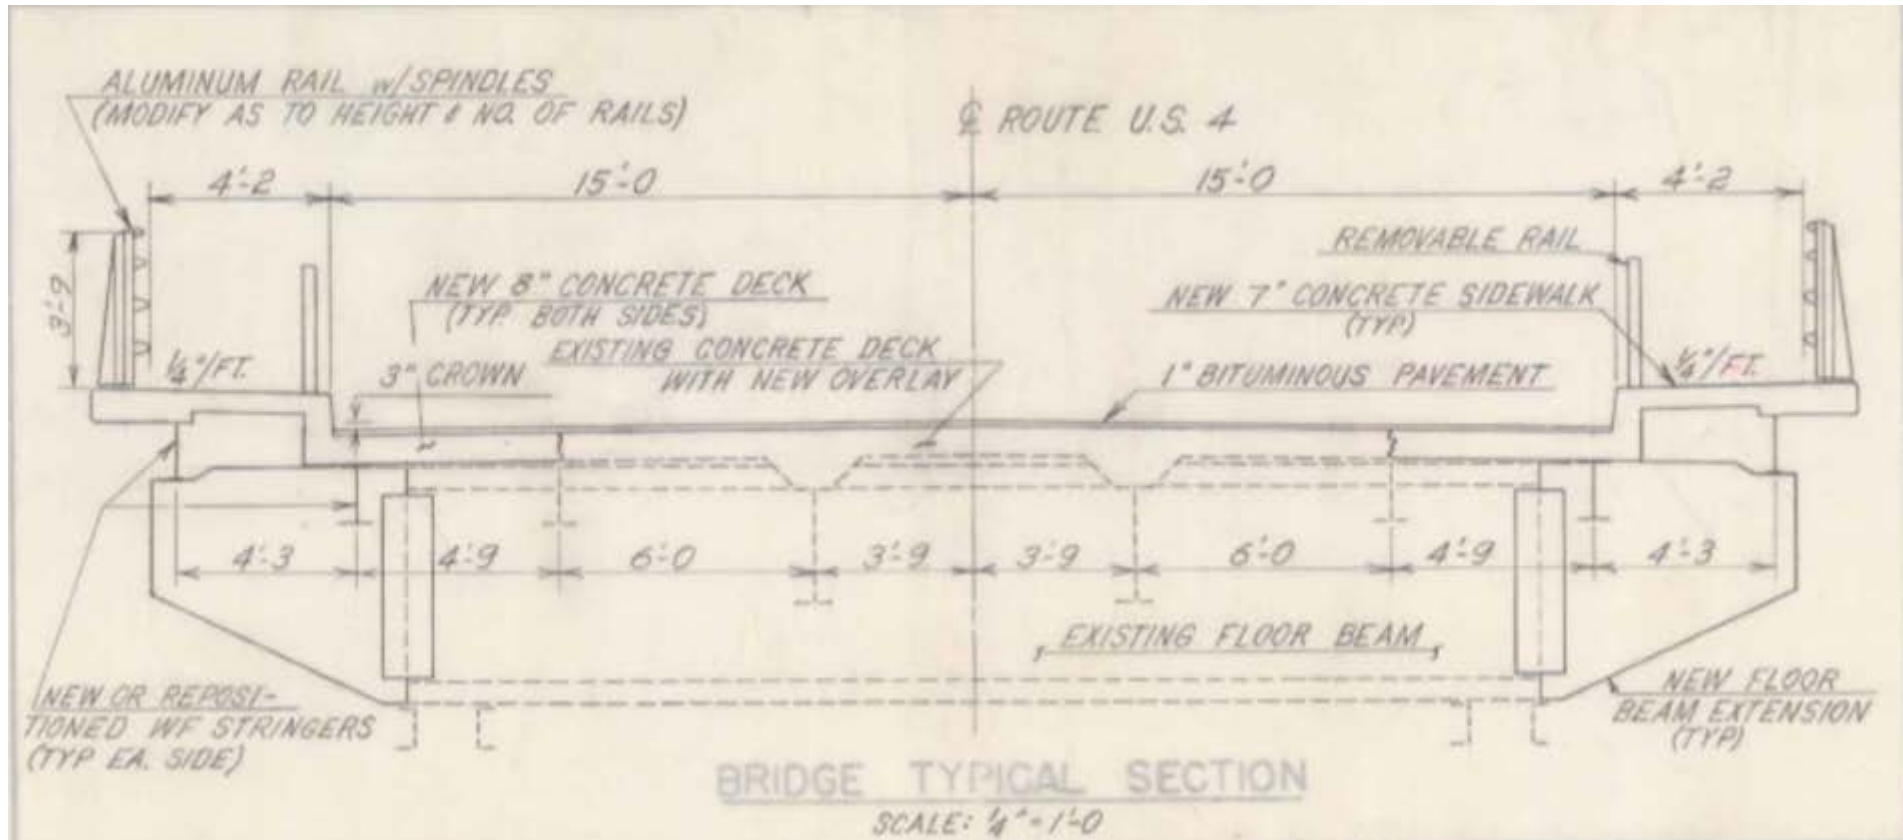
Hartford (Quechee) US 4 (NHS) Br. 61 Typical Bridge Section

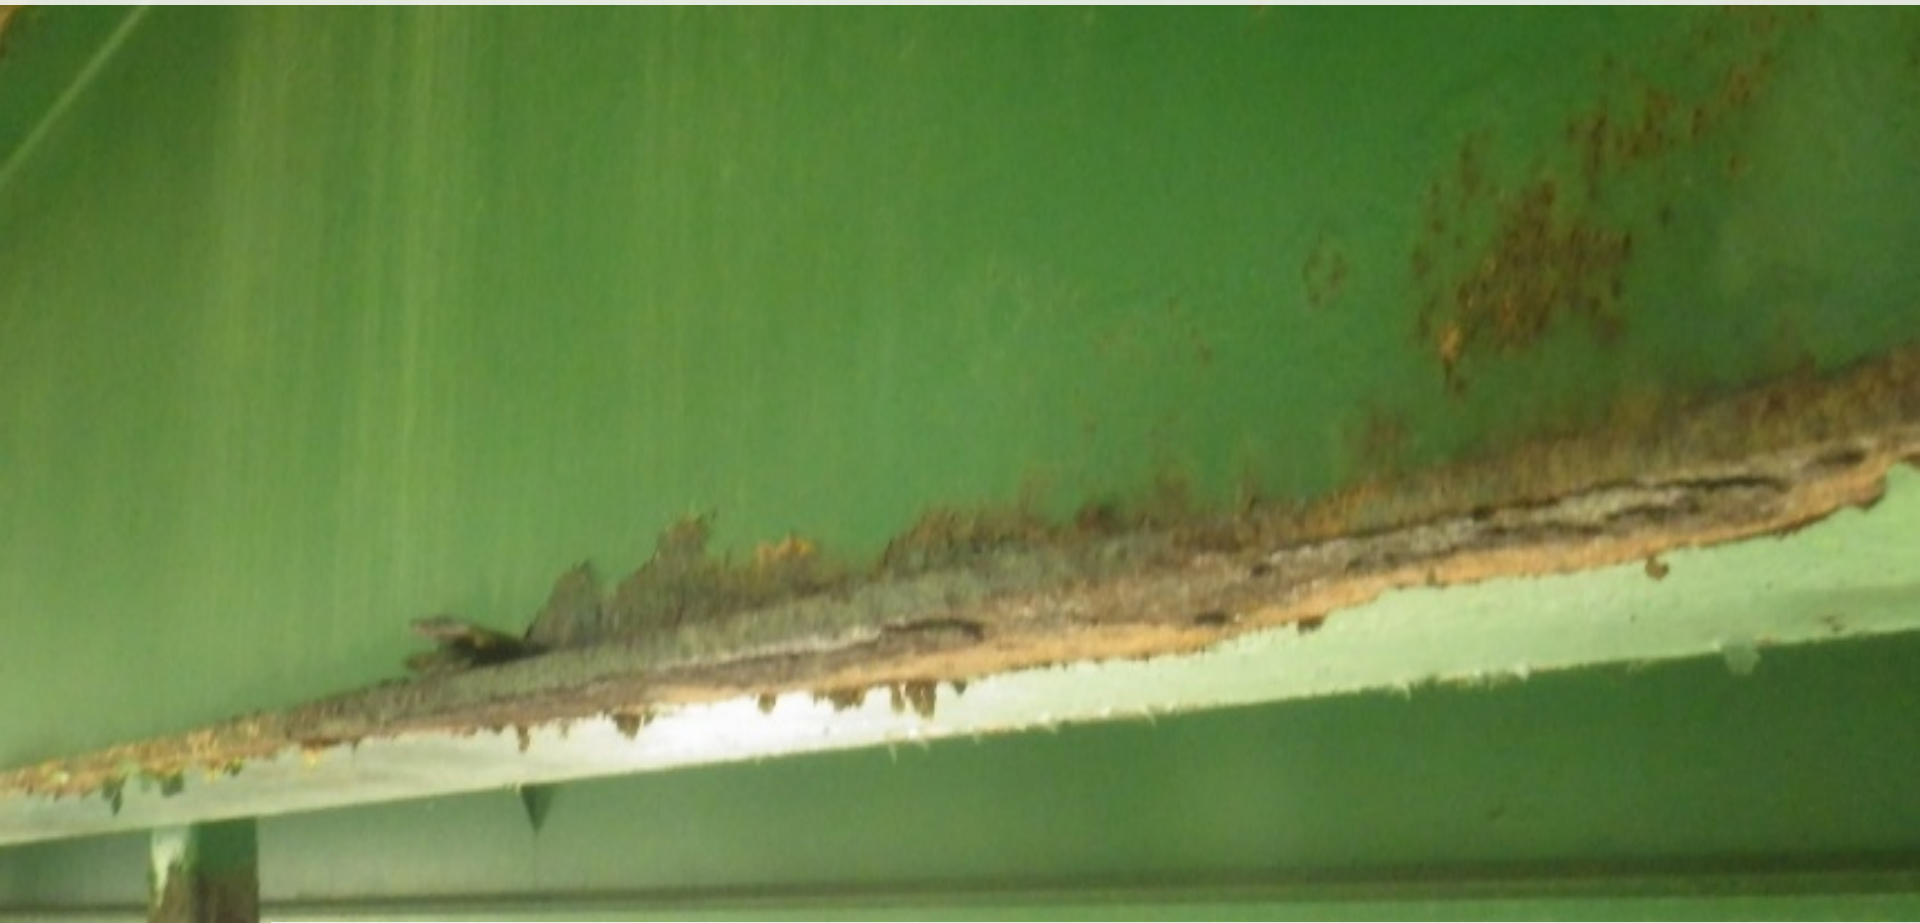
- Existing paint starting to corrode

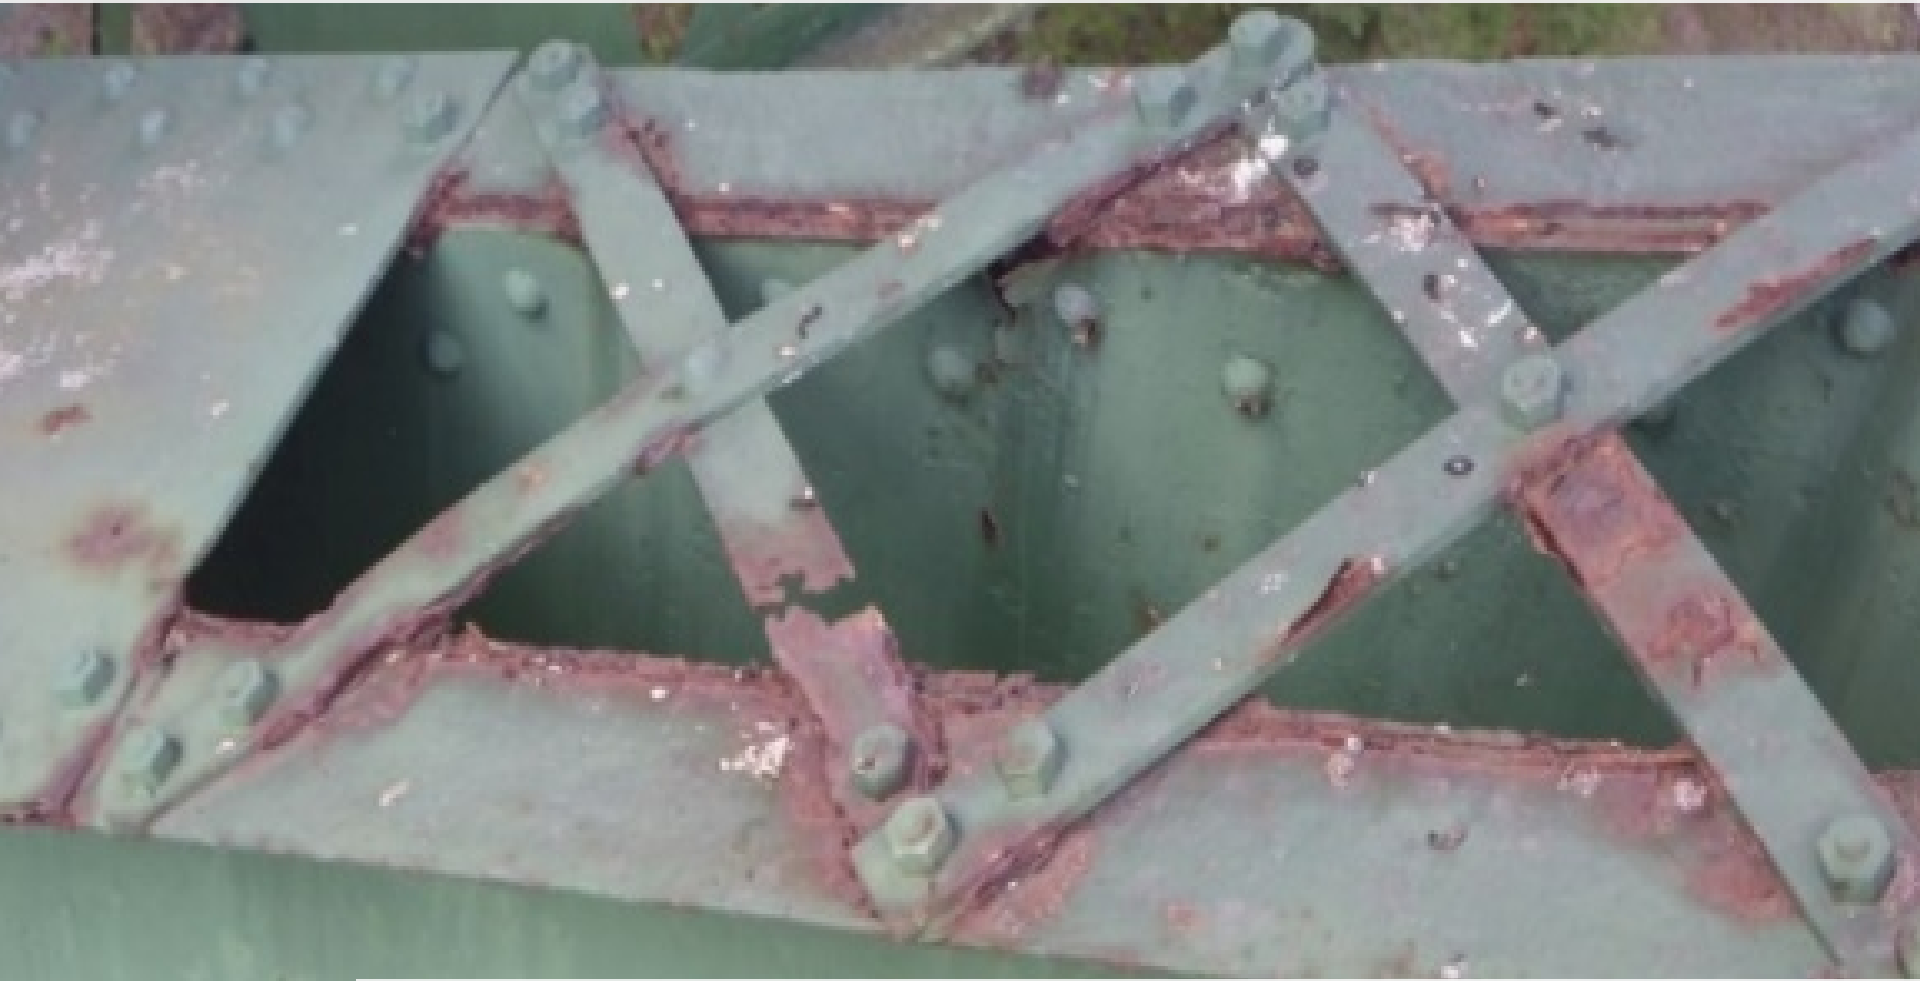
- Replace Lattice Members – increase section

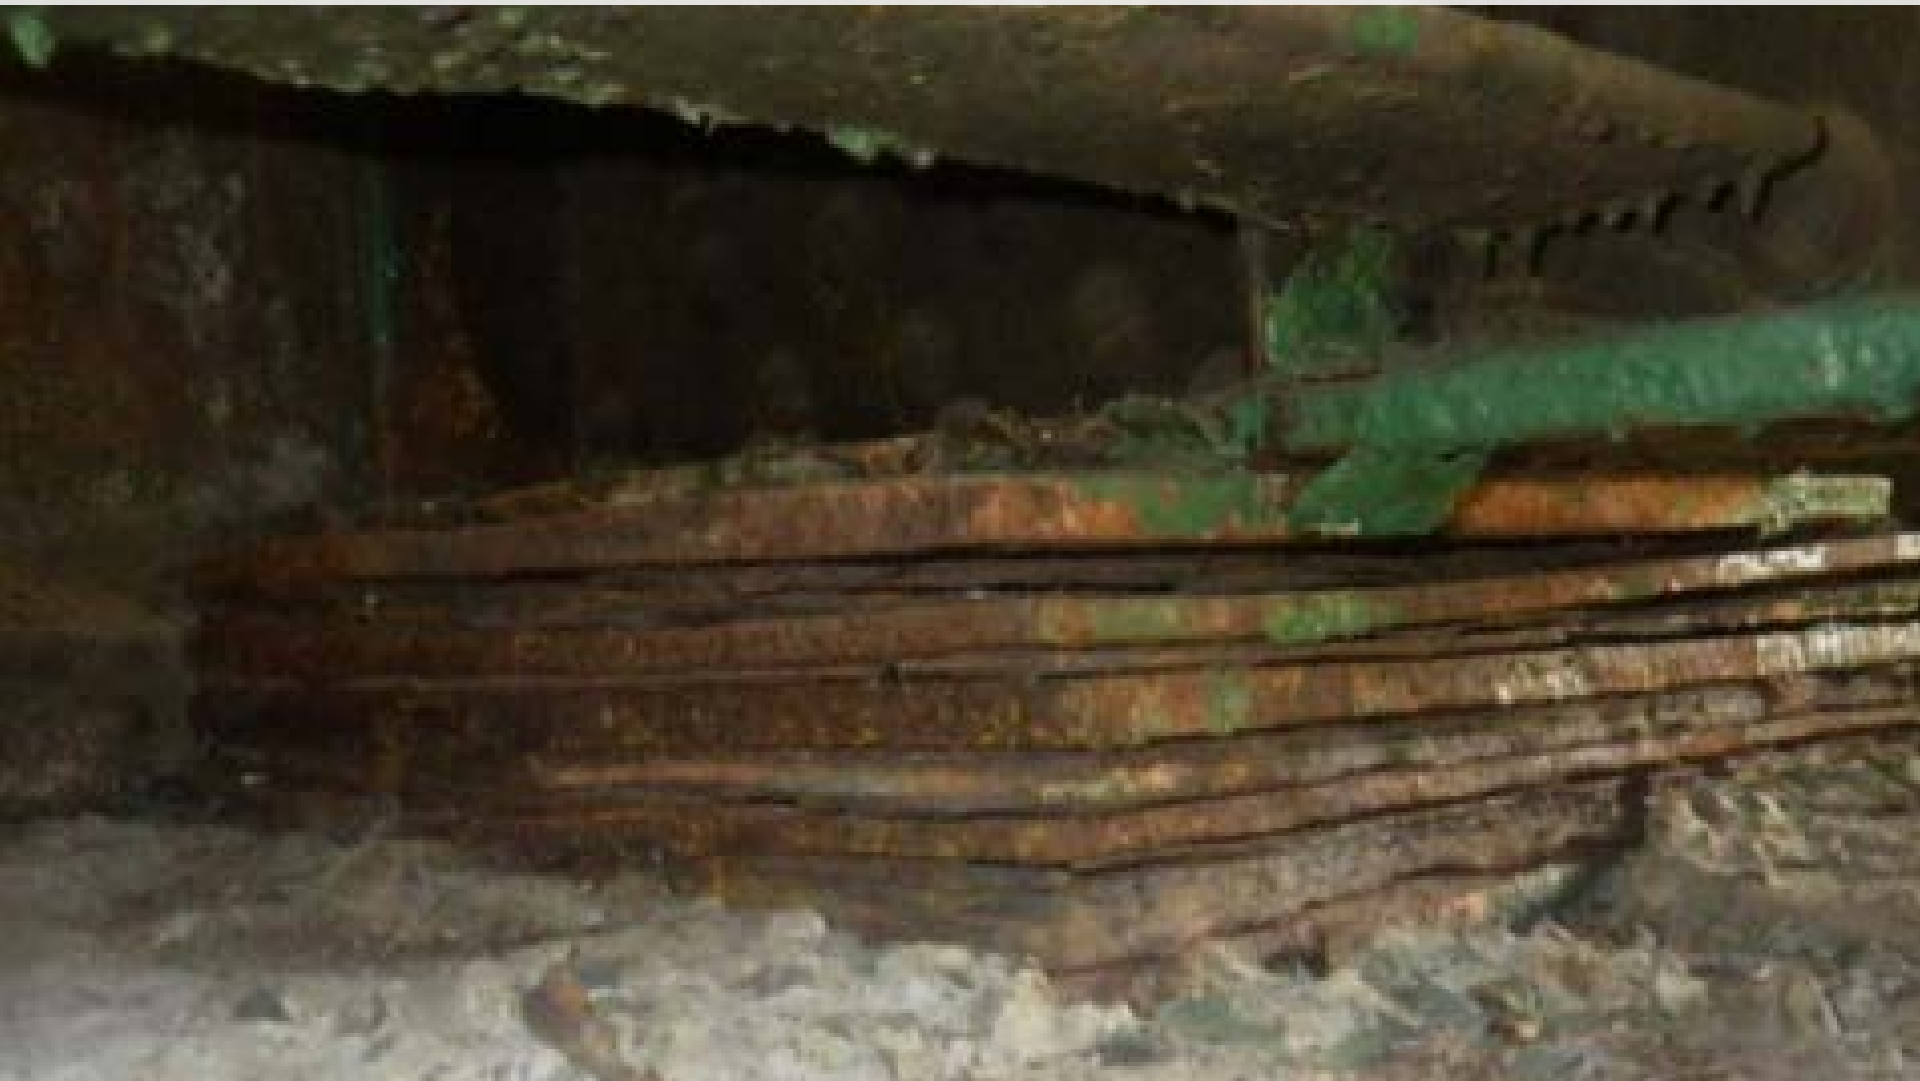
- Bearings at abutments are in poor condition

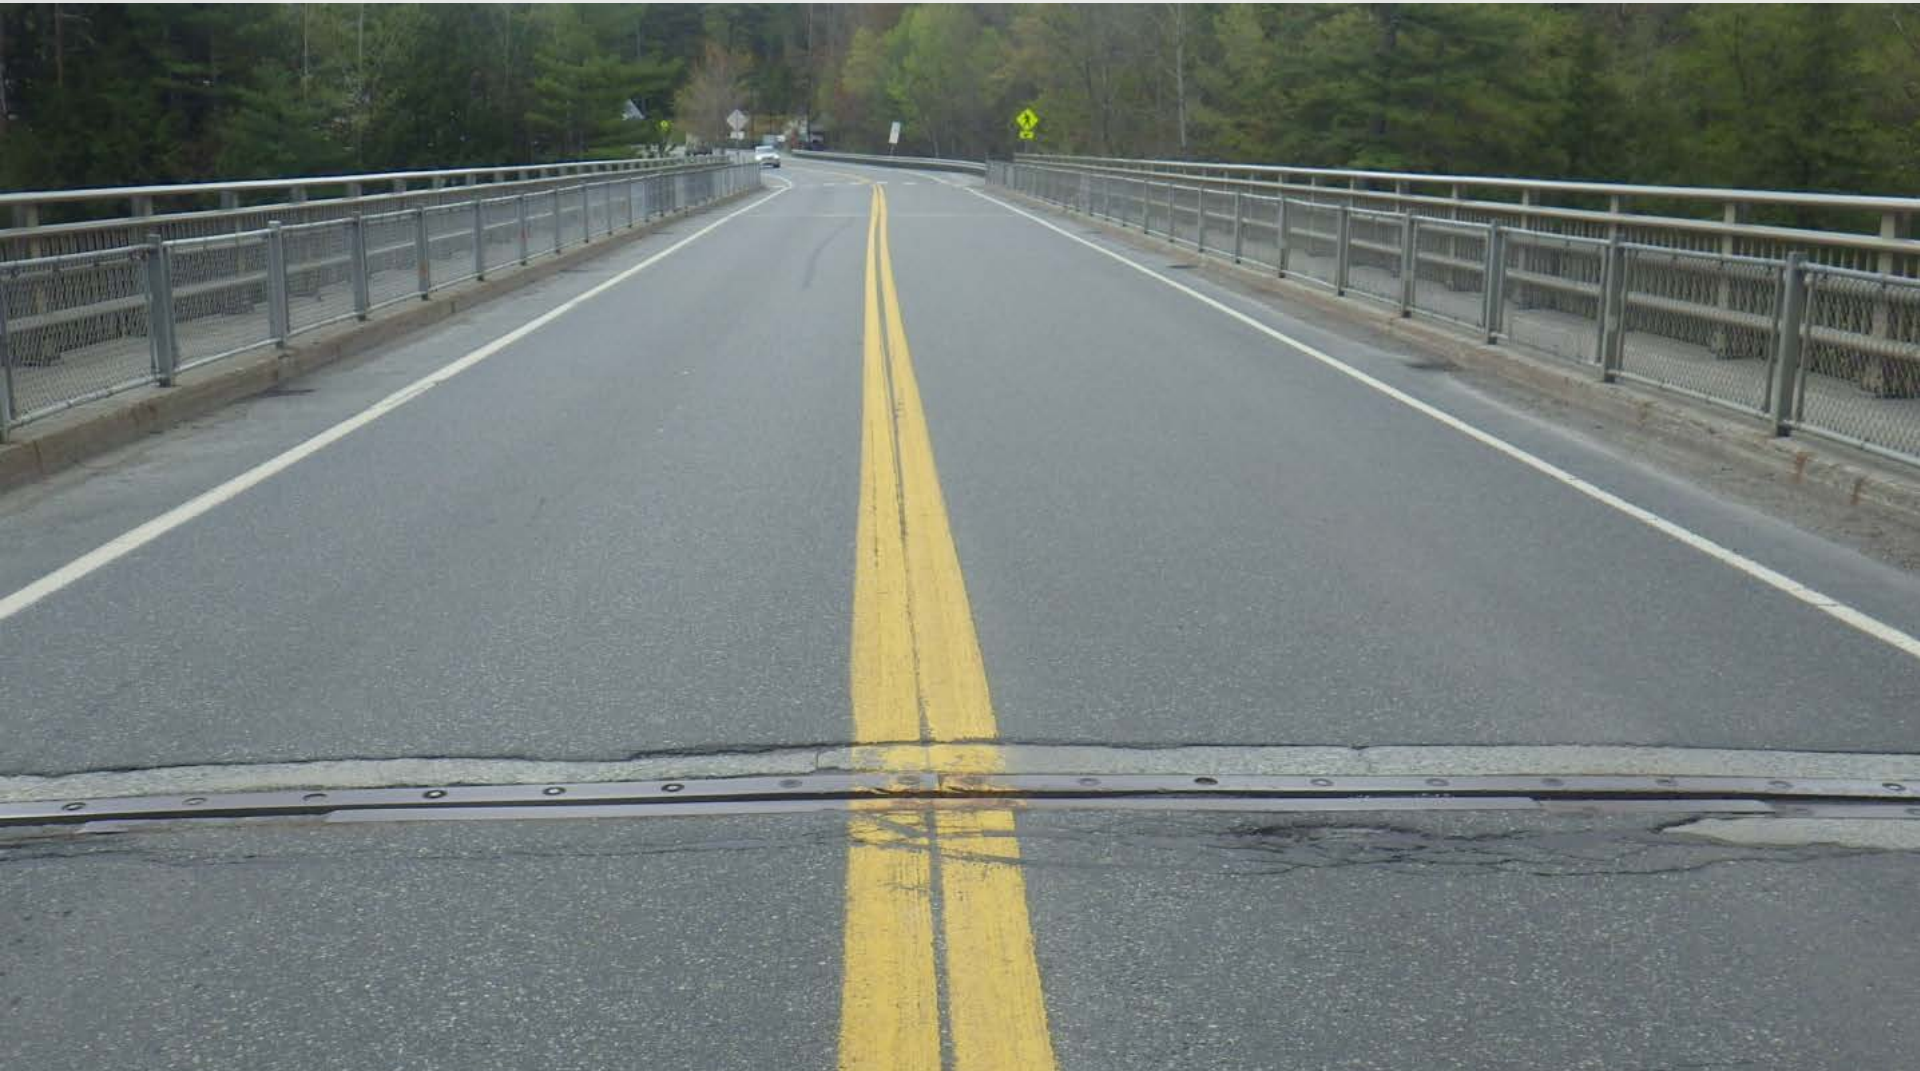
- Spray on membrane recommended for increase design life

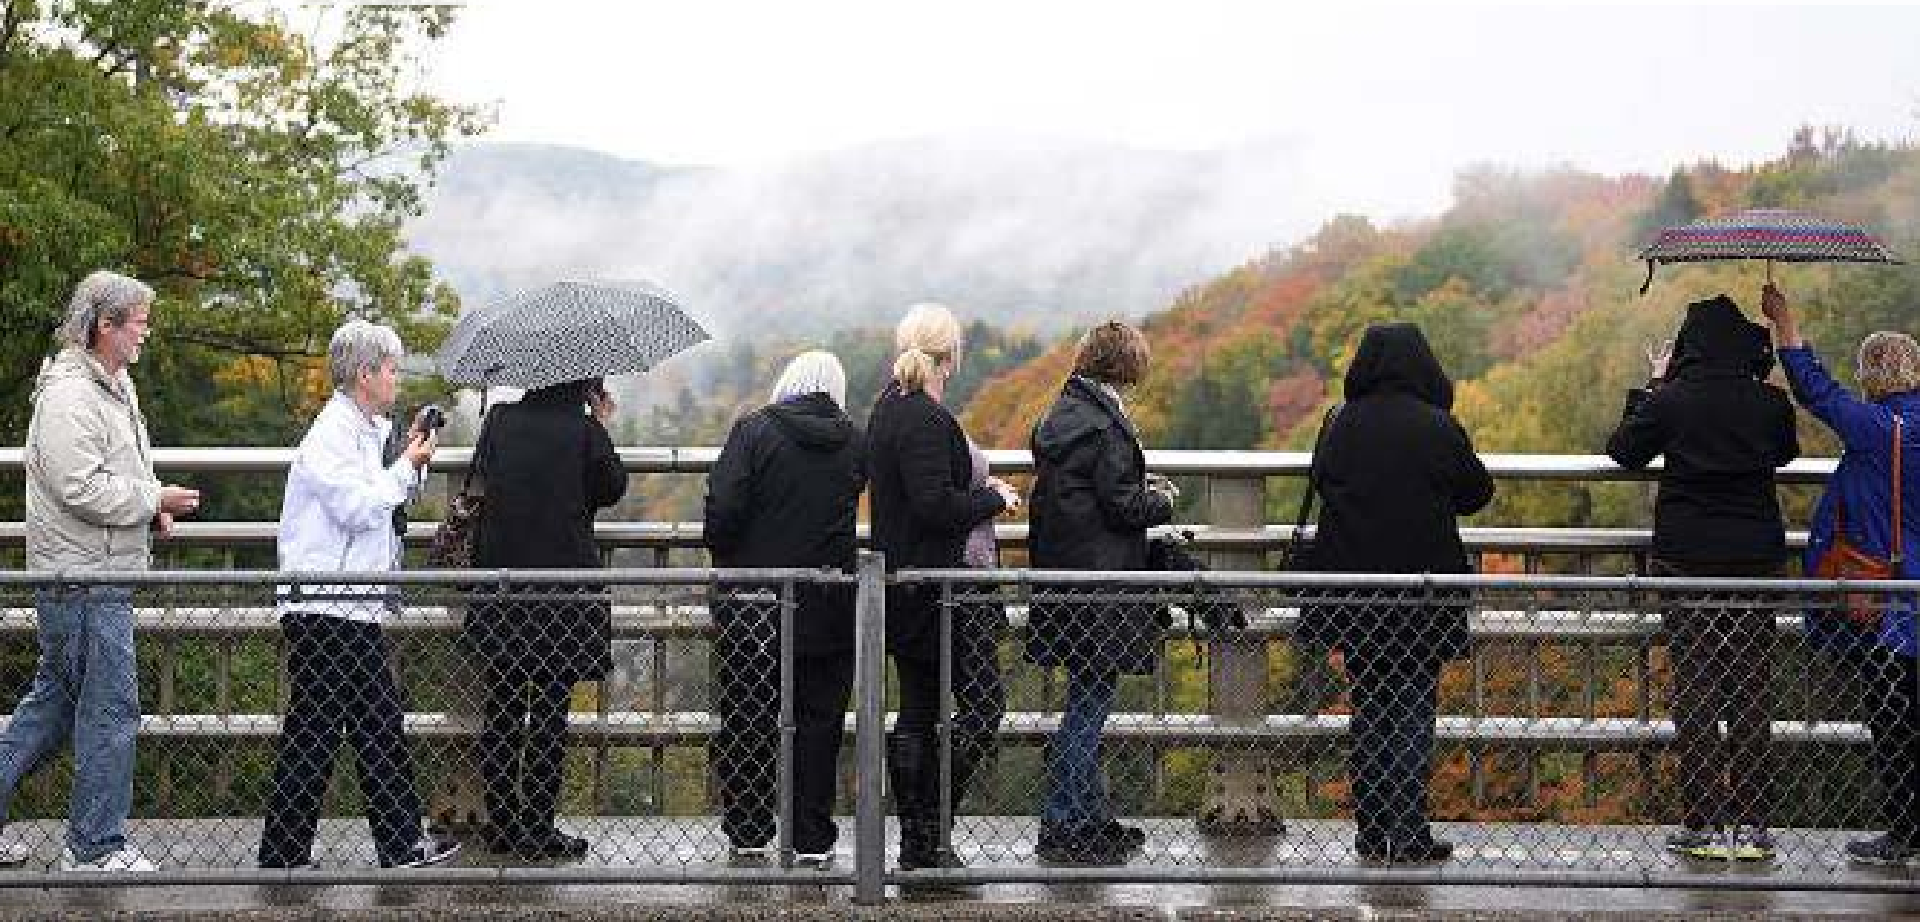
- Existing Sidewalks are 3.5' widen to 5'-0"
- Heavy pedestrian traffic
- May have impacts to 8" water main attached to northern fascia

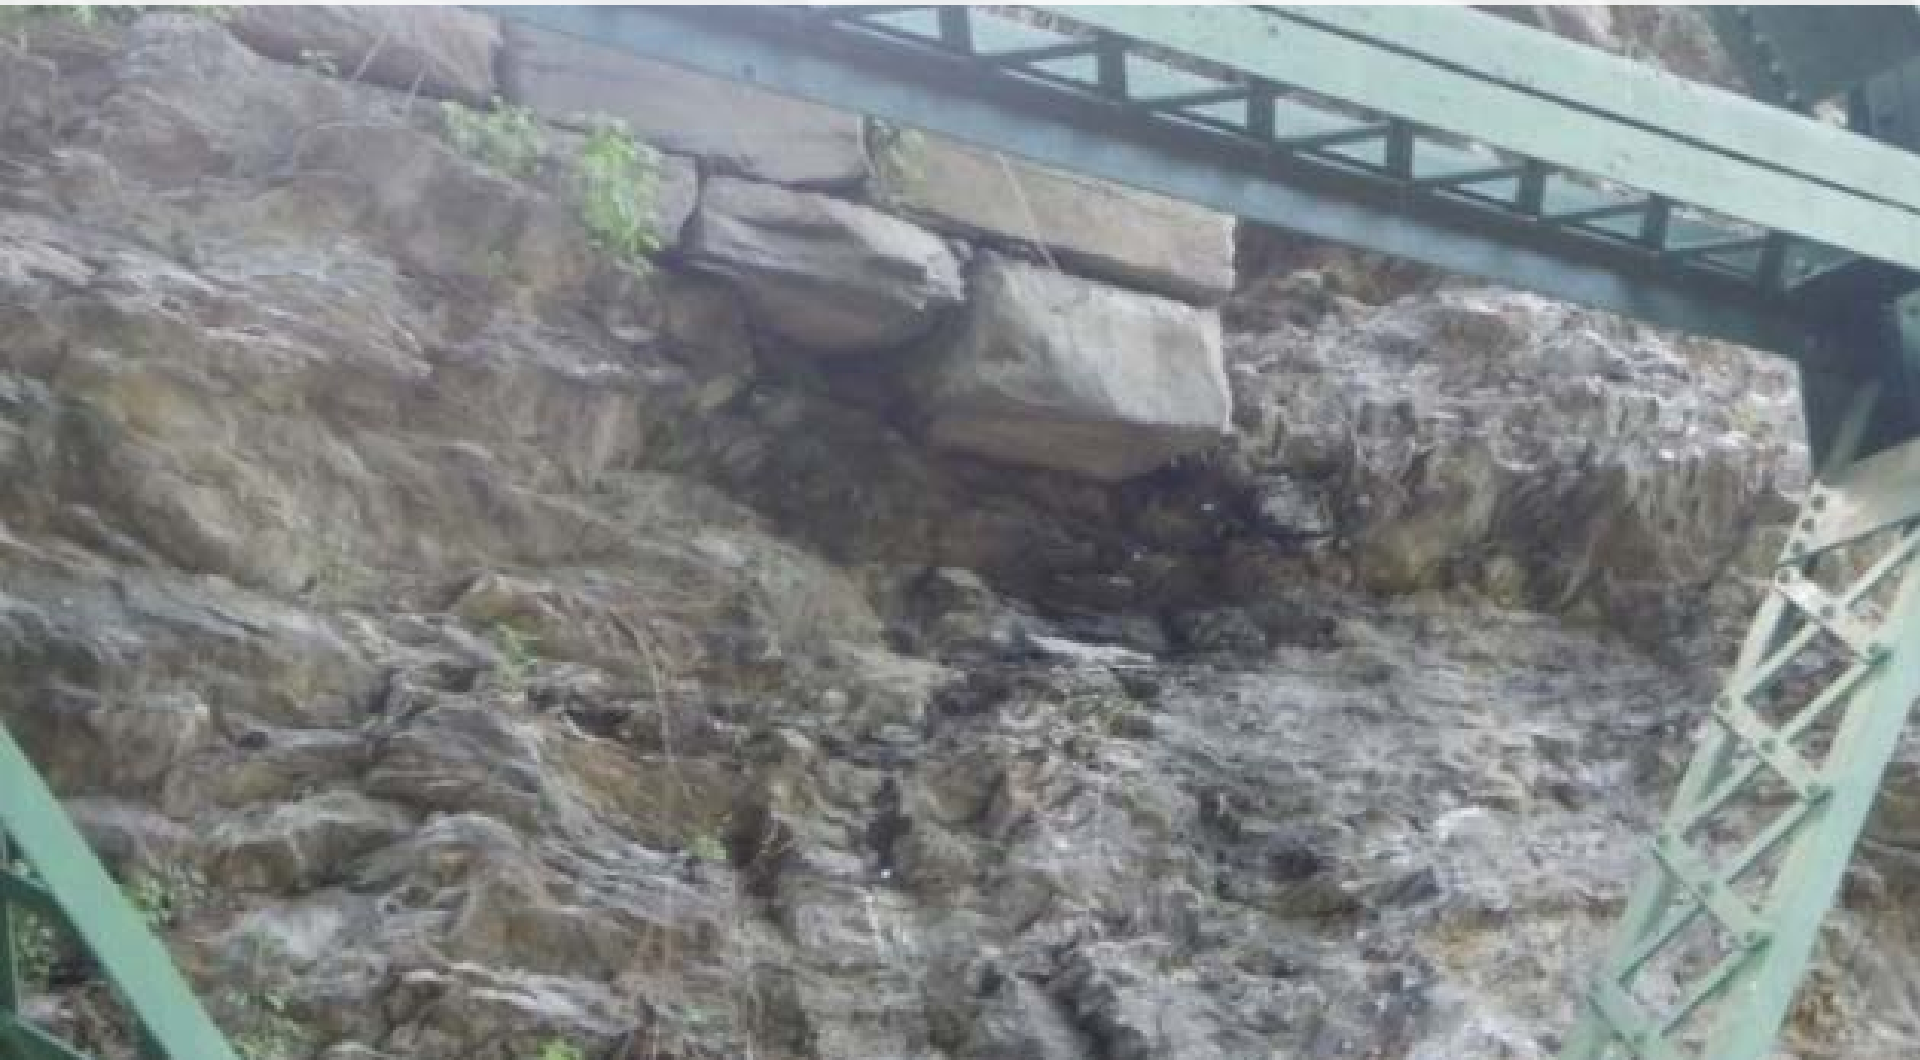
- Shale slope

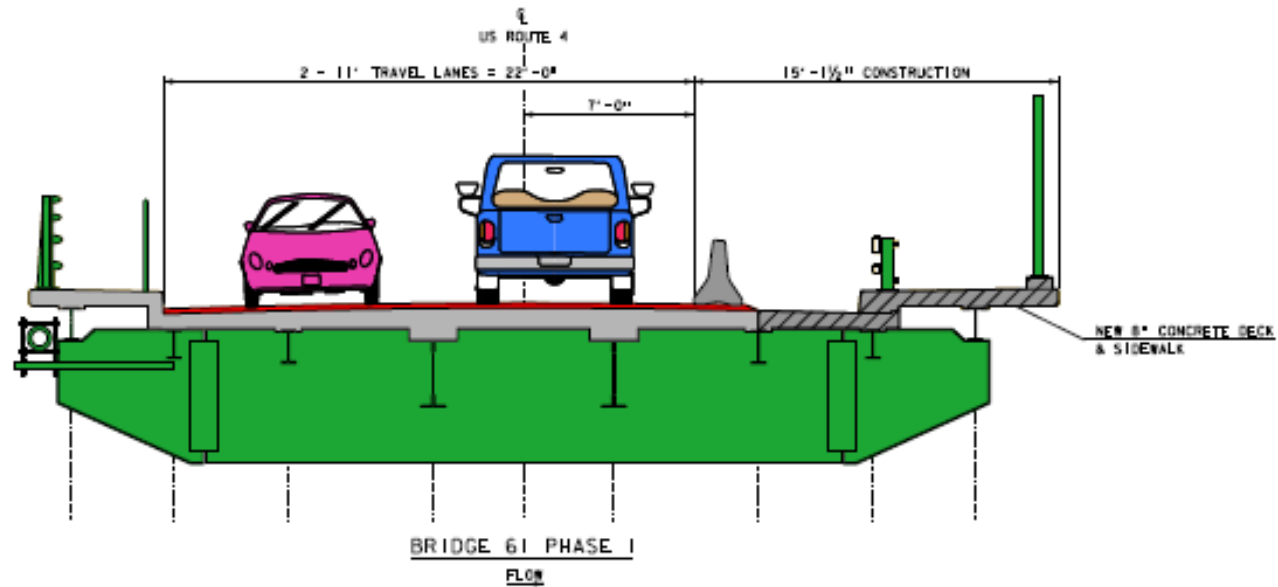
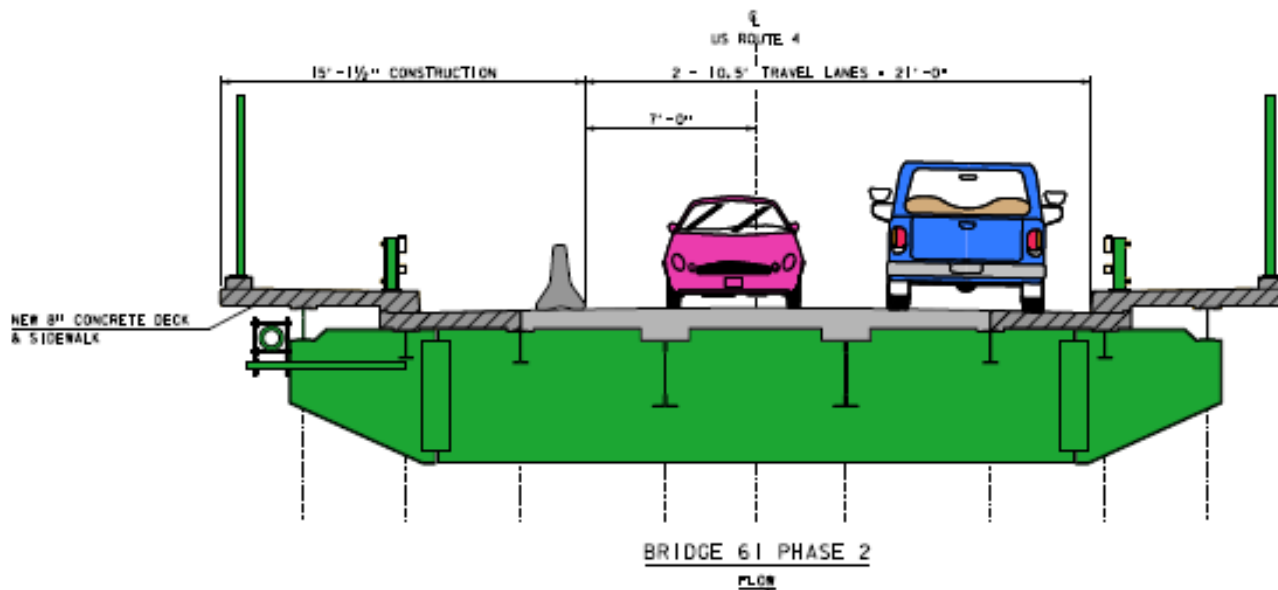
Traffic Control – Phased Construction

- **Traffic lanes reduced to two 10-foot lanes with no shoulders**

- 2 lanes needs to be maintained during peak hours to avoid queue
- Travel way reduced 10-foot lanes for a continuous 3-week period.

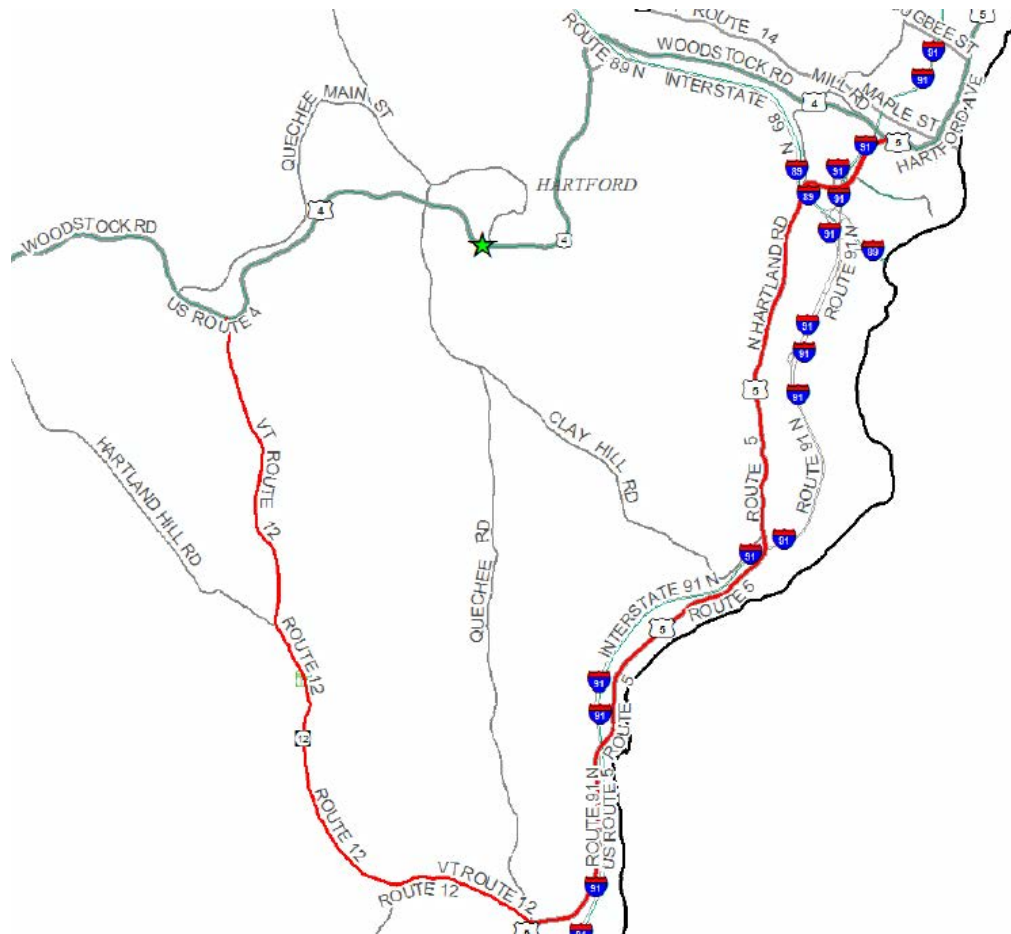
- **Regional Detour:** US Route 4, to US Route 5, and VT Route 12, back to US Route 4 (26.8 mi end-to-end)

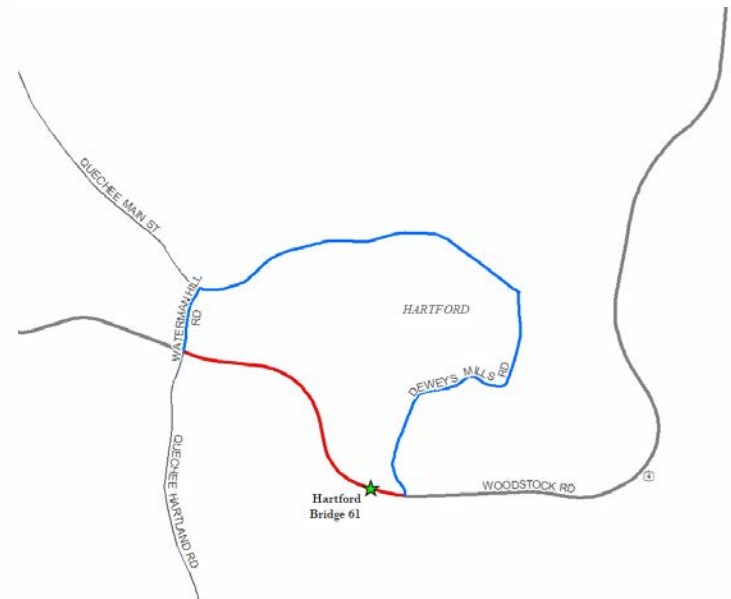
The shortest local bypass route, has an End-to-End distance of 3.0 miles

- US Route 4, to Dewey's Mills Road, Quechee Main Street, and Waterman Hill Road, back to US Route 4
