**ASSESSMENT OF TECHCRETE A CONCRETE REPAIR
MATERIAL AND JOINT SEALANT**

Report 2013 – 11

December 2013

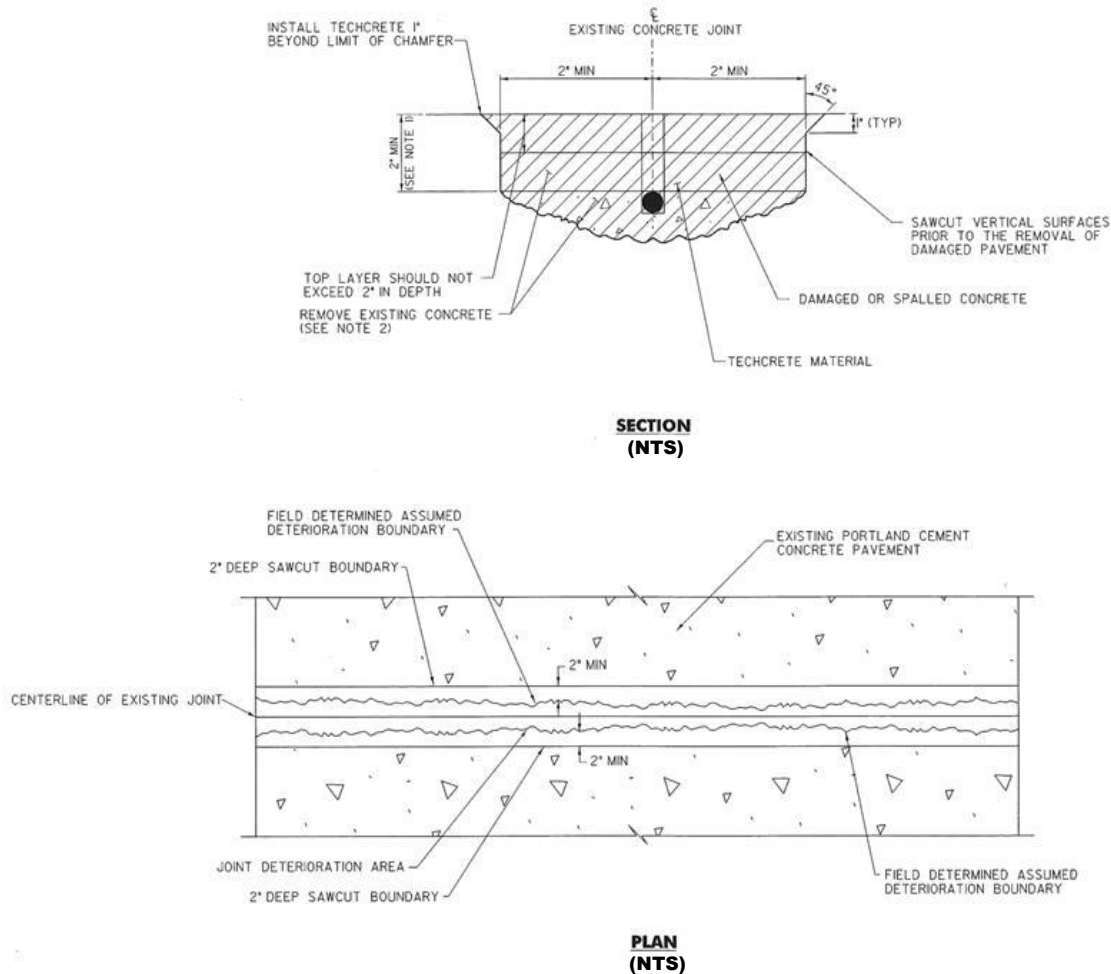
Figure 4 Typical concrete joint deterioration prior to repair

To determine which joints needed to be repaired for this project, professional judgment was employed by Project Engineers in their evaluation of the site prior to final design. An example of a selected joint in need of repair is shown in Figure 4. Per project specifications and contract, the installation of TechCrete was originally proposed to be limited to an 80-day project, with as many joints being repaired as possible in the timeframe, weather permitting. Additional days were to be added when needed to complete the necessary repairs. The time limit required a prioritization of cracks that would eventually be repaired. The 80 days was inclusive of both the Winooski and Burlington sections of concrete that needed to be repaired.

Prior to the 2008 pilot project with TechCrete, the concrete repair of 2002 had deteriorated significantly; with lengths of the concrete joint repair being fragmented. Figure 4 in this report gives an example of the state of that repair. Over the years since the repair, Winooski used asphalt patching material to seal the joints in places. In comparison, TechCrete has maintained a monolithic longitudinal integrity, and has maintained its position within the joint.

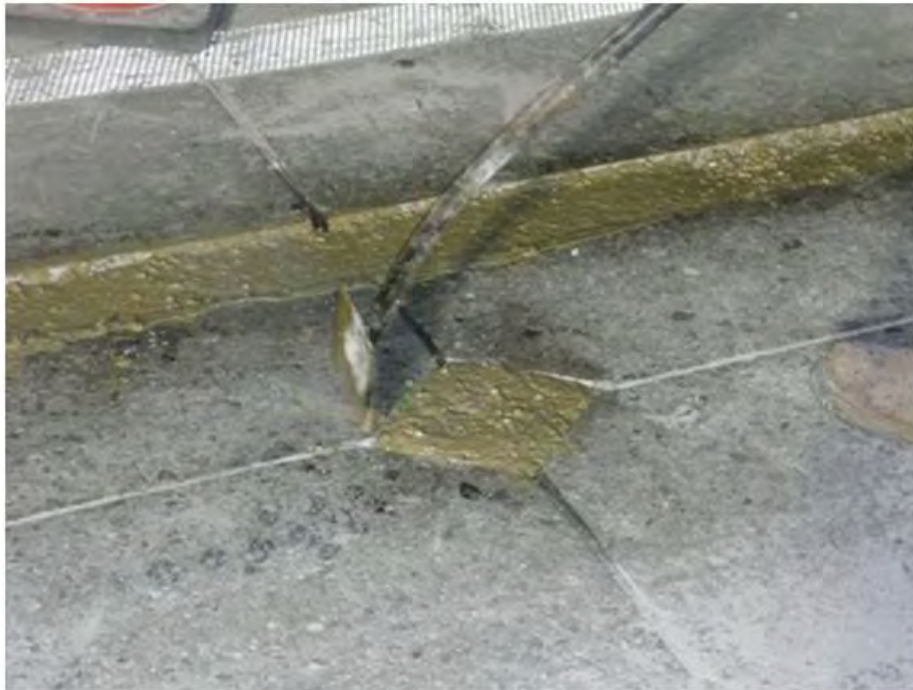
Figure 9 Hot iron used during TechCrete placement for leveling

repairs being necessary. The Burlington repairs occurred between August 30, 2009 and September 18, 2009. Research was onsite on one of the final days of production, September 16. Processes and installation methodologies appeared to be identical with little, if any, change or improvement. An image from the installation, along with the hot iron described in previous sections is shown in Figure 9.

After the completion of the installations, no joint repairs were noted as being in serious need of further repair, unlike what happened with Winooski. Even on the steepest grade (2.92%) on ramp “C” (albeit, not as steep of a grade as Winooski) there was little or no evidence of the same flowing patterns.
