INVESTIGATION OF ALKALI- SILICA-REACTIVITY IN PORTLAND CEMENT CONCRETE

PHASE II – SELECT VERMONT STRUCTURES

**Vermont Agency of
Transportation
Research, Development and
Technology Transfer Project**

DECEMBER 2008

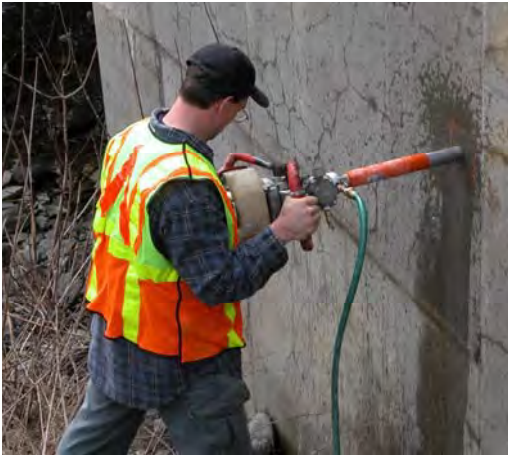
Vertical surfaces were generally selected for coring as depicted in Figure 2. Because of poor access to some curbs, horizontal surfaces were also cored, Figure 3.

Figure 2 Coring vertical surface. Figure 3 Coring horizontal surface.

After the cores were extracted, labeled and tagged, the holes were filled using a VTrans approved concrete repair material.
