VERMONT AGENCY OF TRANSPORTATION

**Research and Development Section
Research Report**

**COLD IN-PLACE RECYCLED BITUMINOUS PAVEMENT
DORSET-DANBY, VT**

Report 2015 – 04

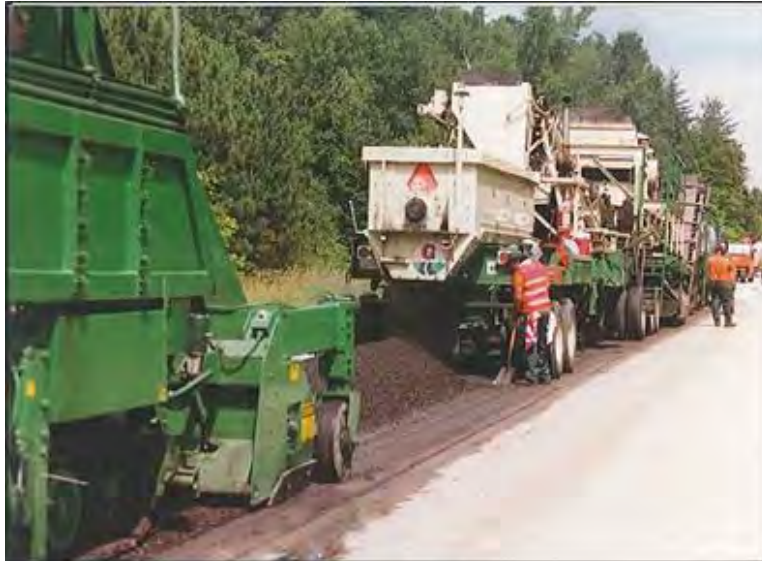
Cold-in-place recycling, shown in Figure 2, was performed during October 2006 and completed on October 10, to depths of 3 inches and 4 inches in four locations of the project. Asphalt emulsion at a rate from 1.0-1.5 gallons per square yard was added to the mix for all CIR locations. Due to seasonal constraints and sequencing of contracts, one lift of bituminous pavement was applied to all CIR locations in an effort to protect the treatment over winter months. A binder course was applied to two segments while the remaining two segments received only a wearing course. The binder course, consisting of a 1¾-inch Type II 75 blow Marshall Mix, was applied between October 23 and October 31. As stated on the approved design, the Type II mix contained 5% of performance graded (PG) 58-34 asphalt cement along with 0.5% Wetfix 312. According to historical weather data provided by Weatherunderground.com, the average ambient air temperature for this period was 47°F with an average minimum temperature of 38.5°F. A wearing course comprised of a 1½-inch Type III 75 blow Marshall Mix was placed on the remaining two CIR sections between November 6 and November 26. Similarly, this mix contained 4.8% of a PG 58-34 asphalt cement and 0.5% Wetfix 312. The average ambient air temperature for this period was 42°F with an average minimum temperature of 38°F, which is slightly elevated due to a 60°F day on November 8, 1996. The ambient air temperatures are somewhat of a concern during paving activities as they were below the specifications for placement. In accordance with the 1990 Vermont Agency of Transportation Standard Specifications for Construction, bituminous “*courses shall not be placed when the air temperature at the paving site in the shade and away from artificial heat is*

Figure 2 CIR process

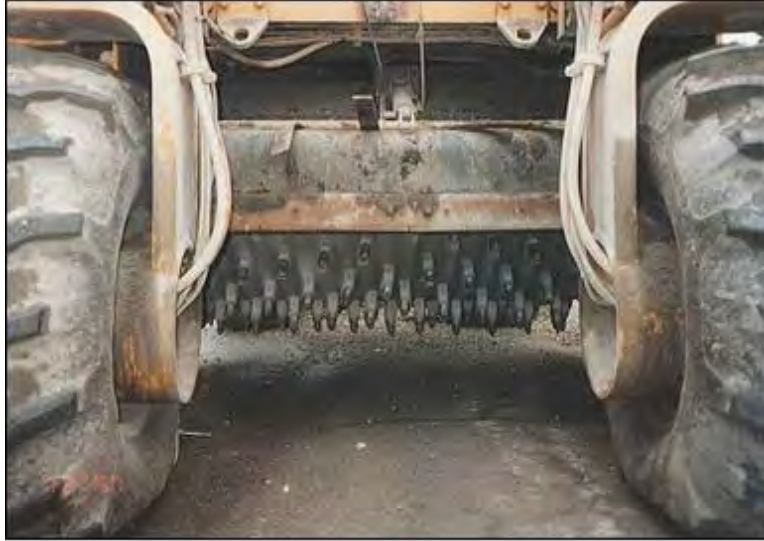
Figure 3 Reclaiming machine

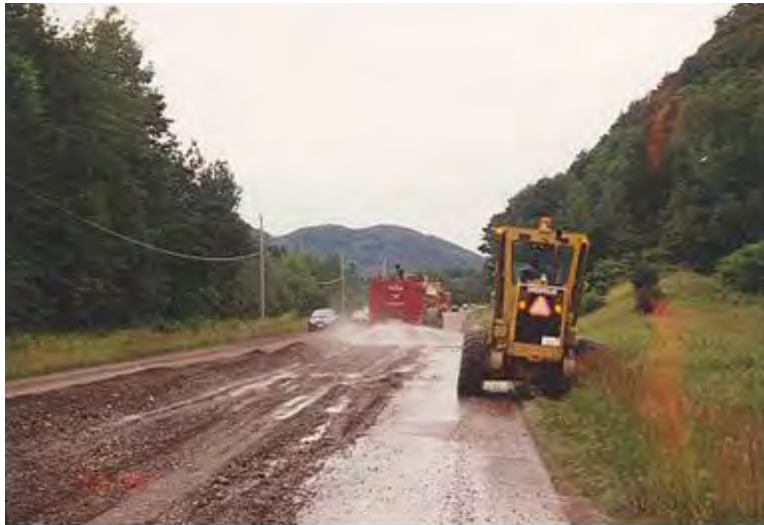
Figure 4 Water application during RSB construction

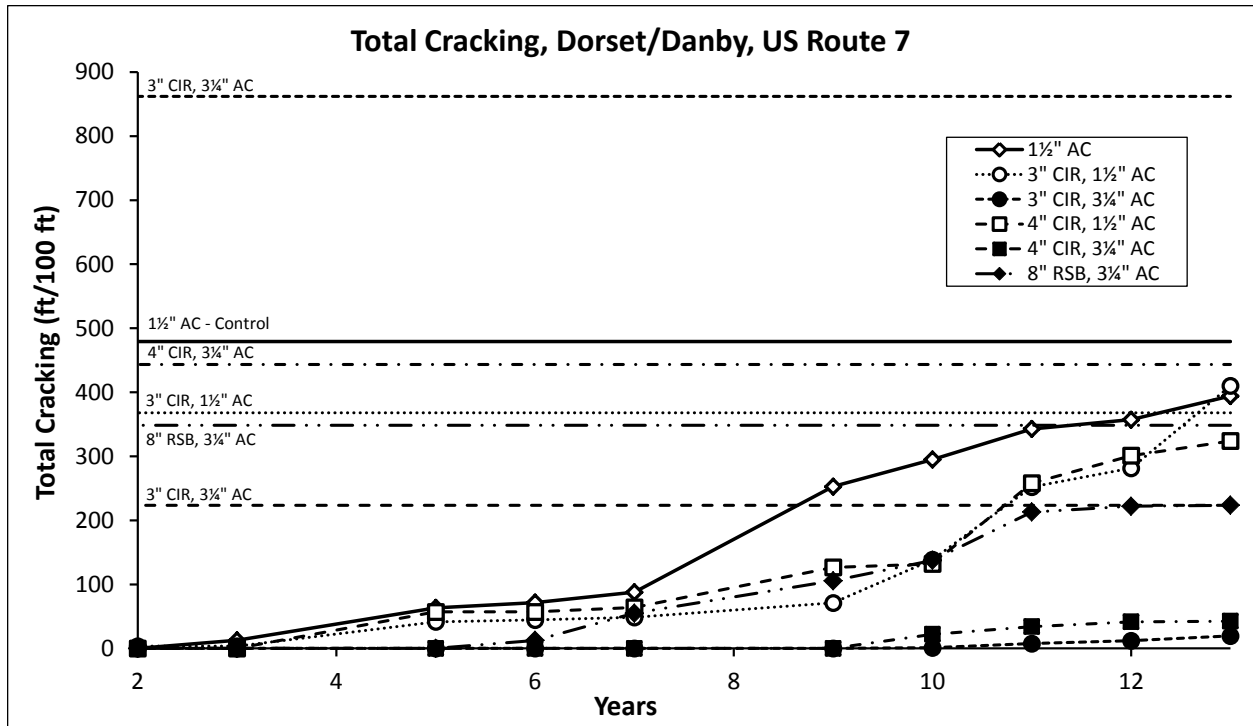
Cumulative total cracking in terms of average linear feet per treatment as a function of time is provided in Table 6 with the corresponding graphical representation in Figure 5. It is important to note that following 9 years of service, test site 11 (4-inch CIR with 1½-inch AC) was discontinued due to alligator cracking, which is indicative of deterioration and test site 13 was removed after year 12 due to the application of a shim course. All years following this were averaged amongst the remaining test sites for this treatment. For comparative purposes, the average preconstruction fatigue cracking in linear feet per treatment is also shown within the table. Through 13 years of service, only the 3-inch CIR with 1½-inch overlay has exceeded its preconstruction levels, meeting the project’s definition of failure with respect to total cracking. Both treatments utilizing the thicker ¾-inch overlay has shown only low amounts of cracking over their service life.

Figure 5 Total cracking in linear feet. Preconstruction values are shown as horizontal lines in corresponding line patterns.

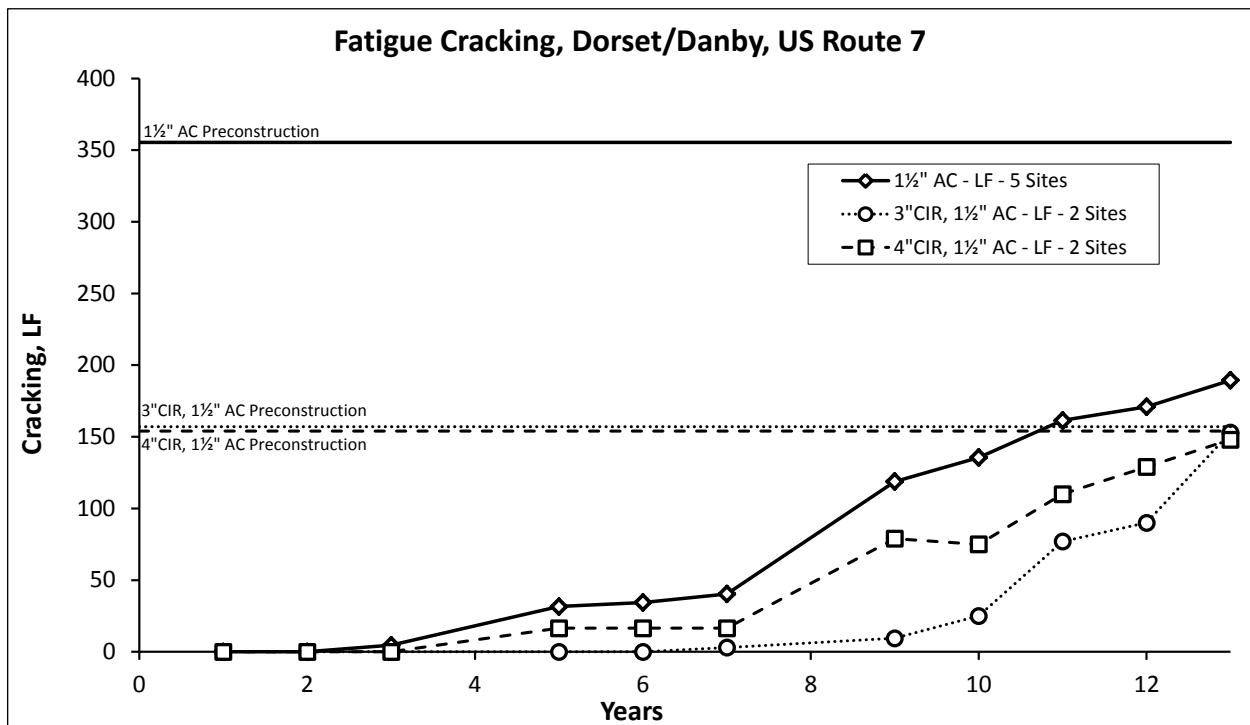
Cumulative fatigue cracking in terms of average linear feet per treatment as a function of time is provided in Figure 7. These data series consist of the averaged values of all test sites within each of the treatments. Only treatments with a substantive amount of observed fatigue cracking to date have been included. Those not included in the figure are 3-inch CIR with 3¼-inch AC, 4-inch CIR with 3¼-inch, and 8-inch RSB with 3¼-inch AC. These treatments are also excluded from subsequent cracking plots as well for identical reasons. It is important to note that after year 9, test site 11 (4-inch CIR with 1½-inch AC) was discontinued for all analyses due to alligator cracking, which is indicative of deterioration and test site 13 was removed after year 12 due to the application of a shim course. For all subsequent years, the data used were from the one remaining test site for this treatment. For comparative purposes, the average preconstruction fatigue cracking in linear feet per treatment is also shown in the figure.

Figure 7 Fatigue cracking in linear feet, averaged for all test sites in that treatment. Preconstruction values are shown as dashed lines in corresponding colors.

As expected, sections with the 1½-inch AC overlay displayed the greatest amount of fatigue cracking as opposed to the more comprehensive rehabilitation treatments. However, it is quite impressive that current levels of fatigue cracking across all test sites have yet to meet or exceed preconstruction conditions especially with respect to the overlay only sections. Thirteen years following construction, only 53% of the preconstruction fatigue cracking on average has

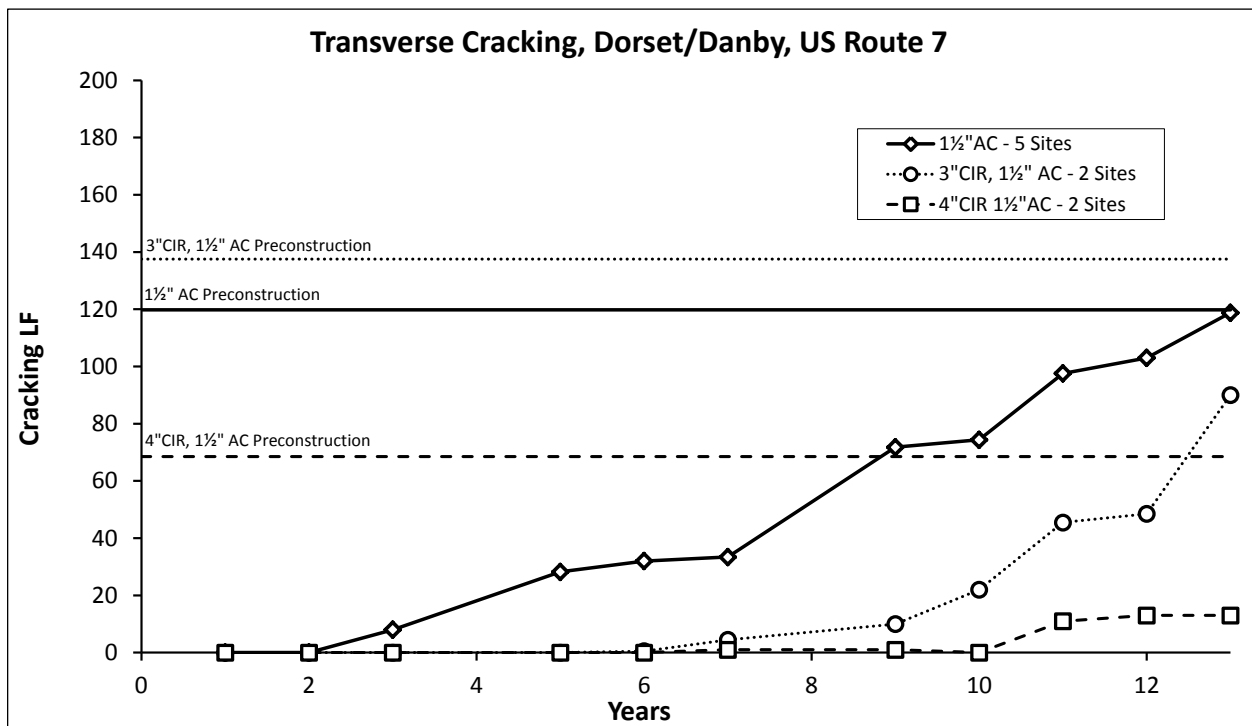
Cumulative transverse cracking in terms of average linear feet per treatment as a function of time is provided in Figure 9. Only treatments with greater than 5 feet of transverse cracking per 100-foot test section 13 years following construction have been included. These include standard overlay, 3-inch CIR with 1½-inch overlay, and 4-inch CIR with 1½-inch overlay. It is important to note that following nine years of service, test site 11 (4-inch CIR with 1½-inch AC) was discontinued due to alligator cracking, which is indicative of deterioration, and test site 13 was removed after year 12 due to the application of a shim course. All years following this were averaged among the remaining test sites for this treatment. For comparative purposes, the average preconstruction transverse cracking in linear feet per treatment is also shown.

Figure 9 Thermal cracking in linear feet. Preconstruction values are shown as dashed lines in corresponding colors.

Once again, the control sections displayed the greatest amount of transverse cracking on average (118 linear feet per 100-foot test section) as compared to all other sections. Comparatively, the other two treatments were found to have 90 and 13 linear feet of cracking for the 3 and 4-inch CIR depths, respectively, 13 years following construction. In examining Figure 9, none of the treatments have met or exceeded the amount of documented transverse cracking prior to construction. As of the summer of 2010, 99% of preconstruction transverse cracking on average had returned to the control treatment (1½-inch pavement overlay). These segments are anticipated to exceed these levels 14 years following construction. In the same timeframe, 65% of preconstruction transverse cracking has returned to the 3-inch CIR treatment with 1½-inch overlay. These segments are expected to provide a 16-year study life. Similarly, 19% of preconstruction transverse cracking had returned to the 4-inch CIR treatment and these segments are anticipated to exceed preconstruction levels around 19 years of service.

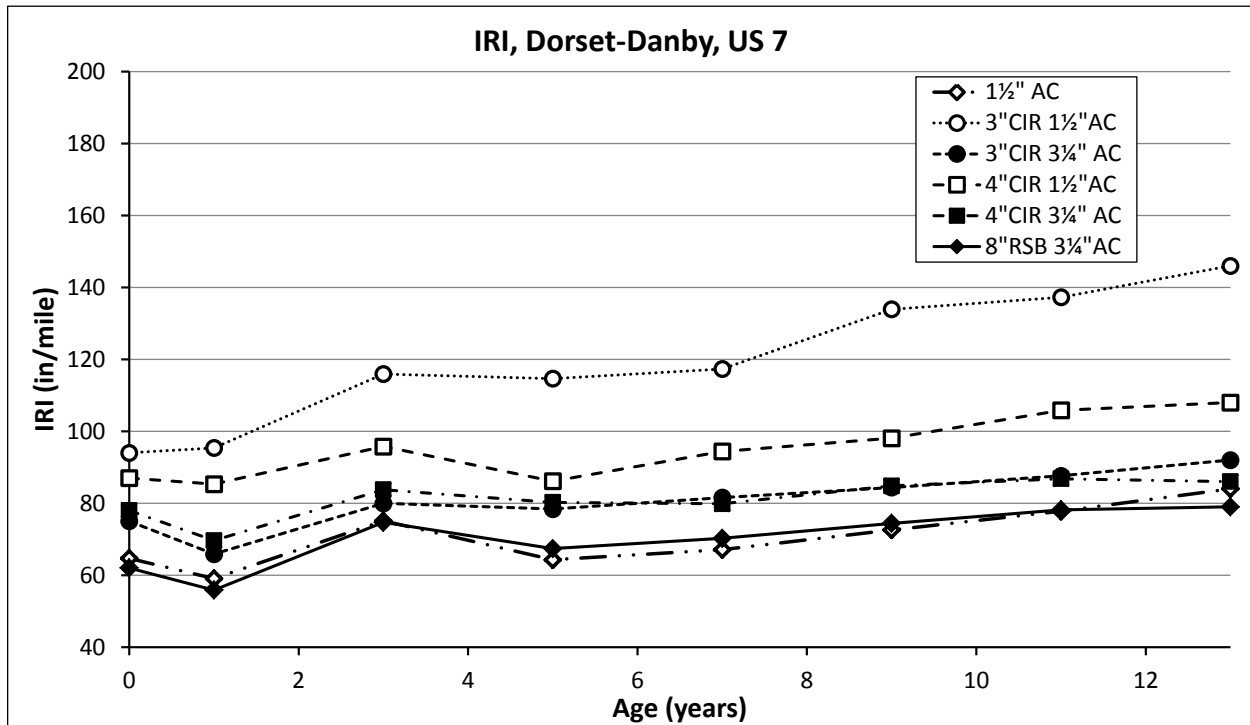
Figure 10 displays a graphical time series plot of comparative treatment performance, over time, with respect to average IRI values in terms of inches per mile.

Immediately following construction, all of the treatments were considered to be in good condition with respect to the Pavement Condition Scale. While many of the treatments remain in good condition following 13 years of service, both the 3 and 4-inch CIR with 1½-inch overlay treatments are in fair condition. Overall, IRI values for each of the six treatment types display a

mostly consistent increasing trend over time. At 13 years, the 3-inch CIR with 1½-inch overlay displays the highest IRI values as well as the largest increase in IRI over time. Surprisingly, the standard overlay appears to be outperforming the majority of the other pavement treatments. This is likely due to the condition of these roadway segments prior to construction as the associated IRI values were significantly lower than the IRI values addressed with cold recycled or reclaimed stabilized base treatments.

Figure 10 IRI plot for US 7 Dorset/Danby.

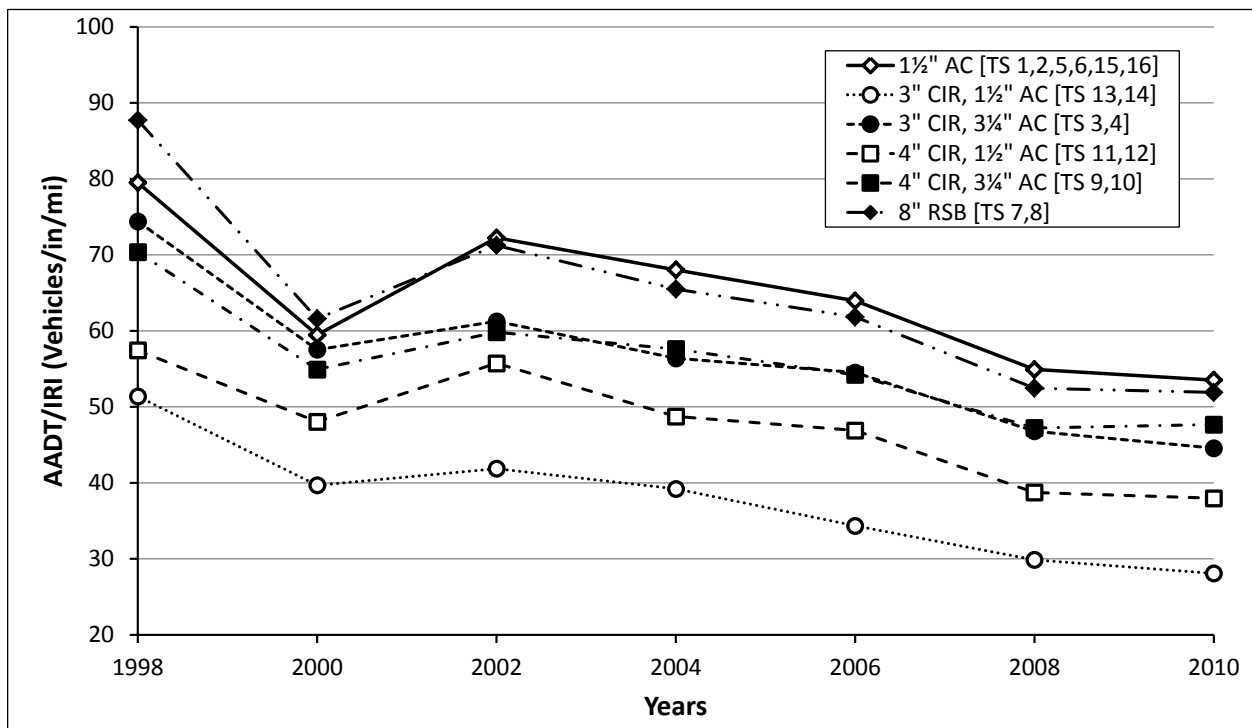
Another relationship was developed to estimate the benefit of the different treatment types with respect to the traffic characteristics (AADT) and roughness (IRI) of the roadway over time, which will be referred to as public benefit. It is a gauge of the perceived ride quality by the public in relation to the amount of daily traffic along this roadway segment. A larger value of the AADT/IRI quantity indicates a higher public benefit. Figure 11 displays the public benefit versus time for the six various treatments, using the IRI values in Table 10 and the AADT values from Table 3.

Interestingly the most and least comprehensive of the six pavement treatments, the RSB and the overlay only treatment, respectively, provide greater public benefit with respect to ride quality. The fact that the 1½-inch overlay was the optimum treatment in this analysis contradicts the previous rating system where the overlay was easily deemed the lowest quality of roadway based on cracking, rutting and IRI. This can be explained by the fact that the previous rating

system is based upon comparing current conditions to preconstruction conditions, while the public benefit displays only actual current conditions (per year). Being the least comprehensive (and cheapest) treatment, the overlay only treatment was placed on the sections of roadway that were in the best preconstruction condition, therefore this shows that this treatment type had degraded significantly over its service life as compared to its condition prior to construction (again cracking, rutting, and IRI), while still maintaining a smooth overall ride. The more comprehensive treatments, on the other hand, performed very well in both analysis methods, showing that although the driving public cannot perceive a large difference between the treatments, there is considerable long term structural and monetary benefits to a more extensively rehabilitated roadway.

Figure 11 Plot of public benefit (AADT/IRI) versus service years for all treatments.
