ASSESSMENT OF THE BDM WATERPROOFING MEMBRANE SYSTEM

Experimental Feature
Reporting on Work Plan 2011-R-06

Final Report 2019-07

The BDM system was used on one bridge replacement project, Warren ER-STP 013-4(36), bridge number 165 on VT 100 in the town of Warren, 50 feet north of the Warren and Granville town line (Figure 1). The bridge was produced under rapid construction techniques. The bridge is 21 feet long by 34 feet wide and has a reported average annual daily traffic (AADT) of 980.

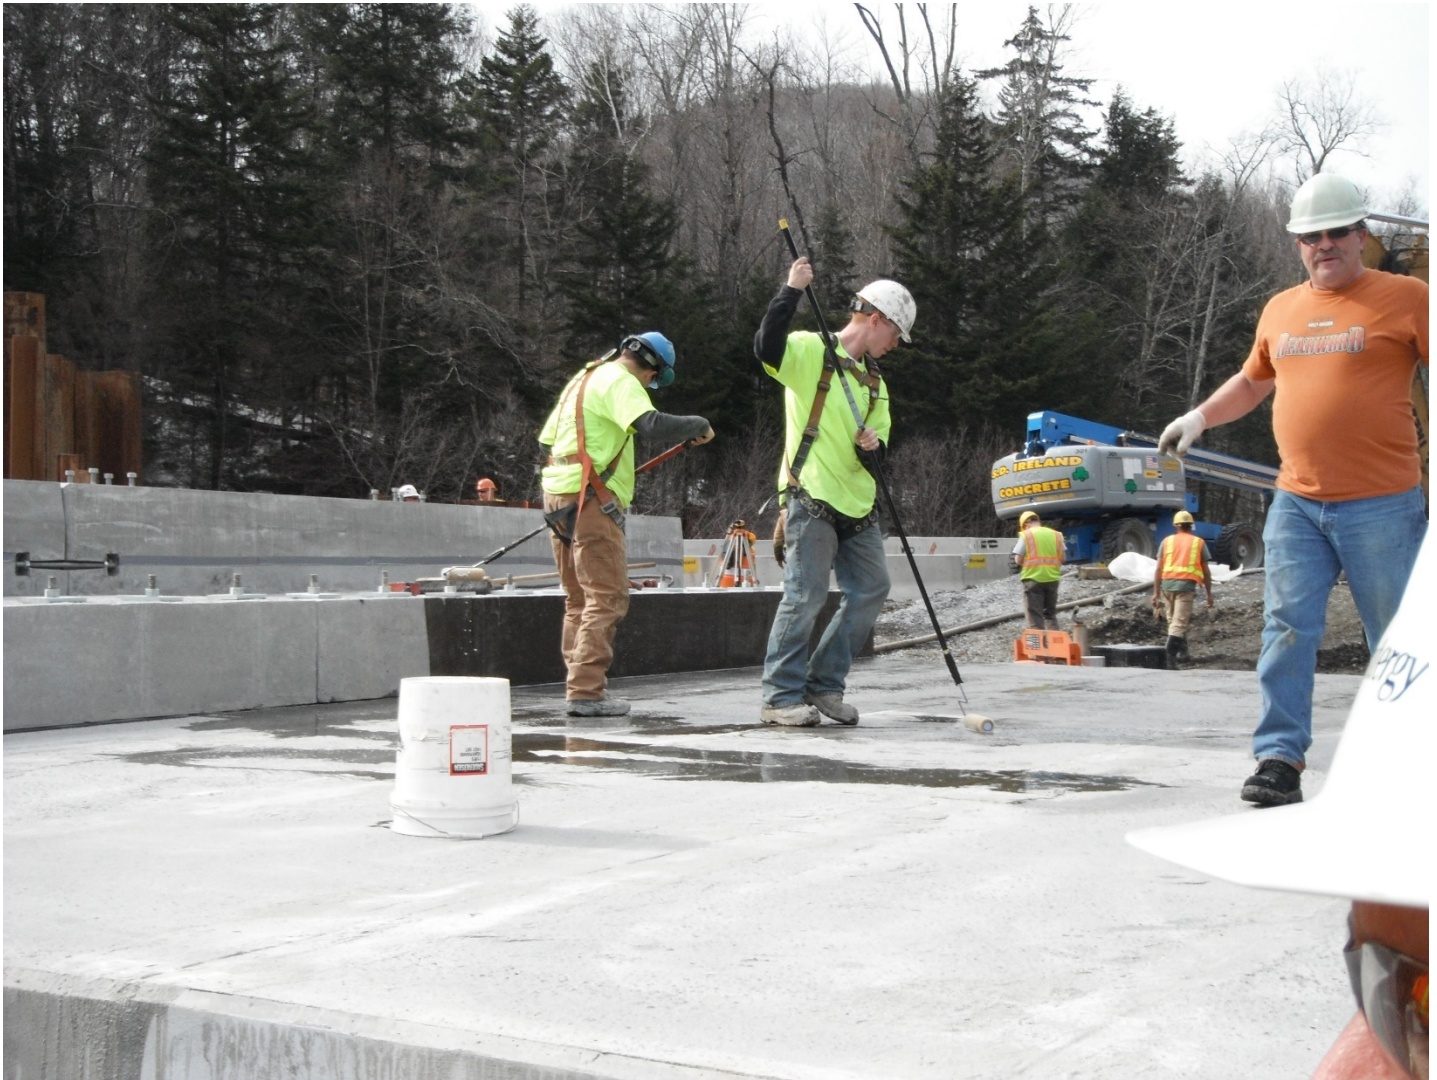
Figure 2: Installation of the BDM system, application of the primer (March 12, 2012)

On the day of membrane application, the surfaces which it was to be applied to were shot blasted and cleaned thoroughly. Foam backer rods were wedged into any open joints. The primer was rolled on all surfaces (Figure 2), followed by the membrane application. The membrane was sprayed onto all surfaces, using a mechanized spraying apparatus in a truck, hoses, and nozzles (Figure 3). The membrane is bright orange in color, which makes it easier to observe if all surfaces have been covered to a uniform nominal 80 mil thickness.

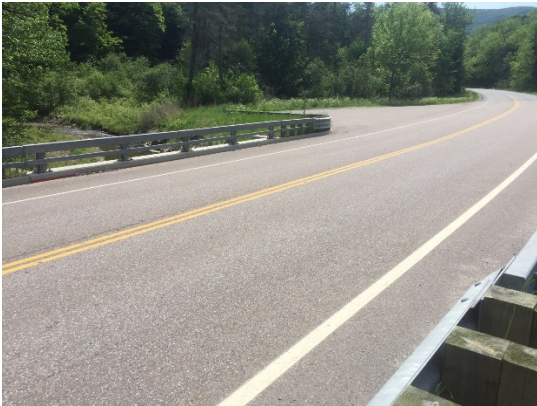
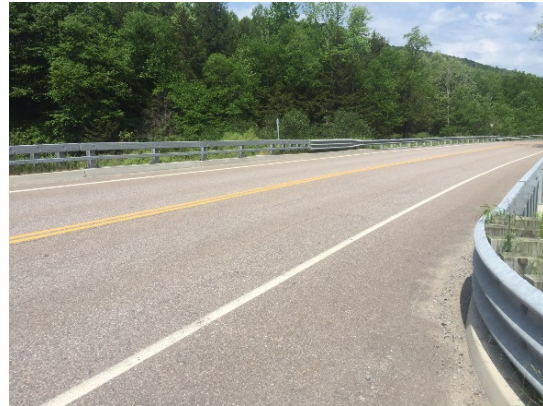
Figure 6: Overall view of bridge overlay (June 2, 2016)

From the visual inspection and photographic evidence, it can be said that the BDM is working and at this point it is inconclusive if the membrane is contributing to the longitudinal cracking on the bridge deck. During the inspection it was noticed that the longitudinal cracking was also occurring in the surrounding asphalt overlay, which means that the cracking could be attributed to the material properties of the asphalt overlay. While on the site visit it was noted that there was one longitudinal crack in the southbound lane and seven cracks on the northbound lane. The cracks ranged from approximately 3ft to 12ft. Figure 8 shows a centerline crack that runs the whole length of the bridge. Figure 11, which shows the underside of bridge 165, depicts some sort of white material seeping through bridge deck joints and cracks and depositing on the underside of the bridge. The depositing material is most likely chloride or salt from de-icing the roads during the winter season. The condition of the bridge deck is good in general, and further studies of the bridge deck would have to be conducted to determine if the BDM is contributing to the bridge deck cracking.

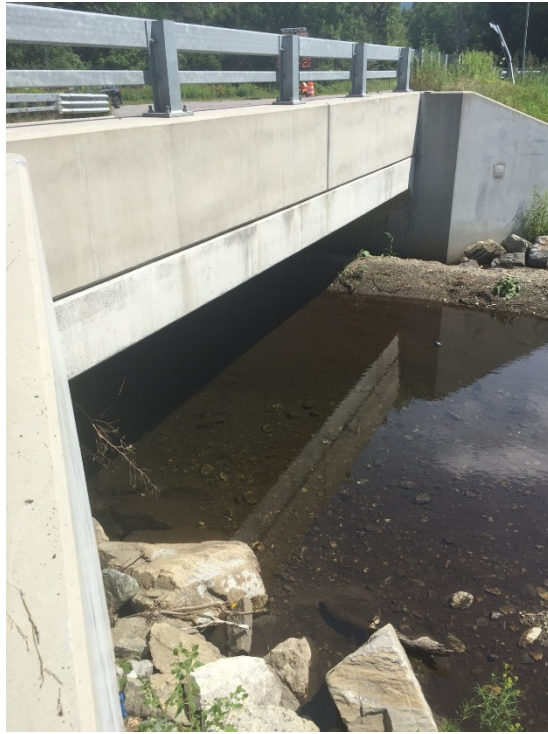
Figure 13: View of right side of bridge, facing south (August 15 ,2017)

After the initial inspection of the surface pavement on bridge 165, a subsequent inspection of the underside of bridge was done. There was no evidence of the white material seeping through the bridge deck joints and cracks that was observed and noted during the [2016 site visit](#). The current inspection revealed no new cracks or leaking of the underside of the concrete bridge. The inspection did yield evidence of wood debris on the north side of the bridge, which can be seen in Figures 13 & 20.

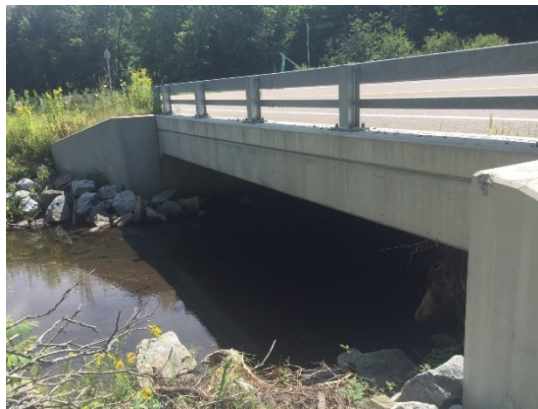
Figure 14: View of left side of bridge, facing north (August 15 ,2017)

A site visit to bridge 165 in Warren was conducted on August 15th, 2017. Observations and photos on the performance and appearance of the Bridge Deck Membrane (BDM) after installation were collected and can be seen in Figures 12 - 19. Figures 12-14 show the overall view of Bridge 165 from both sides. Figures 15 – 18 show the overall condition of the bridge deck overlay. Figure 18 shows evidence of the BDM on the side of the concrete curb above the asphalt overlay. Figure 19 shows a close-up view of the underside of the concrete bridge and the wood debris that has collected on the north end, which can also be seen in Figure 14. Figure 17 show longitudinal cracking on the deck overlay.

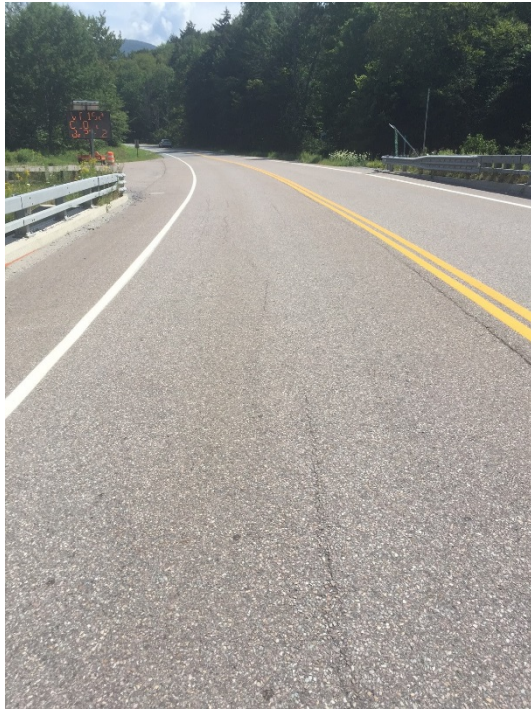
Figure 15: View of bridge overlay, looking south (August 15 ,2017)

From the visual inspection and photographic evidence, the BDM has been working properly. The only signs of deterioration are several longitudinal cracks on the pavement surface. As previously stated from the 2016 field visit, it was observed and monitored that the longitudinal cracking occurring in the surrounding asphalt overlay, again emphasizing the fact that the cracking could be attributed to the material properties of the asphalt overlay and not the bridge deck membrane. The site visit showed the single longitudinal crack on the southbound lane and eight longitudinal cracks on the northbound lane. The crack on the southbound side was located on the south end of the bridge, in the center of the wheel path, and was approximately 12ft long. The northbound lane had two cracks in the wheel path and one between the wheel paths, three cracks near the mid-span of the bridge within the wheel path that were approximately 9, 12 and 15ft long, and two cracks on the north end of the bridge in the center of the wheel path that were 6 and 12ft long. The centerline crack that runs the whole length of the bridge was again evident.
