VERMONT AGENCY OF TRANSPORTATION

ALTERNATIVE PAVEMENT DESIGNS  
RANDOLPH PARK AND RIDE

Report 2013 – 04

**Final Report**

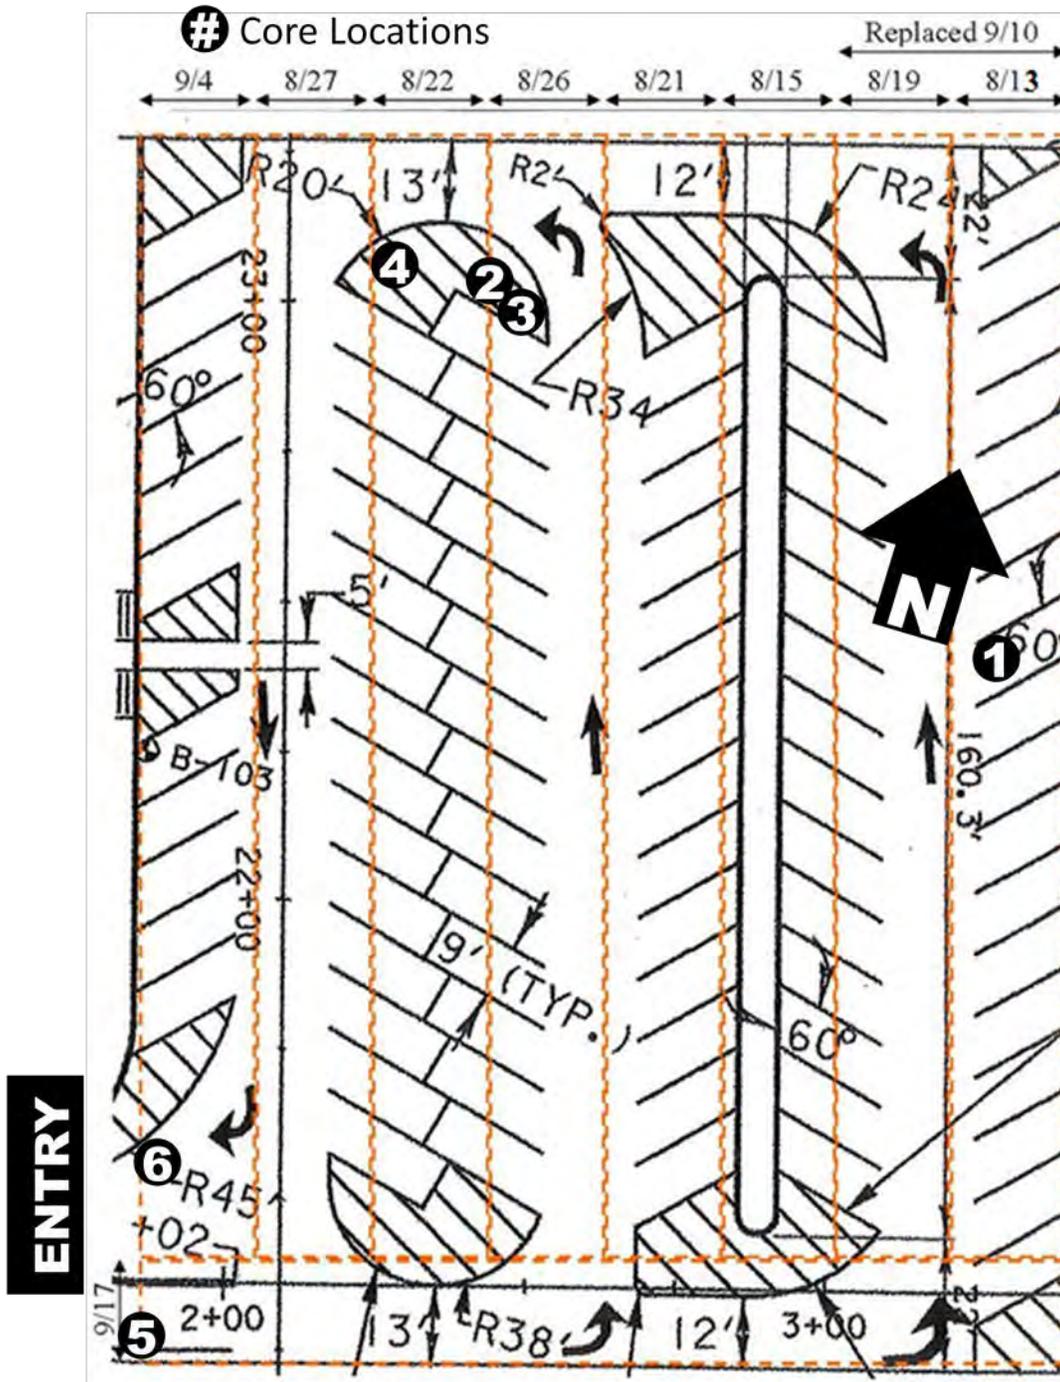
**Figure 4. Concrete placement pattern and dates during construction.**

Six pavement cores were taken through the concrete structure during the summer of 2010 once distresses in the concrete were first noticed. Cores were taken both in areas that appeared

to be in good and poor condition. The locations of the cores are shown in Figure 4. Pictures and brief descriptions of these cores are as follows.
