**ASSESSMENT OF JAHN PERMEABLE MORTAR SYSTEM IN A  
HISTORIC BRIDGE ABUTMENT APPLICATION**

**Report 2015 – 10**

**June 2015**

Reporting on Work Plan 2011-R-05

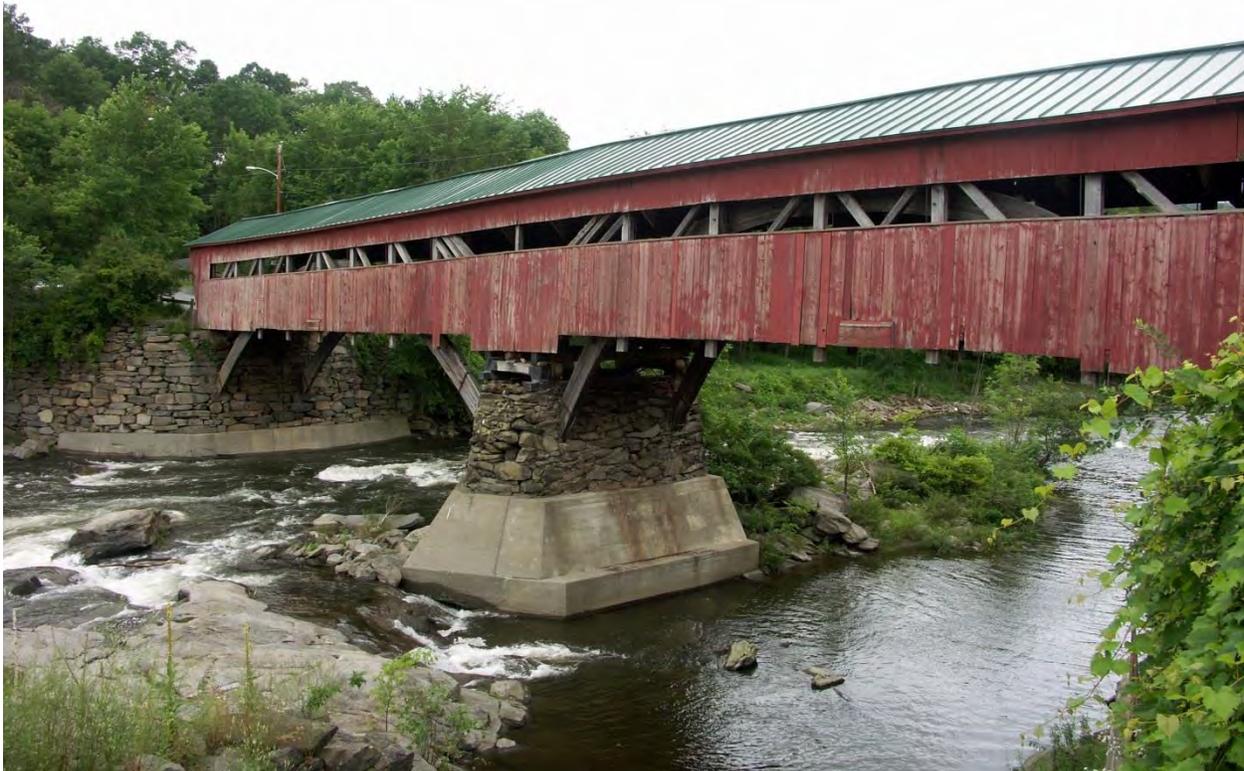
Similar structural capacity enhancements were necessary in the substructure as well. Existing stone and concrete masonry components of the substructure were intact (Figure 2) with the exception of the westerly abutment. The westerly abutment was reconstructed with stone-faced reinforced concrete. The two surviving substructure components were identified for preservation. Typically, this type of preservation is accomplished by removing and replacing the deteriorated mortar with new pointing mortars and grouts to fill in the gaps and void spaces between stones in the wall. During design and construction, it is vital to account for lateral forces that build up behind the wall from rain events, frost penetration and groundwater. In the case of piers and abutments, consideration must also include vertical forces applied by the superstructure's weight and applied live loads. Preservation considerations were centered on maintaining the visual appearance of the surviving pier and abutment. All structural enhancements were hidden from the sight for that reason.

**Figure 2 The Taftsville Covered Bridge in 2006 showing the Pier and Abutment that were preserved ([cmh2315fl](#))**

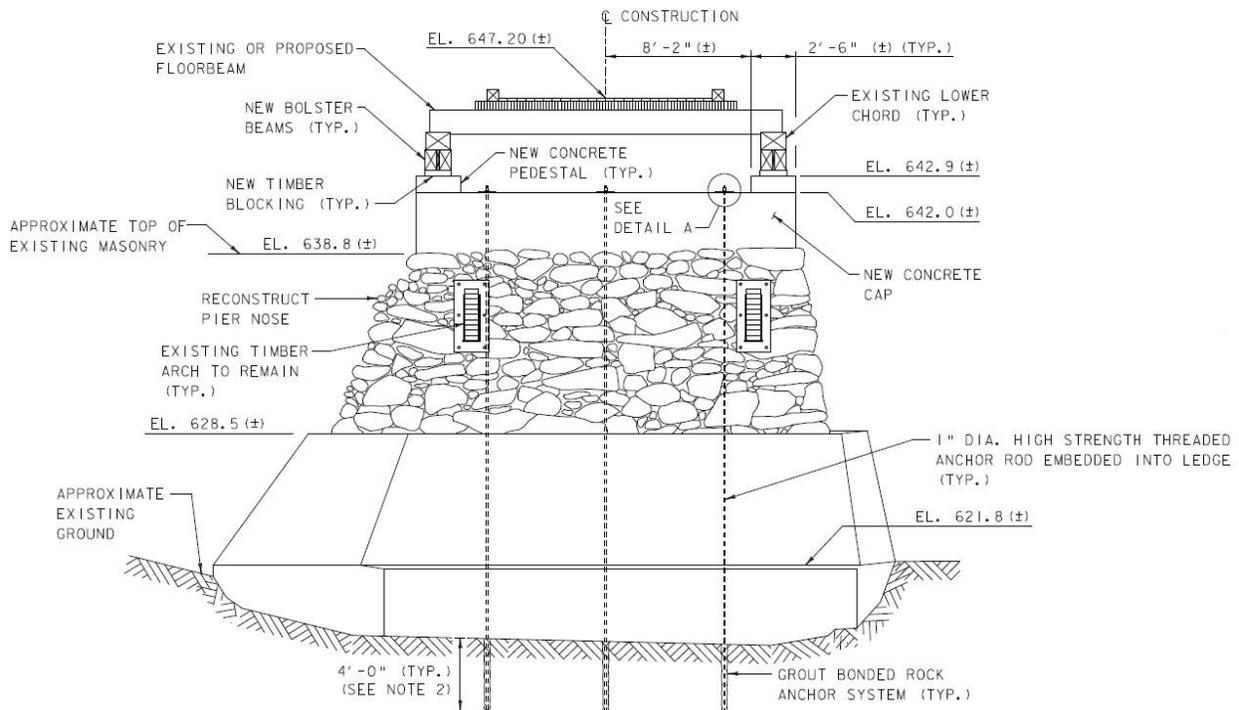
Alpine constructed an enclosure around the pier (Figure 13) and on February 5, 2013, the stonemasons began initial application of the Jahn Pointing Mortar on the westerly face of the pier. (Chase, 2013) The purpose of this initial activity was for testing and training on how to prepare the dry-laid stone for the mortar, mix the mortar to the right consistency and apply to it. Cathedral Stone Products was onsite to oversee the testing and to train the stonemasons. The contractor provided heat in the enclosure to bring the atmospheric and stone temperatures up to the specified level for stone pointing and grouting. Initial observations indicated that the mortar mix had to be adjusted initially to obtain the consistency required for pointing stones.

**Figure 13 Details of the Bridge Pier (VTrans 2012)**

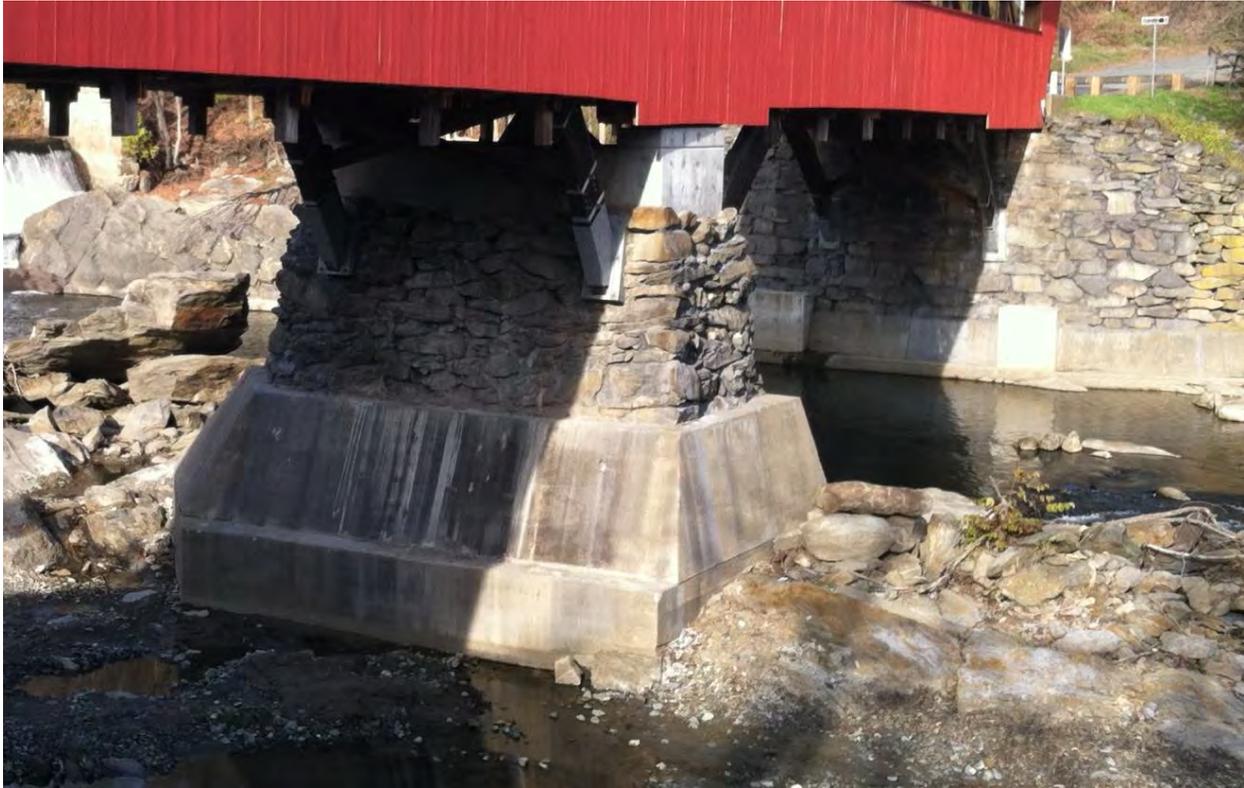
The final work on the pier was placing a new 3-foot high reinforced concrete cap (Figure 17) for the midspan of the bridge span to rest on and to distribute the vertical loads from the bridge into the pier. The cap was affixed to the stone pier by 28 anchor rods that were drilled and grouted into the stone. Six shafts in a 3-by-2 grid were drilled through the concrete cap and on through the grouted stone mass ending 4 feet into the existing riverbed ledge below the pier. 1-inch diameter high-strength threaded steel anchor rods were inserted into the shafts and embedded into the ledge using grout. The rods were bolted and tightened to a specified tension.

Grout was then placed in the shaft. The tensioned rods provide bending resistance caused by lateral forces applied to the pier.

**Figure 17 Completed pier showing the concrete cap and abutment (VTrans 2013)**

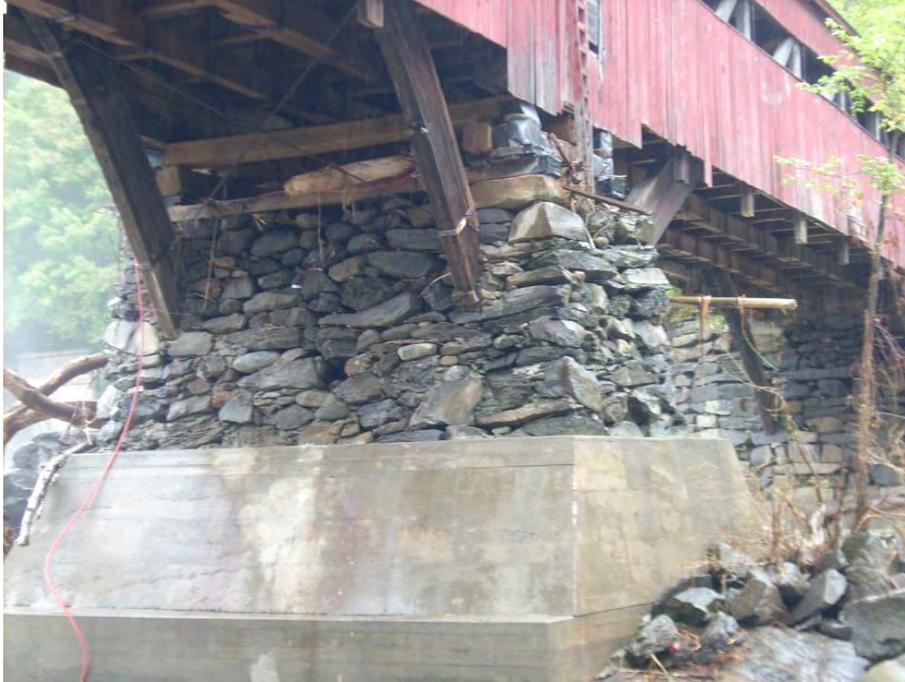
**Figure 19 Pier before Tropical Storm Irene in 2011**

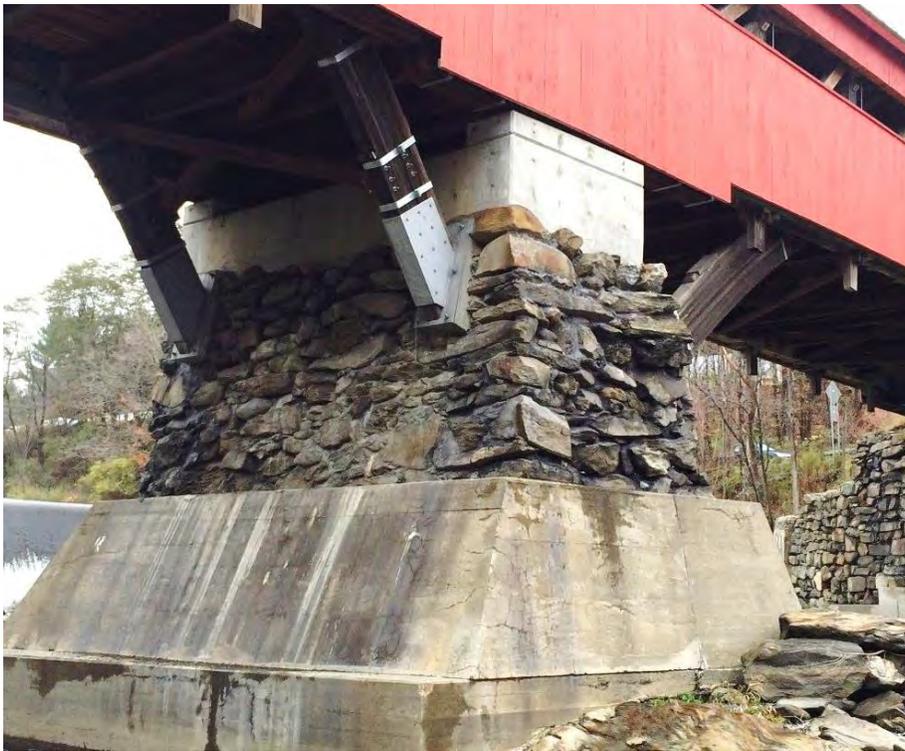
Another purpose of using the Jahn products was to strengthen the dry-laid stone pier and abutment to preserve the overall historic appearance of the bridge. Concerns were that the mortar would be obvious from a distance. Observations at various distances from the substructure units gave an appearance of dark joints between stone (Figure 19 and Figure 20). The mortar and pointed stones were virtually invisible to the eye from afar. Even up close, the dark grey color of the mortar has aged in a way that it is not obvious in most places on each substructure unit. Places where the mortar is visible are where there were large gaps in the dry-laid stone (Figure 21).

**Figure 20 Pier after Construction in 2014**
