- **Project: Hardwick BF 037-3(8)** State Bridge Program
- Route: VT 16  $\bullet$
- Bridge: Br. 1
- **Built: 1950**  $\bullet$
- Span: 82 ft.  $\bullet$
- 6 36WF280 Rolled Beams
- 15 MC 18 x42.7 Channel Diaphragms
- Total Weight of Structural Steel: 142,000 lbs. (71 Tons)
- Total Surface Area Coated: 5300 Sq. ft.

# Field Metalizing of a Steel Beam Bridge

J. B. McCarthy, PE **Vermont Agency of Transportation – Structures Design Section**

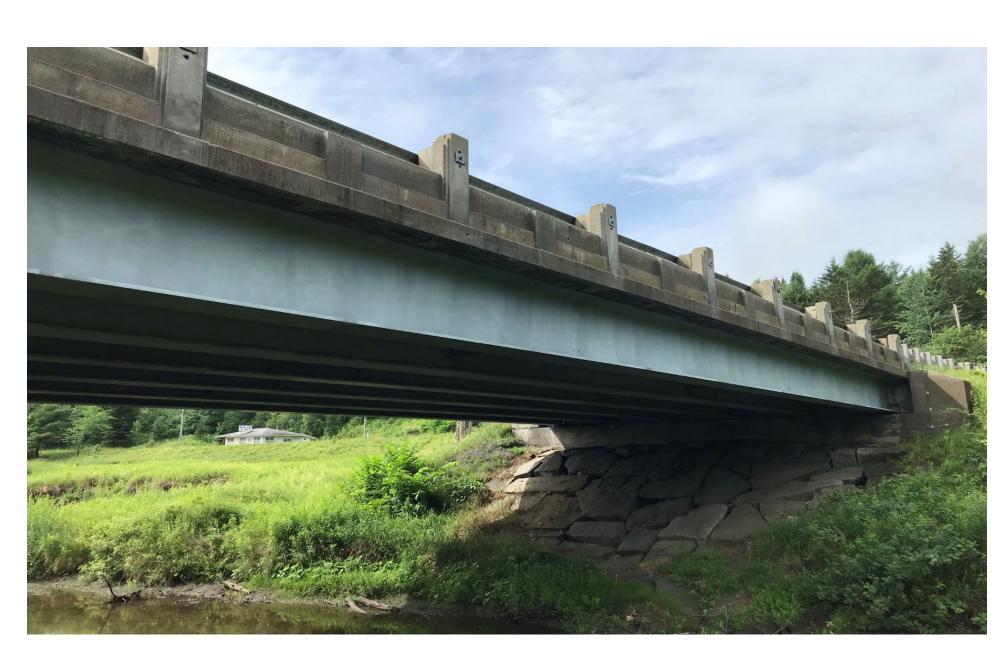
# **Streaks in Metalized Coating**

- Using a larger zinc wire 3/16" vs 1/8" would increase production.
- Humidity is a major factor during metalizing and can be difficult to control in the field.
- **Clear sealer coating over metalizing left** streaks in final appearance.
- All adhesion tests, bend tests and coating thicknesses met specifications.
