Hizb Ullah Sajid, Ph.D. and Ryan Slein, Ph.D.
Structures Laboratory, Turner-Fairbank Highway Research Center, McLean, VA.

Irasburg Bridge Fire Accident – December 2023

Residual Strength Assessment of the Bridge Steel Girder

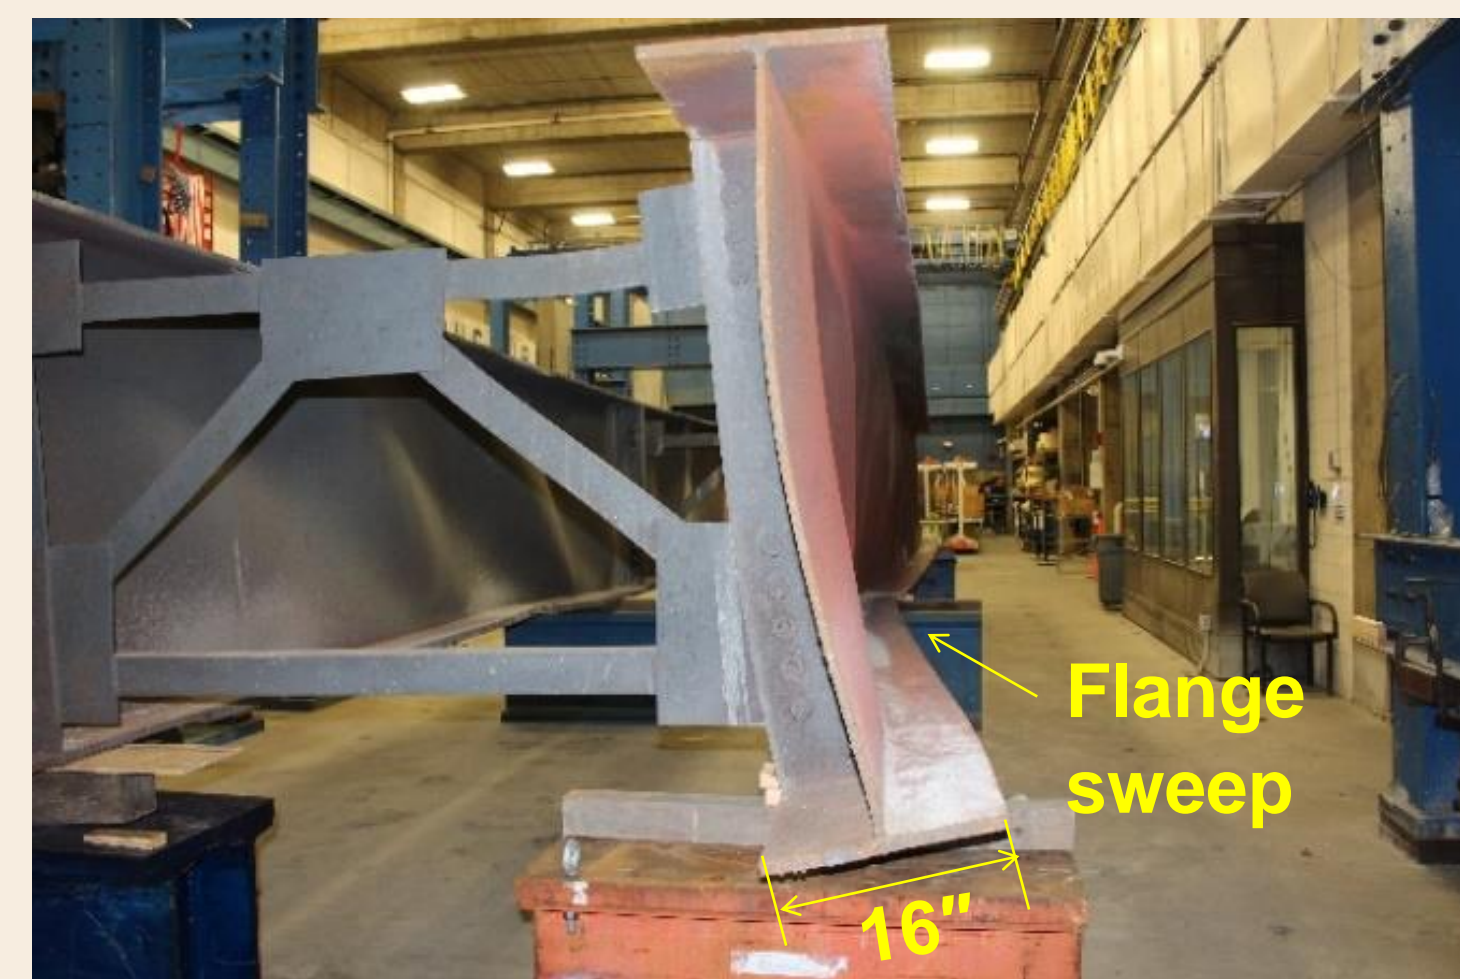
Figure 2. Girder layout depicting flange.

- This project aims to evaluate the performance of a severely-distorted steel I-girder from the fire.
- Performance assessment employs 1) geometric laser scanning, 2) surface condition assessment, 3) mechanical and toughness testing, 4) metallographic analysis, and 5) patina characterization.
