**AN EVALUATION OF BRIFEN WIRE ROPE
SAFETY FENCE**

Report 2013 – 06

Final Report

Follow Up to Initial Report U2006-4

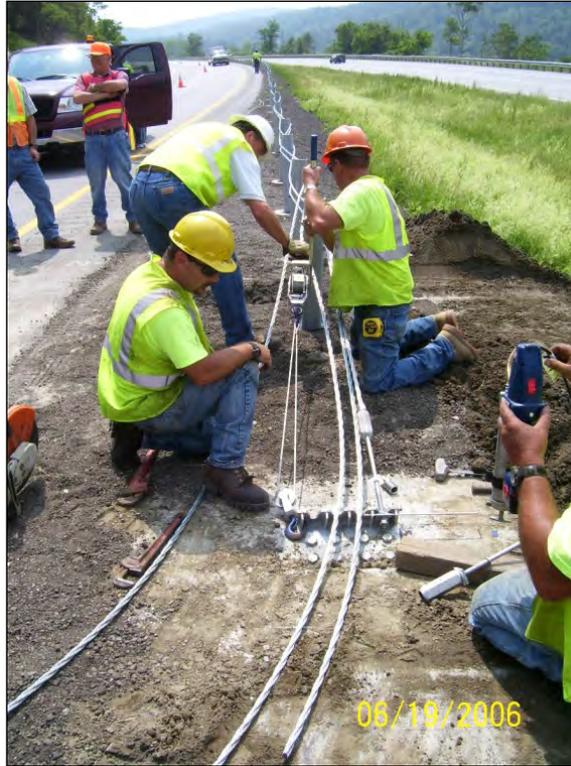
The Brifen Wire Rope Safety Fence was installed on the shoulder of the northbound passing lane of I-89 from mile marker 56.545 to mile marker 56.860. Construction activities took place from May 30, 2006 to June 19, 2006. Installation of the Brifen Wire Safety Fence is shown in Figure 1.

Figure 1: Fence installation

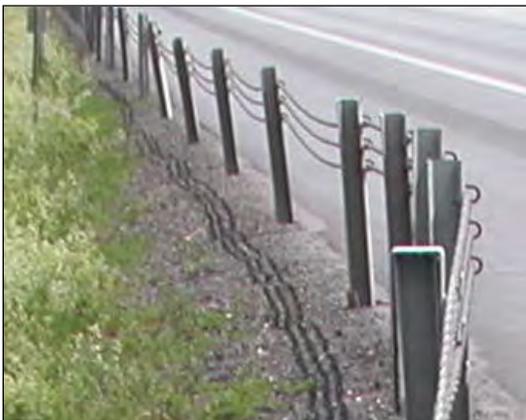
During the initial post installation site visit conducted on June 21st, 2006, the fence appeared to be very highly tensioned and visibly stronger than the standard three rope safety fence which seemed to sag in the middle between posts (See Figures 2 and 3). The referenced three-cable barrier is located on the shoulder of the break down lane of I-89 northbound diagonally across from the Brifen test site and end at MM 56.53. It was also observed that all four wire ropes were secured at the end terminals. While the three-cable wire fence is hung on the front face of the post, the Brifen system weaves two wires around both sides of the posts as shown in Figure 2 and Figure 3.

Figure 2: Traditional Three-Rope Fence

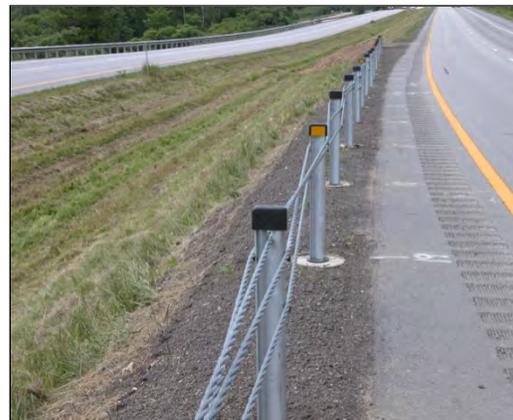
Figure 3: Brifen Wire Rope Fence Showing Interwoven Wire Ropes
