A Masonry Wall and Slide Repair Using Soil Nails and Rock Dowels

Drew Gelfenbein, Christopher Benda, PE and Peter Ingraham, PE

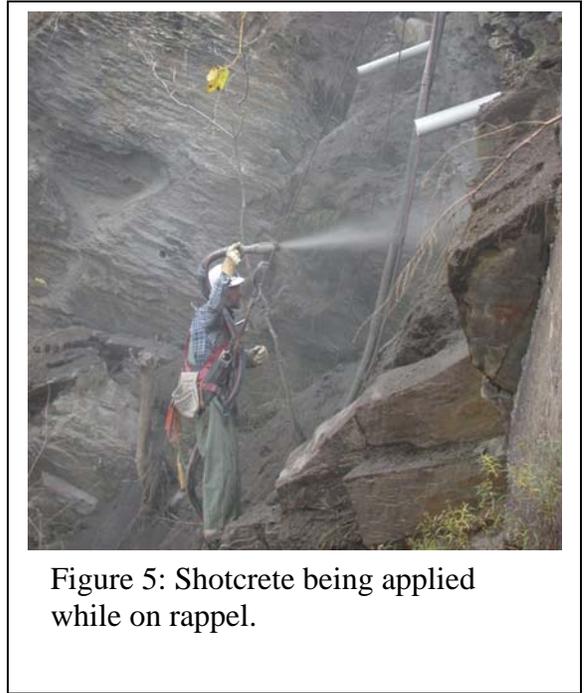
Figure 5: Shotcrete being applied while on rappel.

Due to the highly specialized nature of the rock reinforcement work and steep terrain at the two sites combined with the winter season quickly approaching, it was decided not to bid the project but to hire Janod Inc. (Janod) of Quebec, Canada under a force account contract. Janod specializes in rock scaling and drilling soil nails/rock dowels while on rappel and had completed a similar soil nail wall project on rappel for the New York State Thruway Authority two years earlier. Additionally, Janod has experience applying and protecting shotcrete in winter and inclement weather conditions (Figure 5).

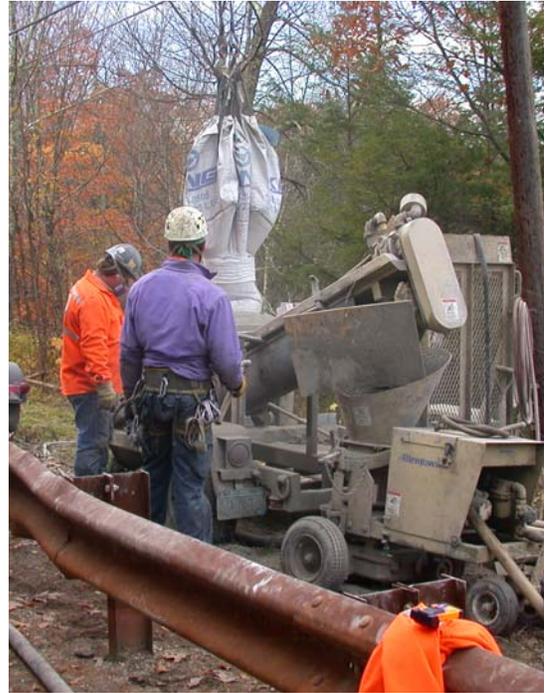
Figure 6: Shotcrete pump with a bag of shotcrete suspended over it.

The shotcrete was delivered in 2200 pound bags and suspended by a crane over the pump (Figure 6). The flow of the shotcrete was under constant supervision during the application. In some areas of the masonry walls the initial thickness of shotcrete was much greater than three inches due to inconsistencies in the rock face and void spaces

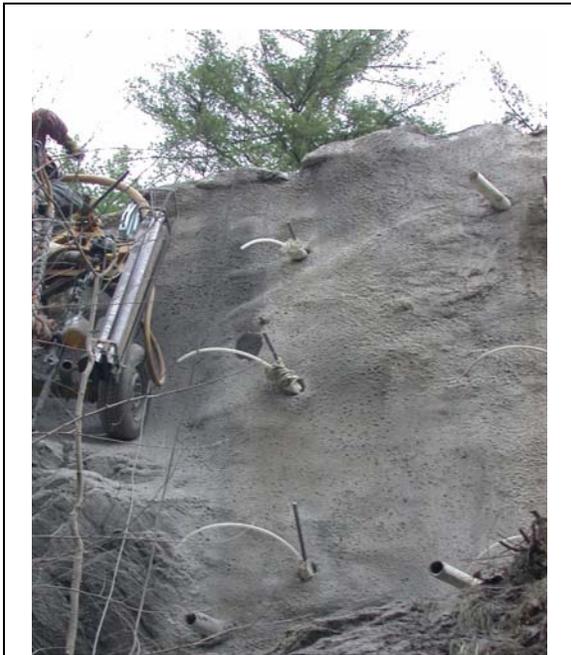
Figure 8: Fiberglass socks shown protruding from the top of soil nail holes.

The production nails were grouted in place using Sika 212 grout. The grout was tremmie pumped into the holes using grout tubes to ensure that the grout reached the bottom of the holes. Pumping continued until the grout flowed from the collar of the holes. If the level of the grout receded, additional grout was placed to bring the grout level up to the surface of the shotcrete wall face.
