# VERMONT AGENCY OF TRANSPORTATION Research Section

Dr. Ian Anderson, Research Engineer March 6, 2019 – Reporting on Work Plan 2018-R-02 Initial Report 2019-06

# Recycled Asphalt Shingles (RAS) in Town Gravel Roads-Initial Report

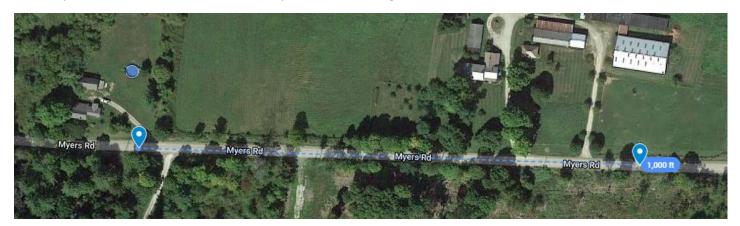
Figure 8: Shaftsbury Resurfacing location

The town of Shaftsbury, in SW Vermont, was sent 64 tons of RAS from Myers Recycling in Colchester. The RAS was mixed at 20% by mass with gravel from William E. Dailey, Inc. (Peckham Industries Subsidiary). The RAS used was approximately comprised of 50% RAS at minus 3/8", and 50% RAS not passing 3/8". The test section (Figure 8), located on Myers Rd (unrelated to Myers Recycling) is approximately 1000ft long, with a 600ft section of between 6-7% grade, and a flat 400ft section. The roadway is uniformly 20ft wide. The existing roadway had a 3-4% crown, with several sections being noticeably flatter. Precondition of the roadway can be seen in Figure 7.
