ASSESSMENT OF POLY-CARB FLEXOGRID BRIDGE DECK OVERLAY SYSTEM

Ian Anderson, Research Engineer
Vermont Agency of Transportation
Research Section

April 2019

Final Report 2019-09

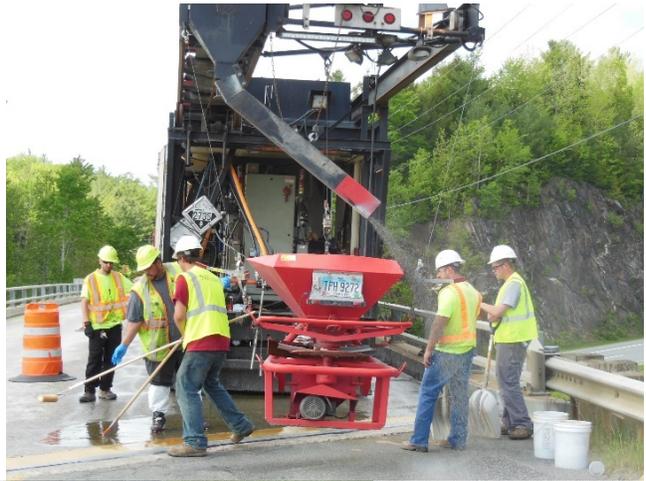
To apply Flexogrid, the hybridized copolymer must be mixed on site for three to four minutes. Once mixed, it is squeegeed onto the surface until it covers 35 square feet per gallon. After the Flexogrid is applied, aggregate is broadcasted onto the surface at a rate of 15 pounds per square yard. After the aggregate has been applied and has been given time to set, any excess aggregate is removed. Next, a second coat of Flexogrid is applied at a rate of 15-20 square feet per gallon and an aggregate distribution rate of 15 pounds per square yard. A close up of the material, showing its coarse texture can be seen in Figure 4.
