MATERIALS & RESEARCH

INSTALLATION REPORT

U 2003-4

GALVASHIELD XP SACRIFICIAL ANODES

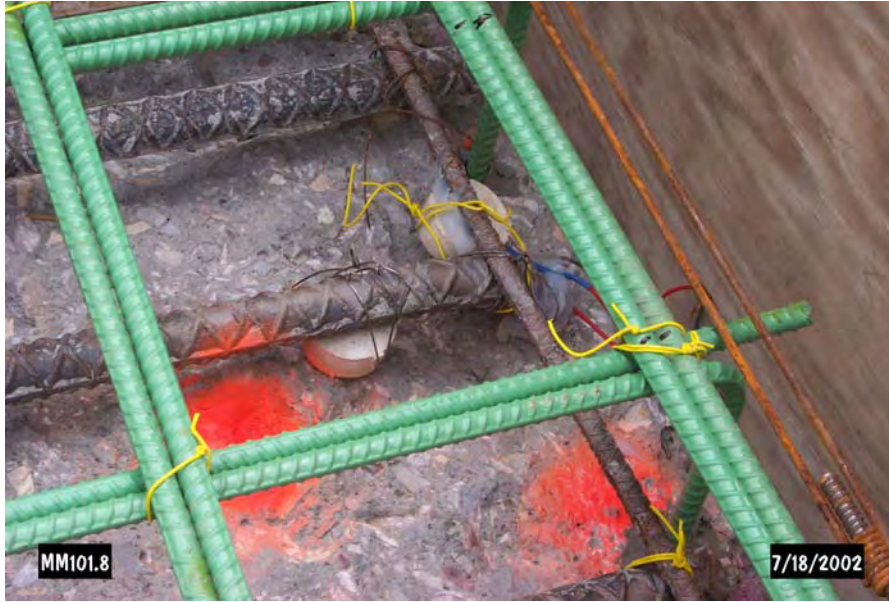
Galvashield XP Anode and Test Kit installed in the Cap of Pier 2 on Br. 48N

3. Anodes were placed just above the old concrete at two foot intervals and tied into place using a rebar tying tool.
4. Test kit anodes were placed in the stem and pier cap of bridges 48N & S. These were secured to the rebar using epoxy coated rebar ties and silicone. The ground wire was attached to the rebar using a hose clamp and silicone.

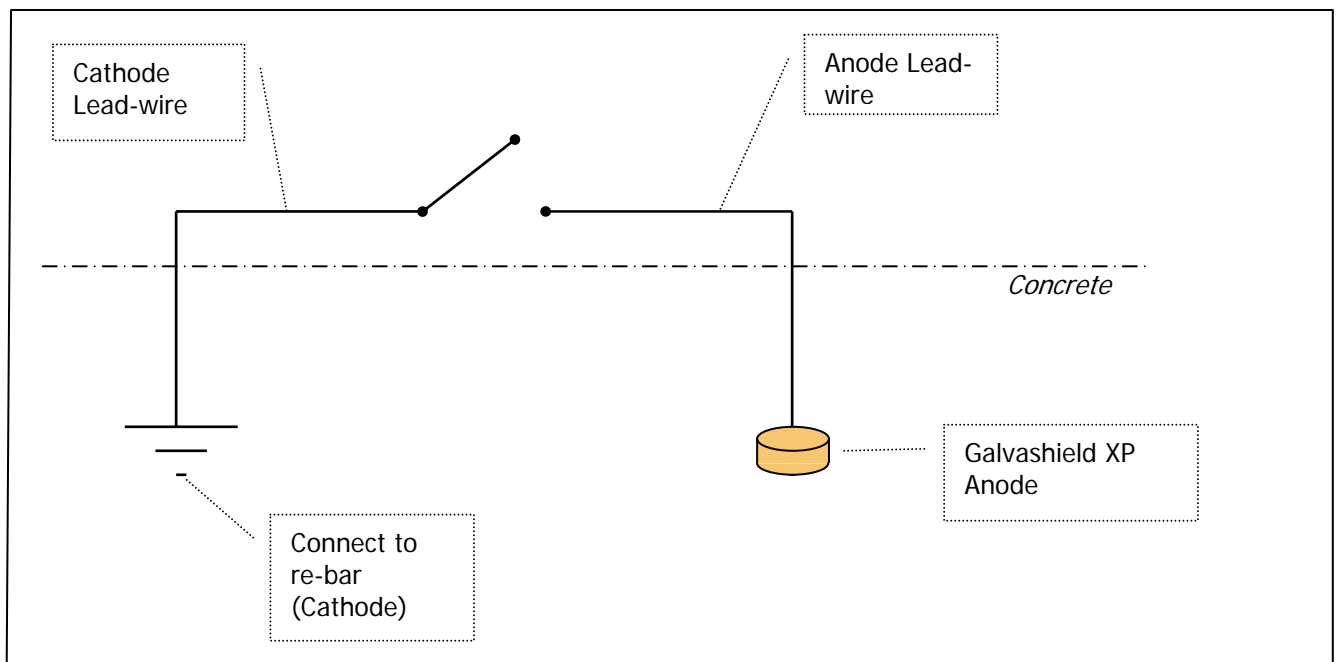
Schematic of Galvashield XP Test Kit

7. Inside the central box, the leads were attached to a switch for each anode. The switches are numbered and indexed to a location diagram inside the cover to the box.

8. Measurements of current and voltage can be taken by attaching a multimeter to the leads going into the switch.

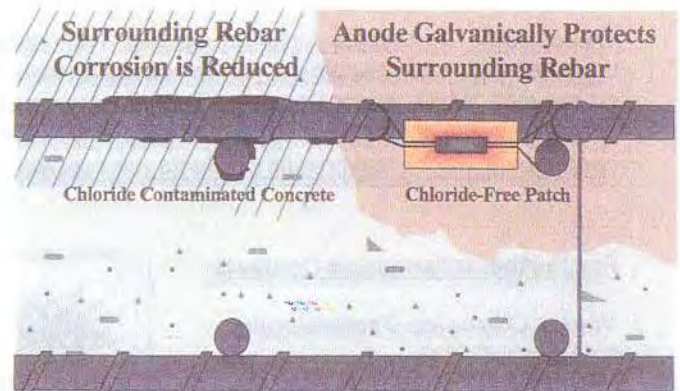
Galvashield XP Reduces "Ring Anode" Corrosion
