Weekly List 20181214

The enclosed disk contains a true and correct copy of the Multiple Property Documentation Form (MPDF) for *Metal Truss, Masonry and Concrete Bridges of Vermont, 1820-1978* (Amended Submission). This statewide MPDF incorporates and replaces the existing MPDF, *Metal Truss, Masonry and Concrete Bridges of Vermont, 1820-1940*, completed in 1990 by Heather Rudge, Vermont Division for Historic Preservation. The temporal limit has been extended from 1940 to 1978, and two new historic contexts have been added:

This multiple property documentation form (MPDF) incorporates and replaces the existing MPDF, Metal Truss, Masonry, and Concrete Bridges in Vermont: 1820-1940, completed in 1990 by Heather Rudge, Vermont Division for Historic Preservation. The historic context has been extended from 1940 to 1978.

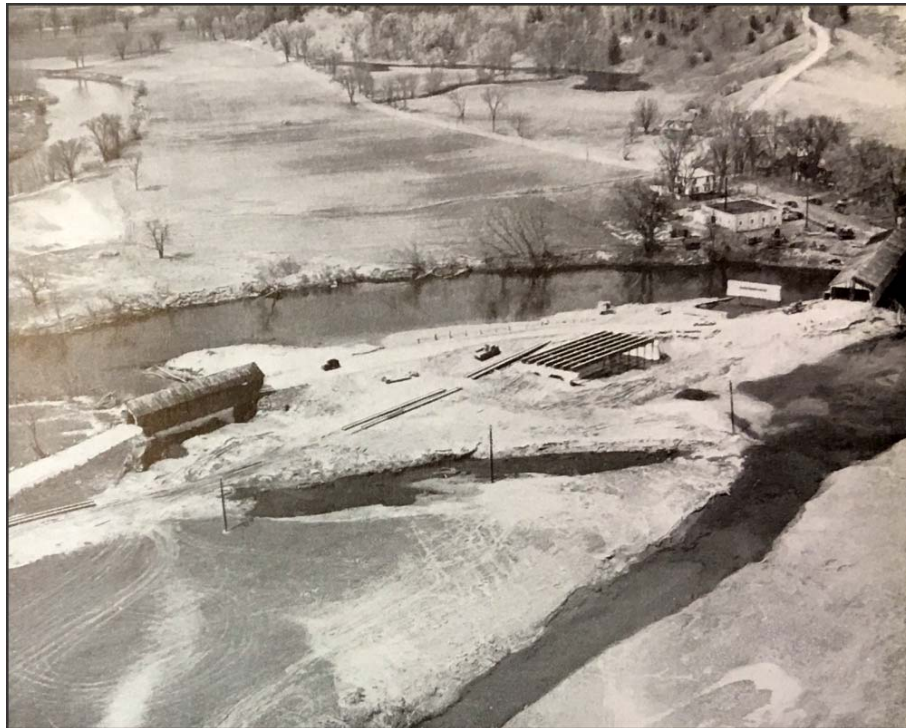
FIGURE 1: Replacement of Covered Bridges in Cambridge, 1950 (Vermont State Highway Board 1948-1950)

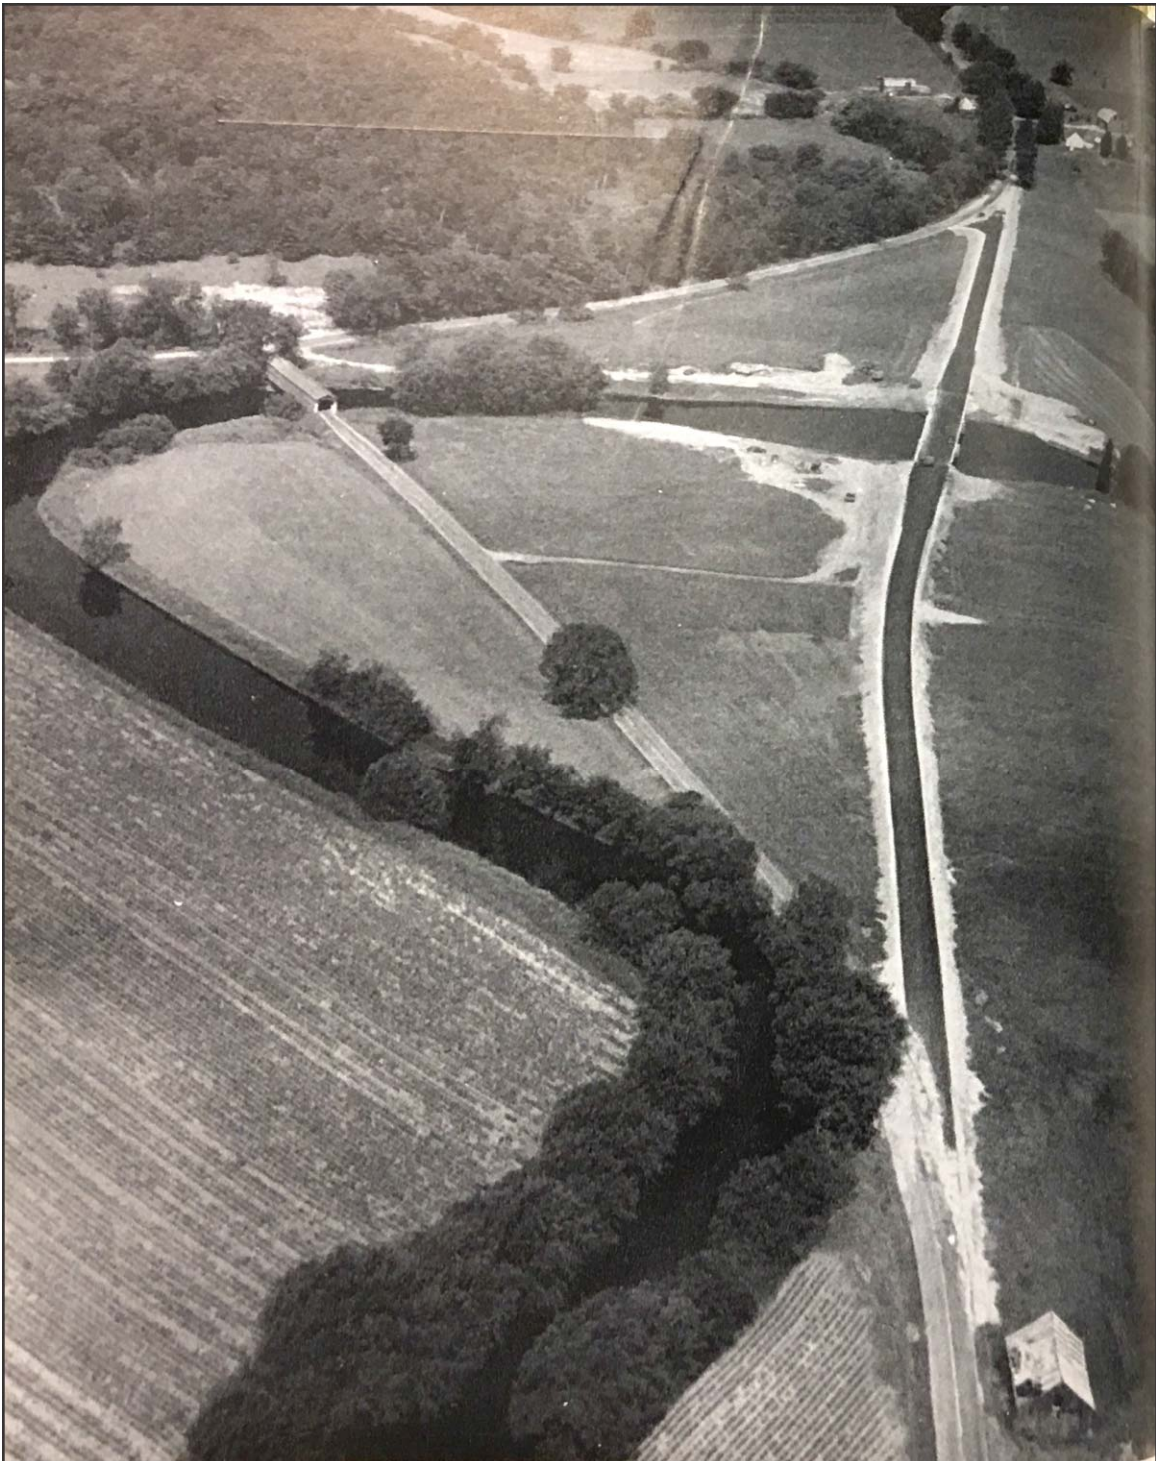
FIGURE 2: New Road Alignment Bypassing the Miller Bridge in Sudbury (Vermont State Highway Board 1950-1952)

After the war the Department of Highways began a program to replace deficient bridges, most of which had been built in the late nineteenth and early twentieth centuries and had a legal gross load limit of 10 tons.⁴⁹ Many of these were covered bridges. The program began in 1944, but very few, if any, bridges had been replaced by 1948. In 1949 the legislature authorized a state bond issue of \$2.8 million to replace "weak, unsafe and deficient" bridges on the state highway system.⁵⁰ The first five bridges replaced under the program were two drawbridges over Lake Champlain on U.S. Route 2 between Alburgh and North Hero and Grand Isle and North Hero, two covered bridges on VT Route 15 over the Lamoille River in Cambridge, and the VT 30 Holland Bridge over the West River in Townshend (Figure 1).⁵¹ Once these were completed, 12 more bridges were slated for replacement (Table E-4). In some cases, such as the Miller Bridge in Sudbury, the covered bridge was merely bypassed with a new road alignment and bridge (Figure 2).

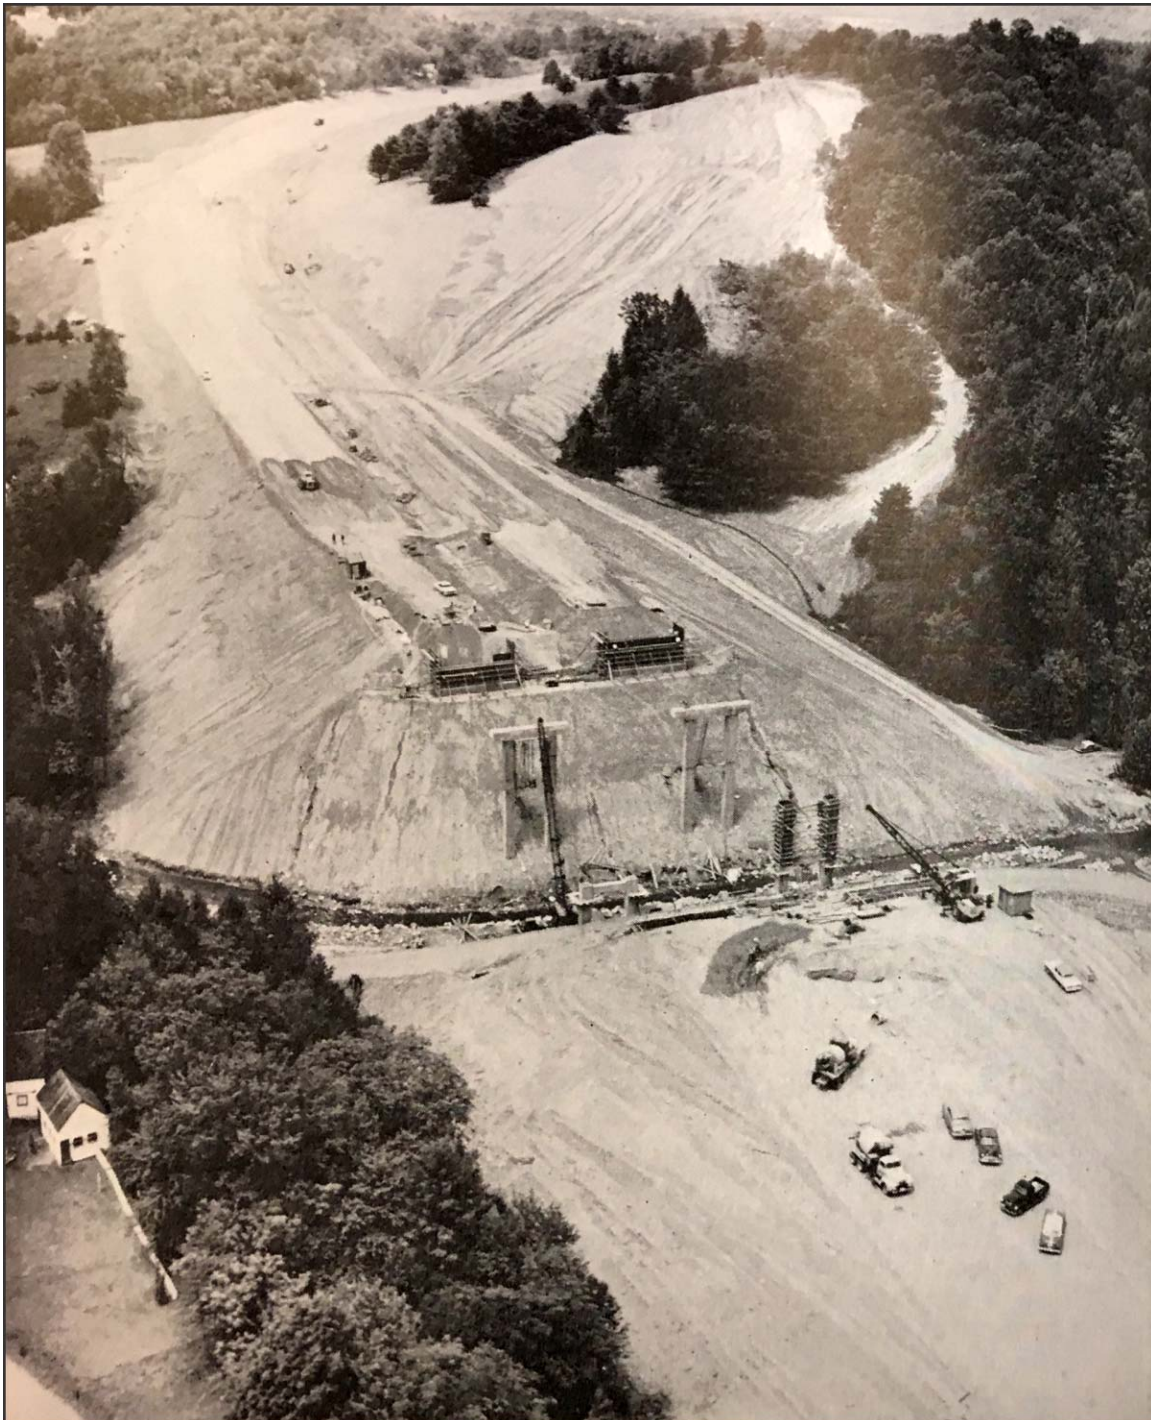
FIGURE 3: Construction of Twin Bridges over Broad Brook on the Brattleboro Bypass (Vermont State Highway Board 1956-1958)
