Contractor	Hartigan Company
Responsible:	Michael Melanson
Department:	
Street:	31 Welch Park Dr.
City:	Middlesex
Telephone:	800-696-0761
Fax:	hartigancompany.com
Mobile:	802-585-9916
E-Mail:	hartigancompany.com

Pipe Segment Refere...	City VILLAGE OF WATERBUR...	Street ELM ST	Material POLYVINYL CHLORIDE	Location C...	Pipe Use SANITARY S...
Upstream MH 55	Total Length	Year Constructed	Shape CIRCULAR	Location Details	
Downstream MH 54	Length surveyed 230	Year Renewed	Height 15	Width 15	Pipe Joint...
SPR 2	MPR 8	PO Number		Customer	
SPRI 2	MPRI 2	Work Order Number		Purpose	
QSR 2100	QMR 2400			ROUTINE ASSESSMENT	
OPR 10	Surveyed By EEM	Direction UPSTREAM	Date 20170517	Media label	
OPRI 2	Certificate Number U-1016-07005746	Pre-Cleaning LIGHT CLEANING	Time 08:11	Weather DRY - NO P...	
Date Cleaned			End Time 08:30	Additional Info

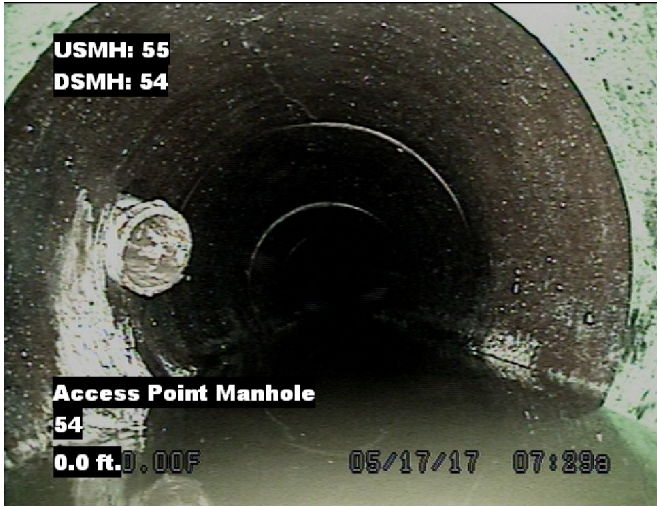
Distance: 0.0 ft. Grade: 0
 Condition: Access Point Manhole
 Remarks: 54

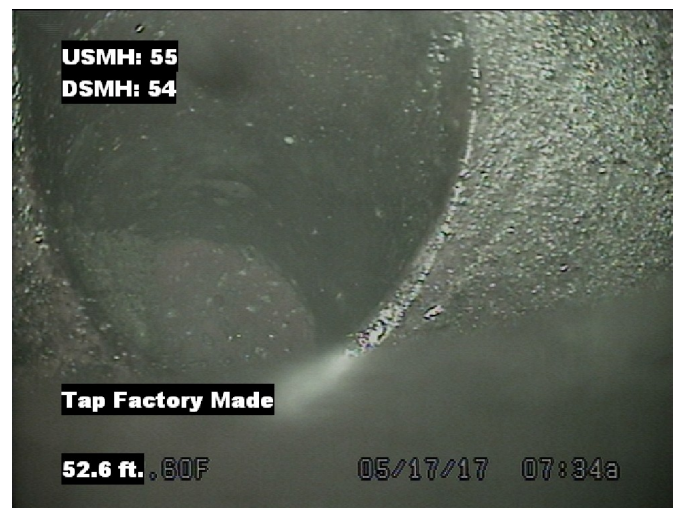
Distance: 52.6 ft. Grade: 0
 Condition: Tap Factory Made
 Remarks: CAPPED

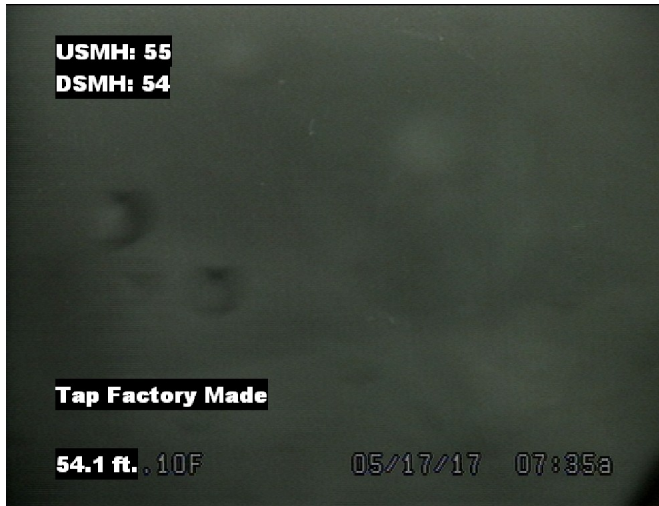
Distance: 54.1 ft. Grade: 0
 Condition: Tap Factory Made
 Remarks: N/A

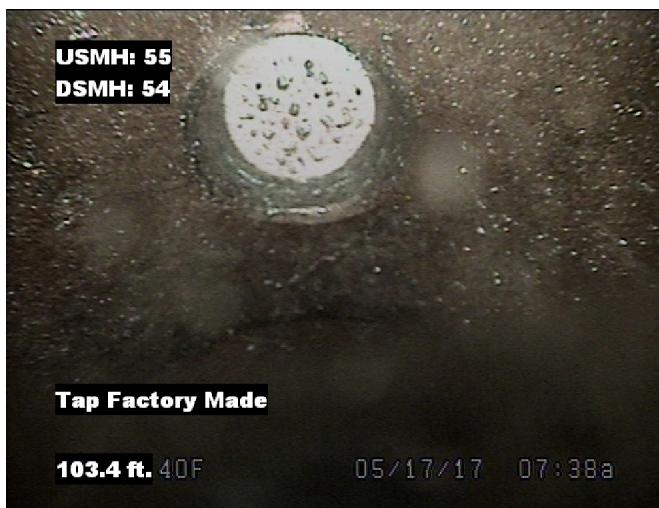
Distance: 103.4 ft. Grade: 0
 Condition: Tap Factory Made
 Remarks: N/A

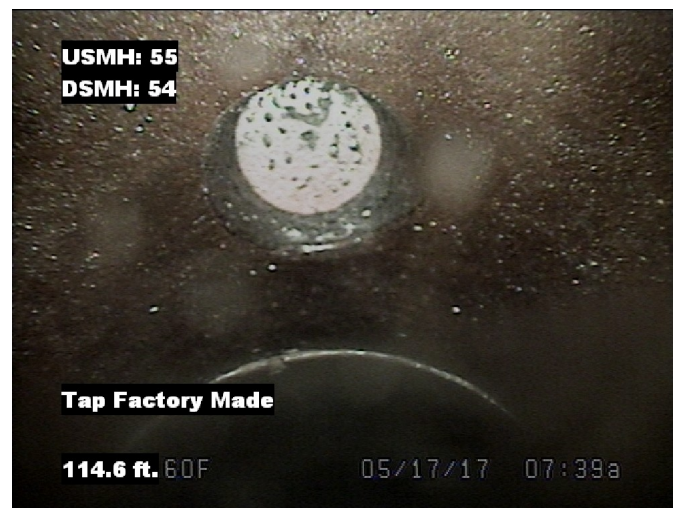
Distance: 114.6 ft. Grade: 0
 Condition: Tap Factory Made
 Remarks: N/A

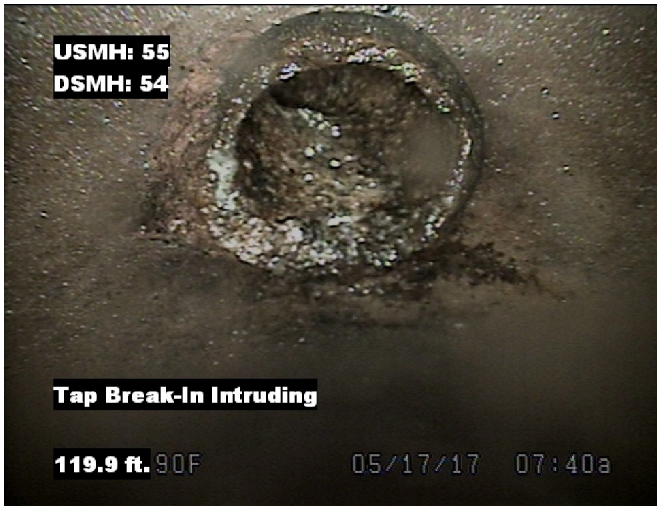
Distance: 119.9 ft. Grade: 2
 Condition: Tap Break-In Intruding
 Remarks: N/A

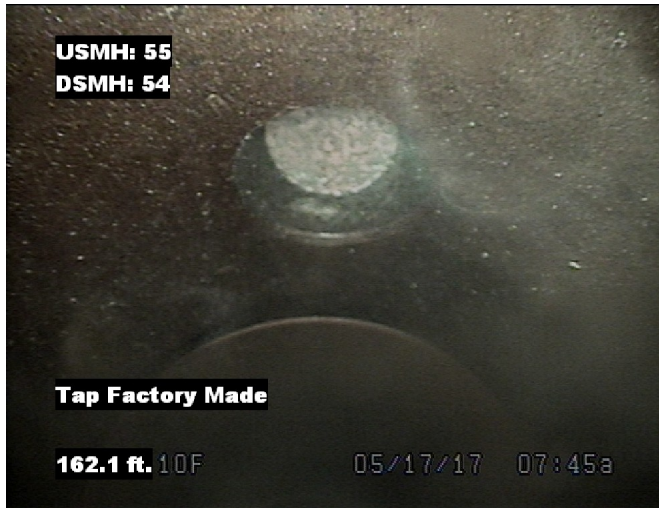
Distance: 162.1 ft. Grade: 0
 Condition: Tap Factory Made
 Remarks: N/A

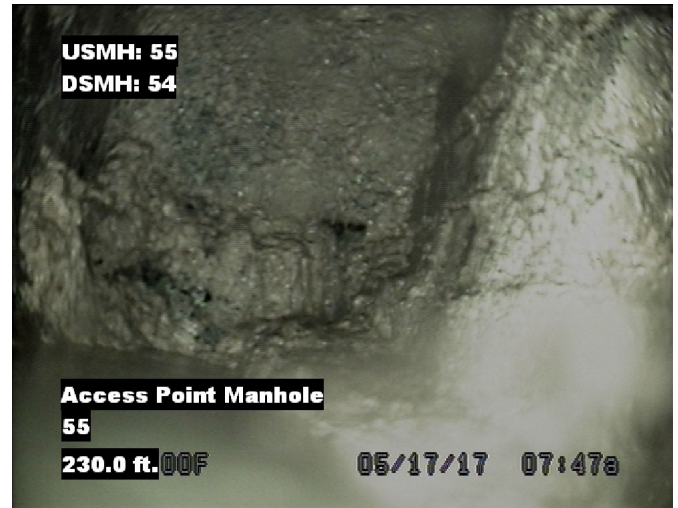
Distance: 230.0 ft. Grade: 0
 Condition: Access Point Manhole
 Remarks: 55

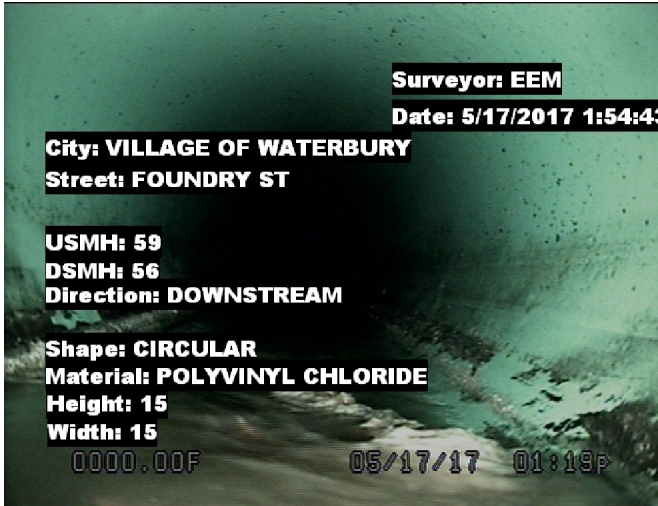
Distance: 0.0 ft. Grade: 0
 Condition: Access Point Manhole
 Remarks: 59

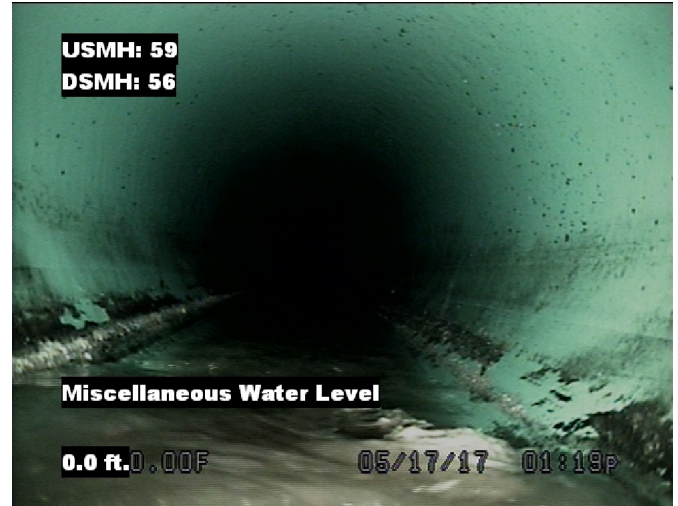
Distance: 0.0 ft. Grade: 0
 Condition: Miscellaneous Water Level
 Remarks: N/A

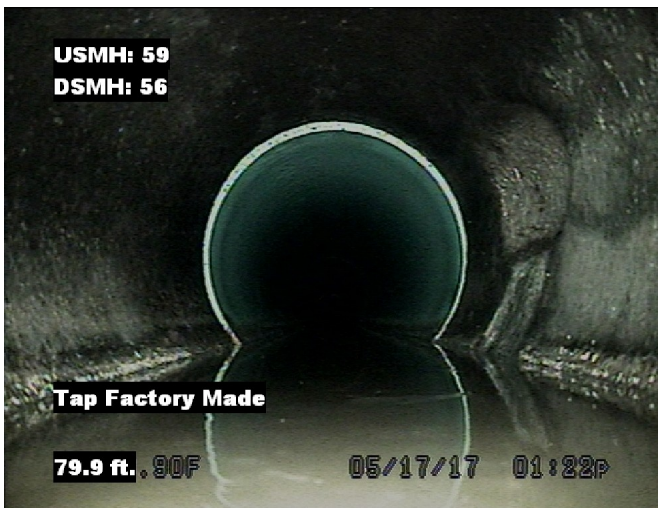
Distance: 82.2 ft. Grade: 0
 Condition: Tap Factory Made
 Remarks: N/A

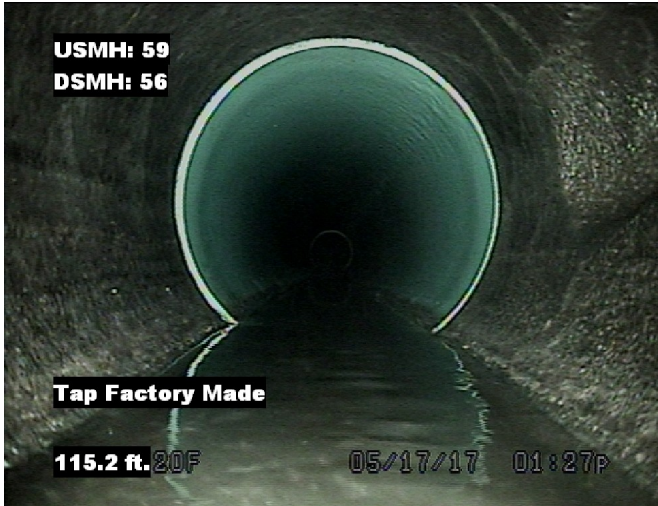
Distance: 115.2 ft. Grade: 0
 Condition: Tap Factory Made
 Remarks: N/A

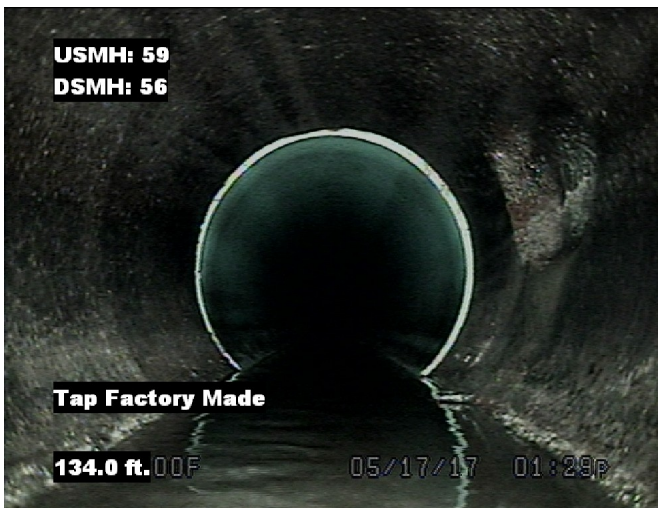
Distance: 136.1 ft. Grade: 0
 Condition: Tap Factory Made
 Remarks: N/A

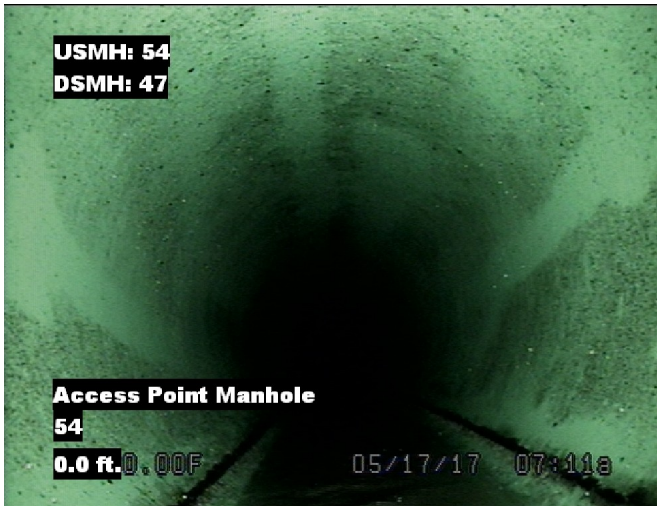
Distance: 0.0 ft. Grade: 0
 Condition: Access Point Manhole
 Remarks: 54

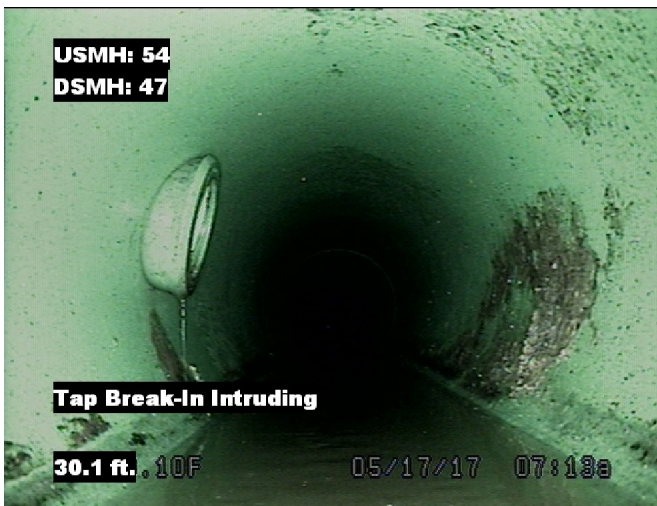
Distance: 33.1 ft. Grade: 2
 Condition: Tap Break-In Intruding
 Remarks: N/A

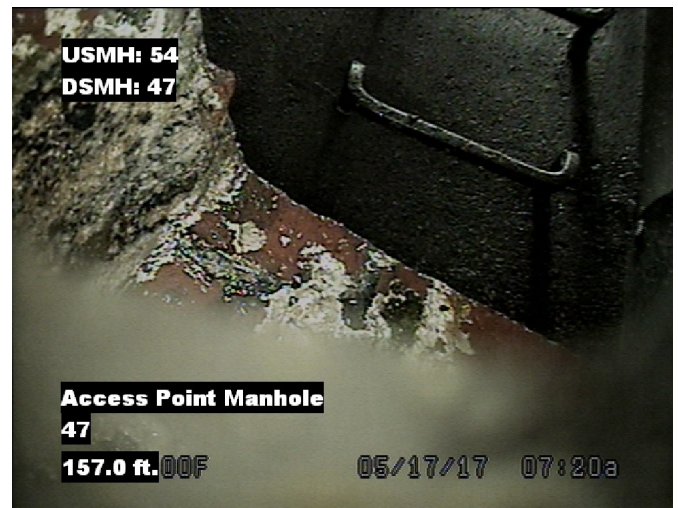
Distance: 157.0 ft. Grade: 0
 Condition: Access Point Manhole
 Remarks: 47

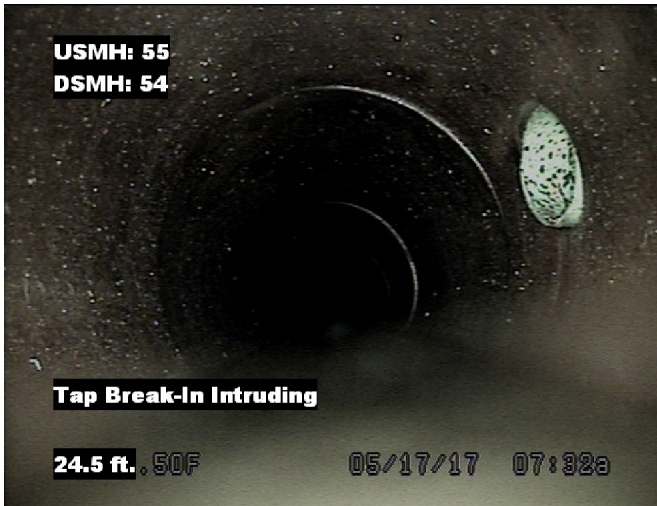
Distance: 26.0 ft. Grade: 2
 Condition: Tap Break-In Intruding
 Remarks: N/A

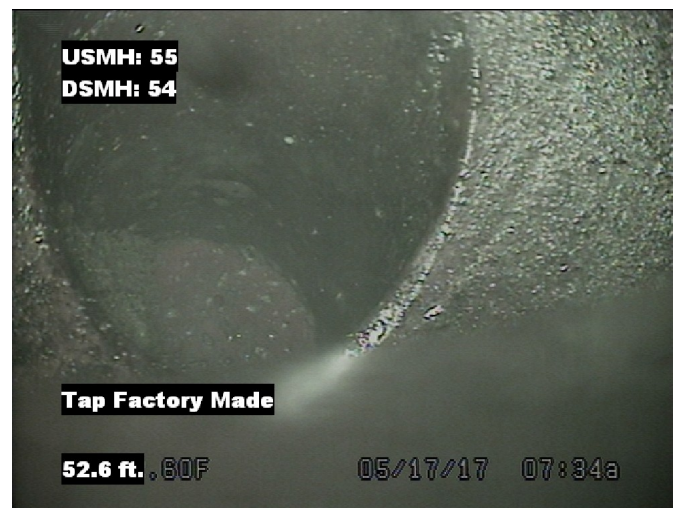
Distance: 52.6 ft. Grade: 0
 Condition: Tap Factory Made
 Remarks: CAPPED

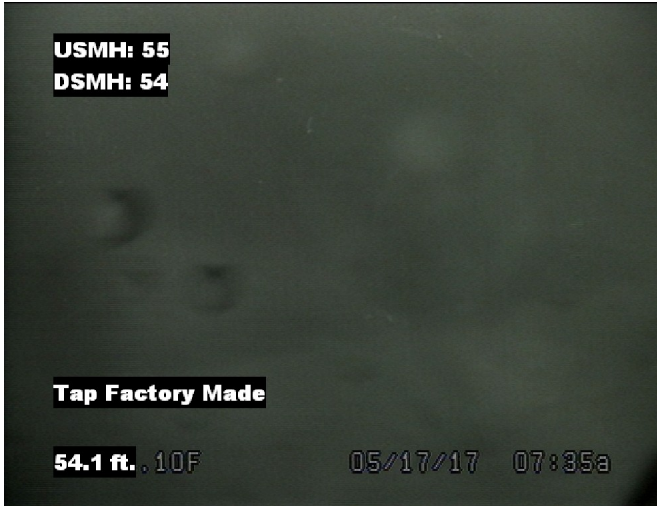
Distance: 54.1 ft. Grade: 0
 Condition: Tap Factory Made
 Remarks: N/A

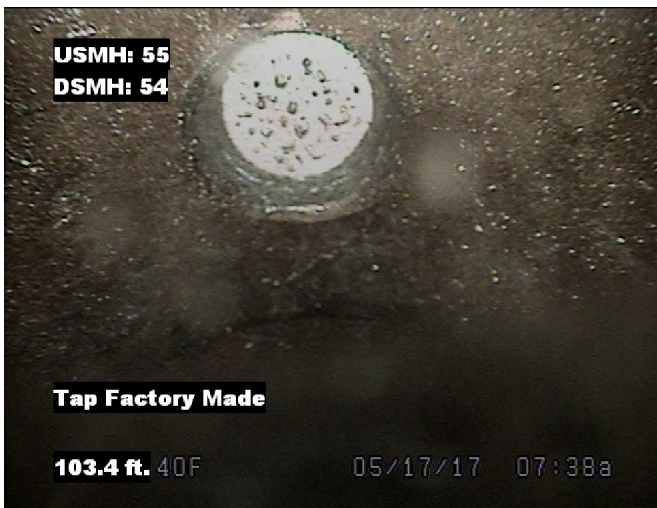
Distance: 103.4 ft. Grade: 0
 Condition: Tap Factory Made
 Remarks: N/A

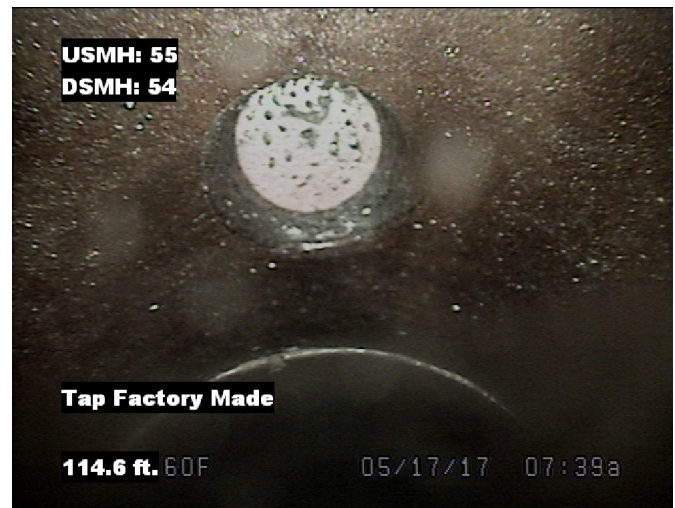
Distance: 114.6 ft. Grade: 0
 Condition: Tap Factory Made
 Remarks: N/A

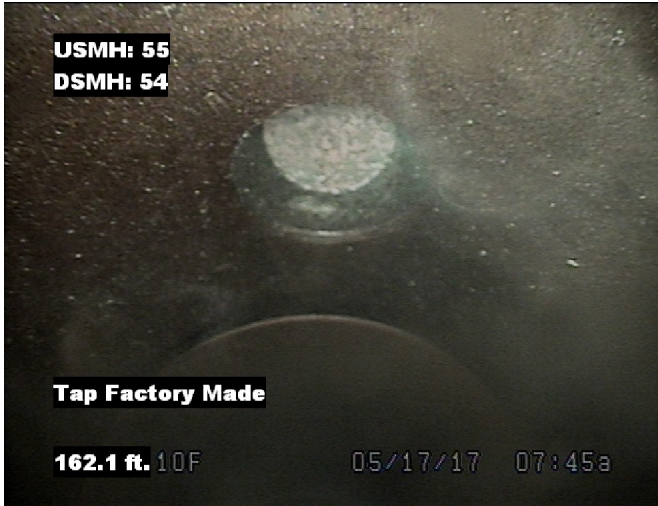
Distance: 162.1 ft. Grade: 0
 Condition: Tap Factory Made
 Remarks: N/A

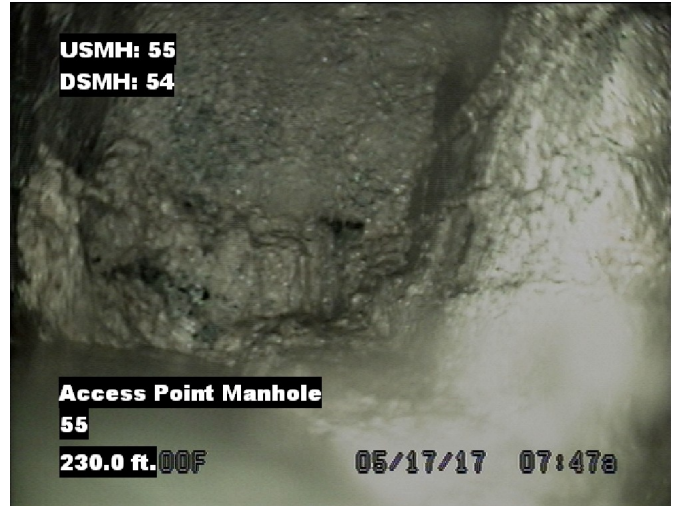
Distance: 230.0 ft. Grade: 0
 Condition: Access Point Manhole
 Remarks: 55

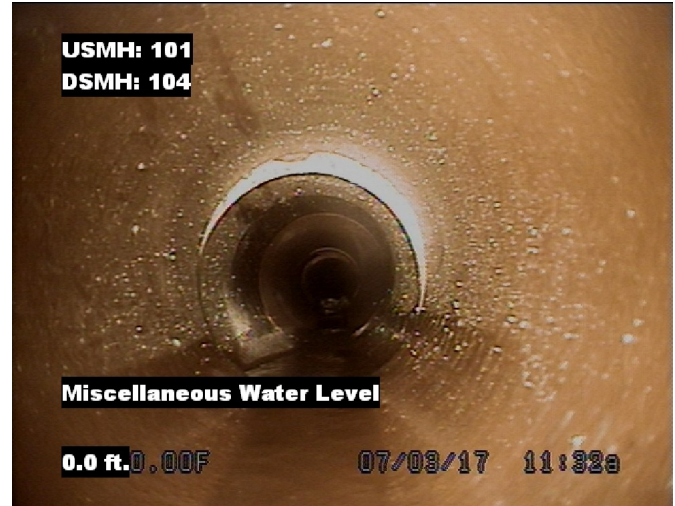
Distance: 0.0 ft. Grade: 0
 Condition: Miscellaneous Water Level
 Remarks: N/A

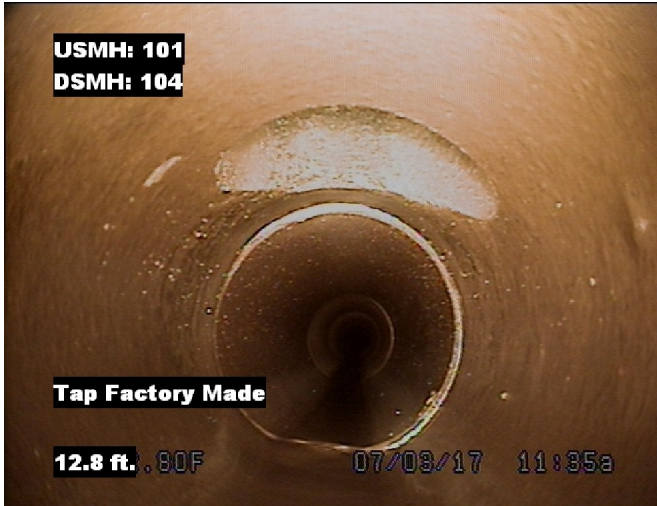
Distance: 13.0 ft. Grade: 0
 Condition: Tap Factory Made
 Remarks: N/A

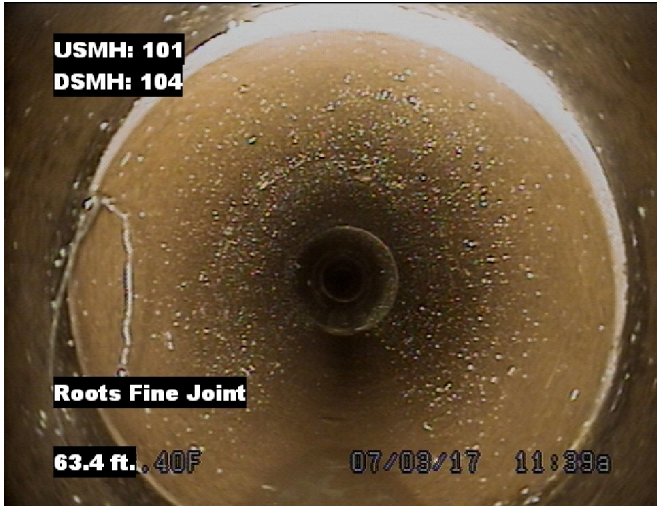
Distance: 63.4 ft. Grade: 1
 Condition: Roots Fine Joint
 Remarks: N/A

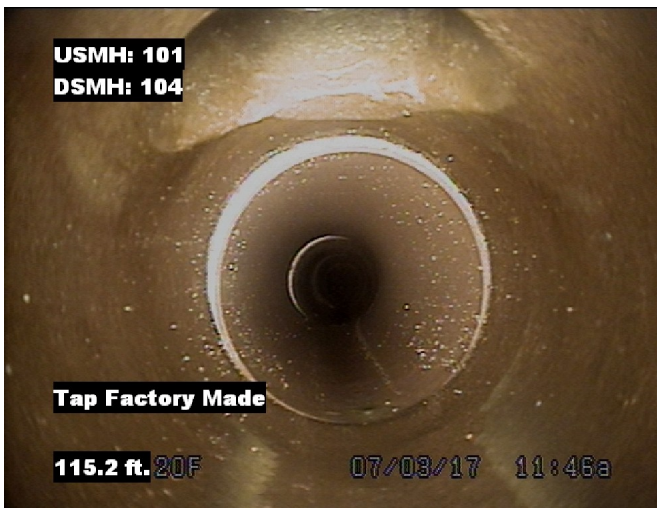
Distance: 115.8 ft. Grade: 0
 Condition: Tap Factory Made
 Remarks: N/A

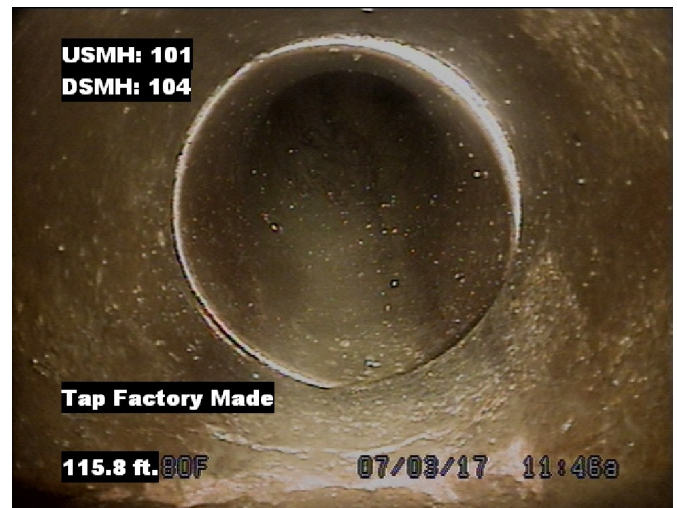
Distance: 115.8 ft. Grade: 0
 Condition: Tap Factory Made
 Remarks: N/A

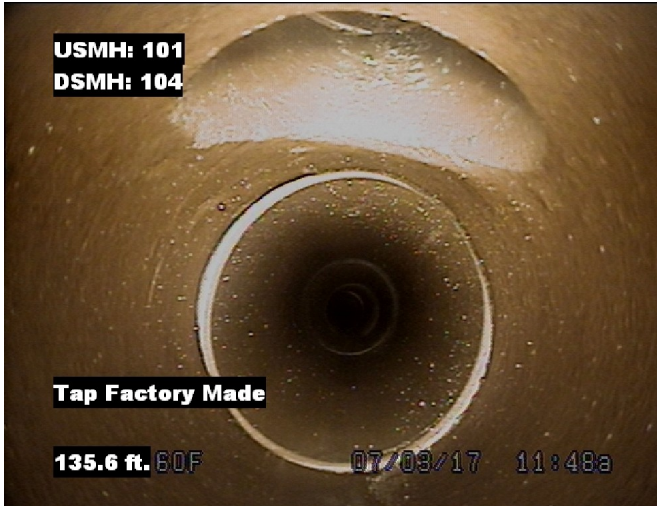
Distance: 136.2 ft. Grade: 0
 Condition: Tap Factory Made
 Remarks: N/A

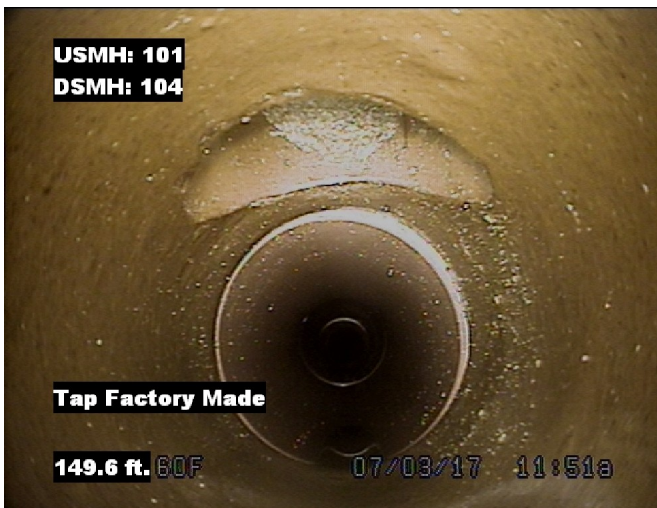
Distance: 150.5 ft. Grade: 0
 Condition: Tap Factory Made
 Remarks: N/A

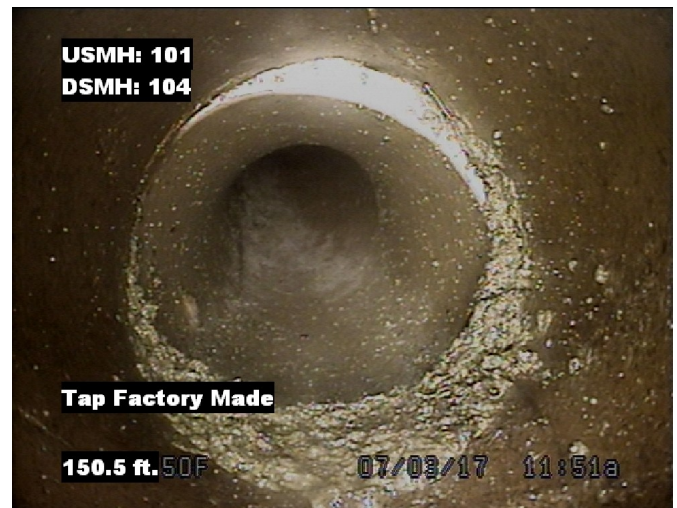
Distance: 150.5 ft. Grade: 0
 Condition: Tap Factory Made
 Remarks: N/A

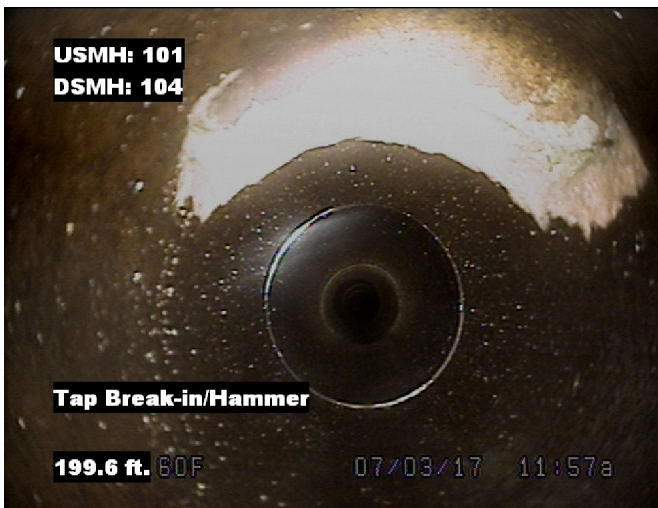
Distance: 200.5 ft. Grade: 0
 Condition: Tap Break-in/Hammer
 Remarks: N/A

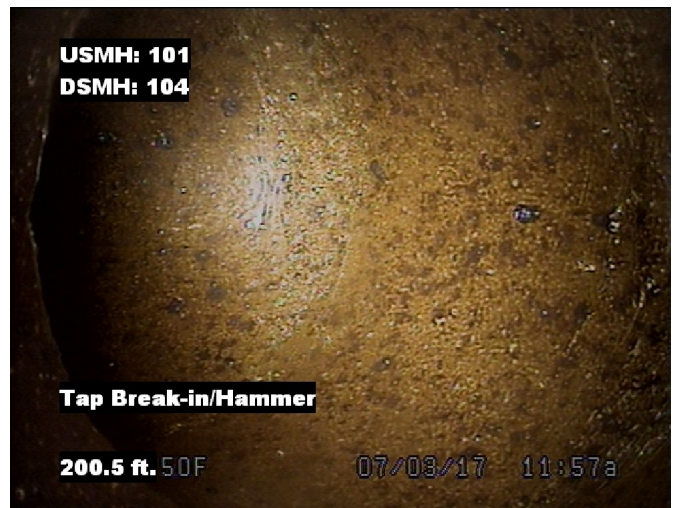
Distance: 200.5 ft. Grade: 0
 Condition: Tap Break-in/Hammer
 Remarks: N/A

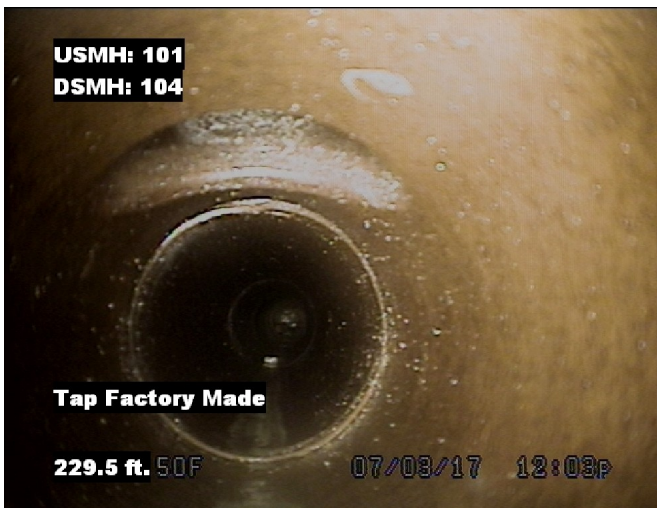
Distance: 229.5 ft. Grade: 0
 Condition: Tap Factory Made
 Remarks: N/A
